# **VINALHAVEN SIDEWALK COMMITTEE**

## **CONDITION ASSESSMENT AND MAINTENANCE & DEVELOPMENT PLAN**

**Prepared by  
Vinalhaven Sidewalk Committee  
Spring 2006**

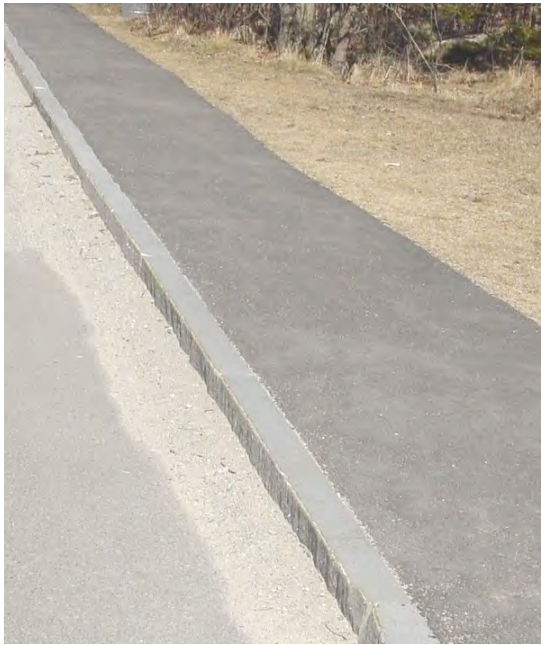
Excellent Condition

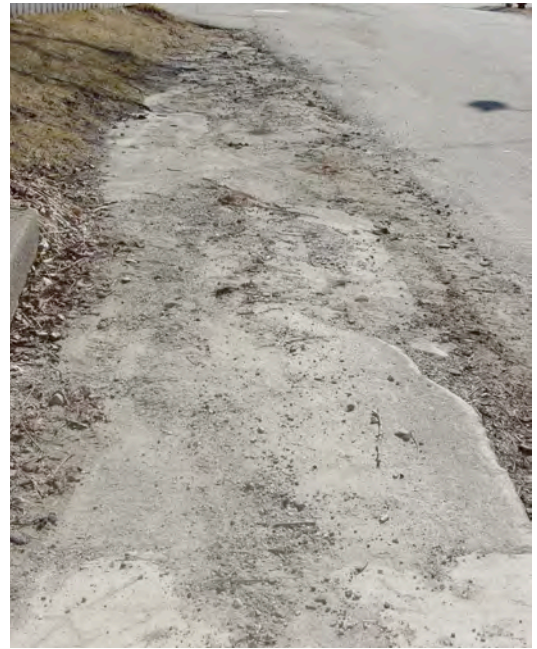
Poor Condition

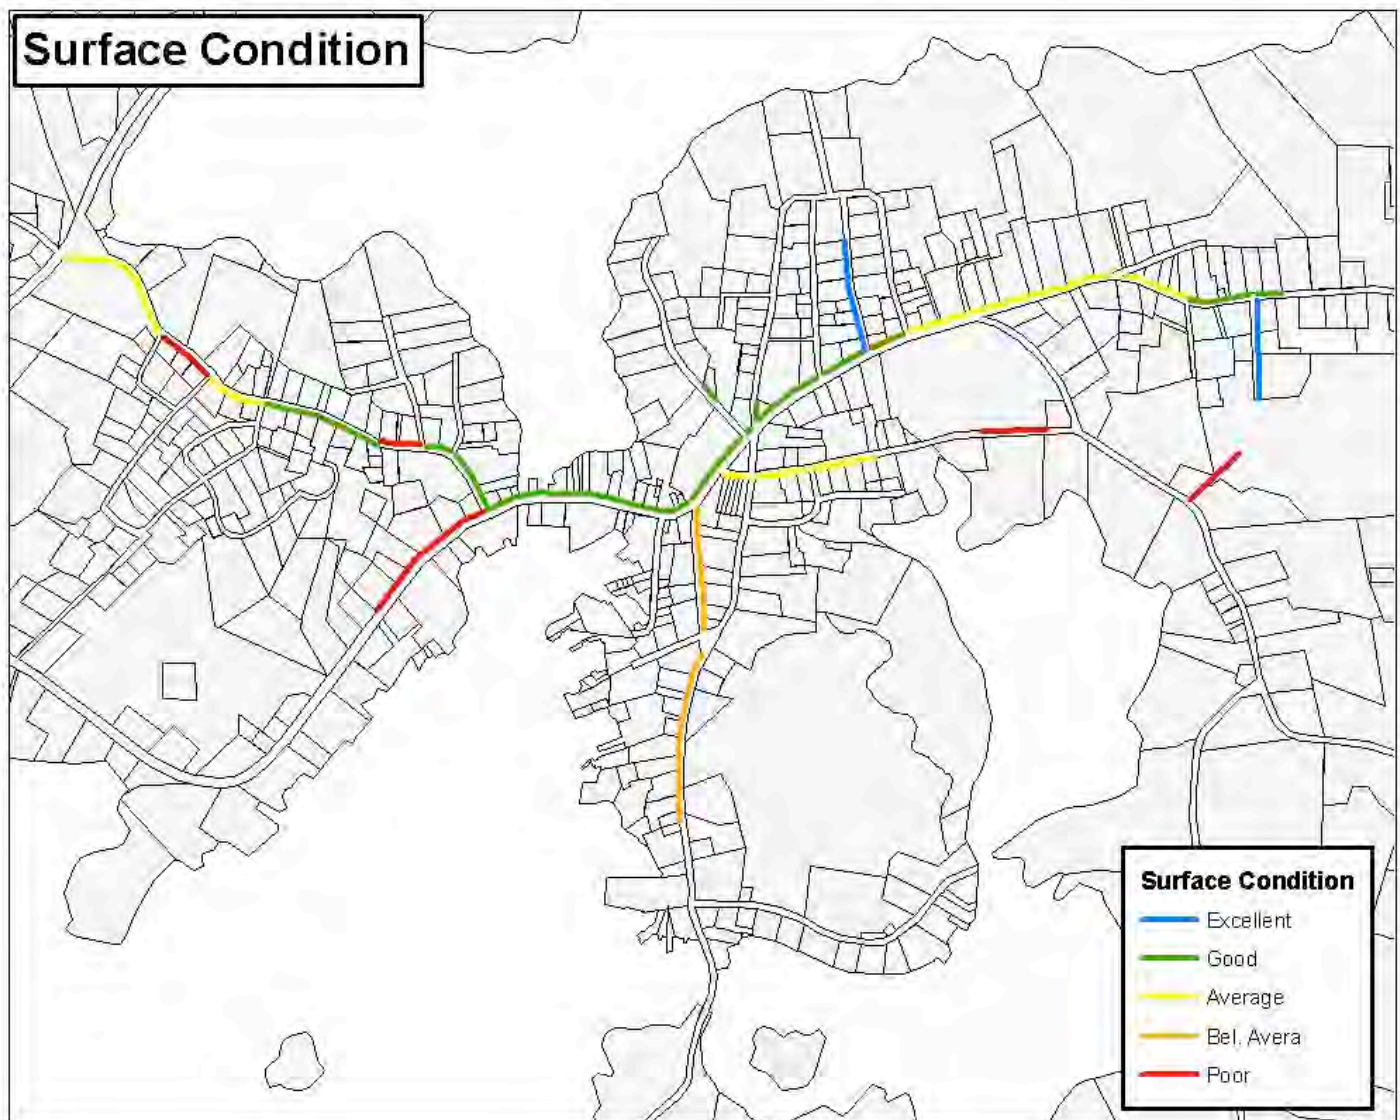
***Figure 2: Surface Condition Map***

**Surface Condition:** Surface condition was a simple measure of the smoothness of the surface of each section. This had to do not only with the actual condition of the surface material (generally asphalt), but also whether the asphalt had heaved, cracked, or otherwise been compromised. In certain cases, storm drainage basins and driveway cuts were allowed to disrupt the sidewalk, resulting in severe dips, slopes, and undulations throughout its course.

Specific areas to note are West Main street, where storm drainage and driveway cuts have impacted the sidewalk, East School Street, where the sidewalk is all but obliterated, and sections of High Street and the School walkway where cracking and heaving have taken their toll.

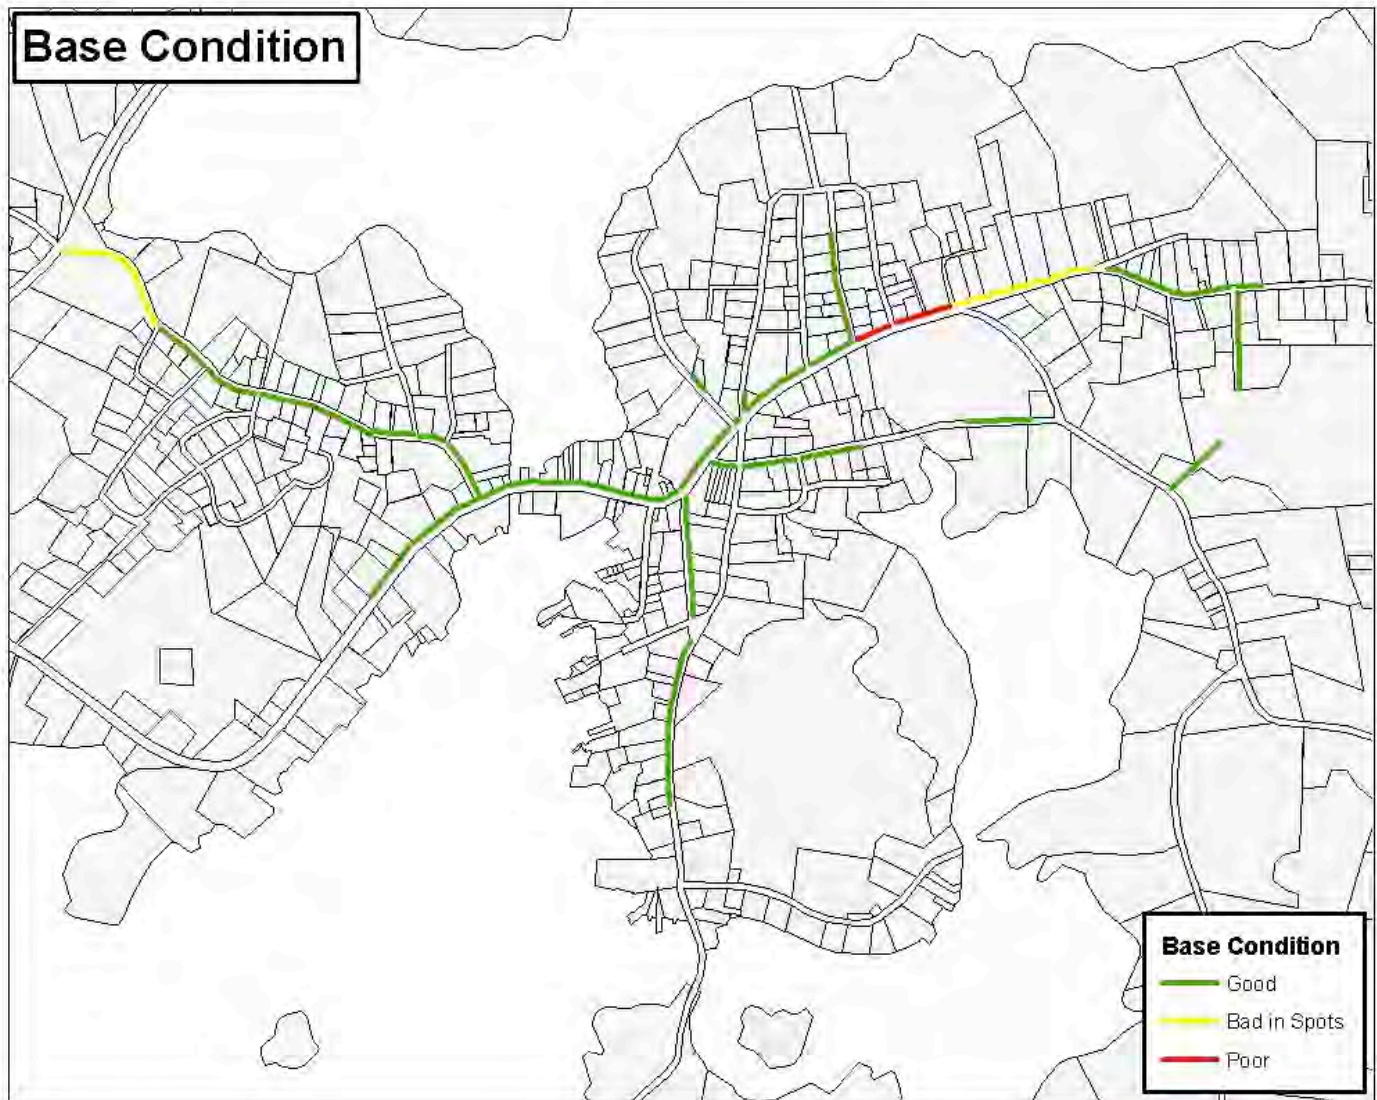
**Figure 3: Base Condition Map**

Specifically, the area between Cottage Street and Clayter Hill Road is in dire need of reconstruction. Areas along the western end of High Street also look as though they could become problematic in the coming years, though they appear sound for the time being.

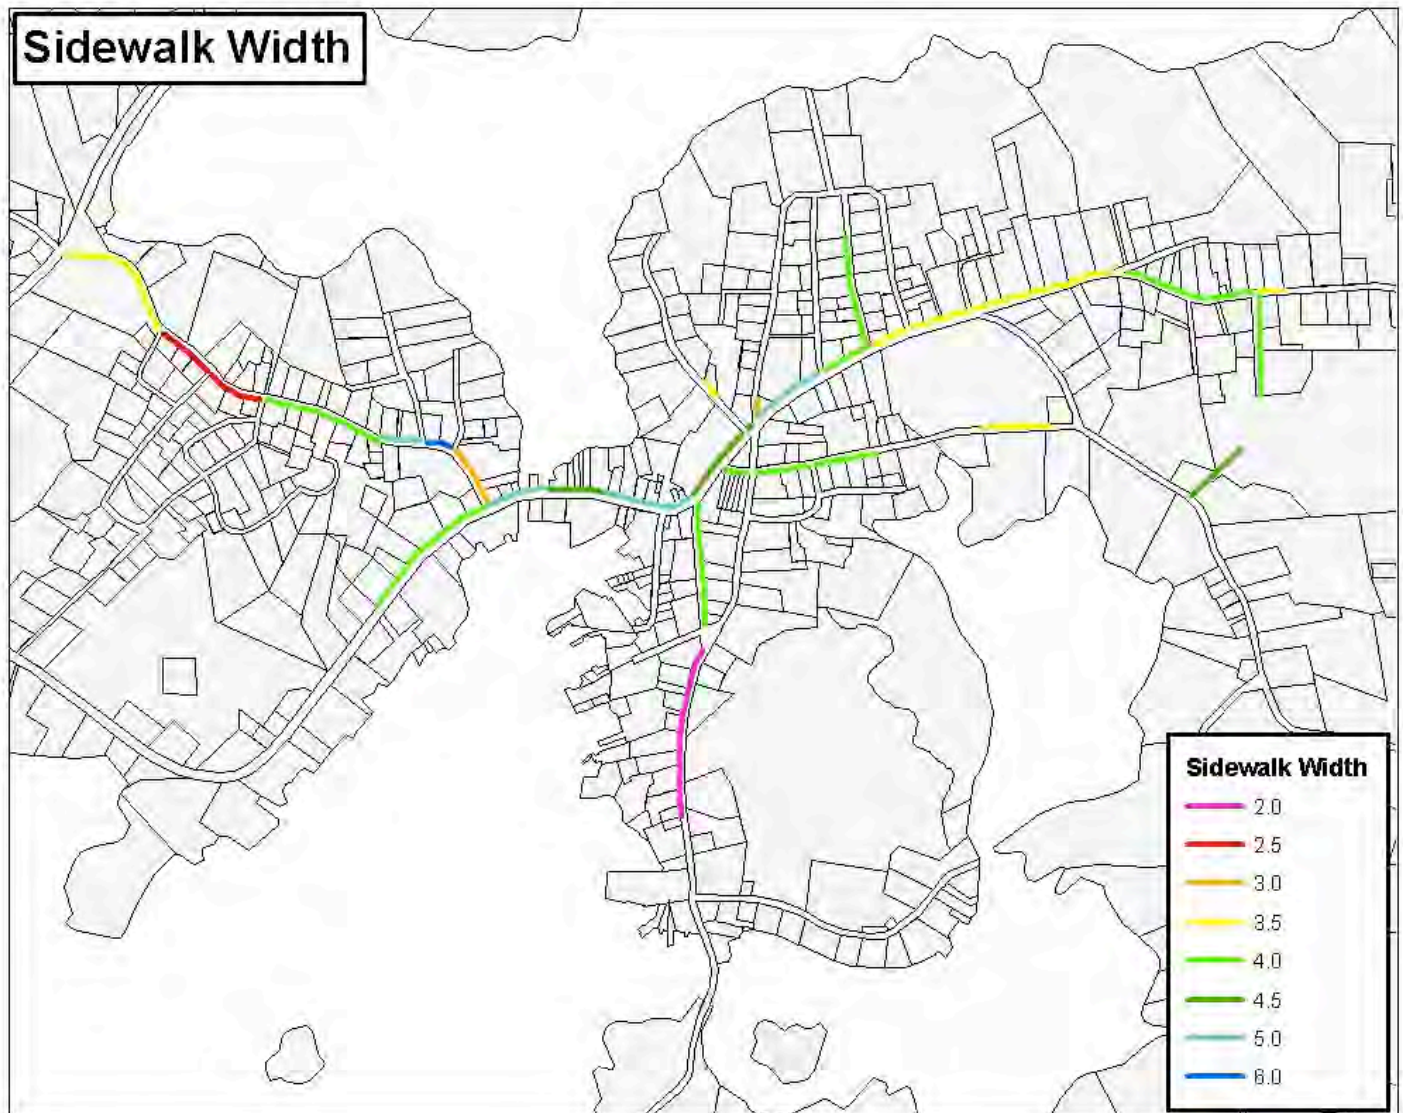
***Figure 4: Sidewalk Width Map***

**Sidewalk Width:** In general, sidewalks should be 4' wide and be free of obstructions. This is wide enough to allow two people to walk comfortably side-by-side, or for two people to pass one another without one having to leave the sidewalk. In heavily traveled areas (such as Downstreet), a wider sidewalk is obviously needed. There are many spots on the island where the minimum 4' width is not met. Our sidewalks are greatly variable in regard to width. The following map shows the narrowest points along the course of each section.

Specific areas to note are along Atlantic Avenue, where the sidewalk is quite narrow because of slope encroachment, as well as near the western end of High Street where the sidewalk is nearly as narrow.

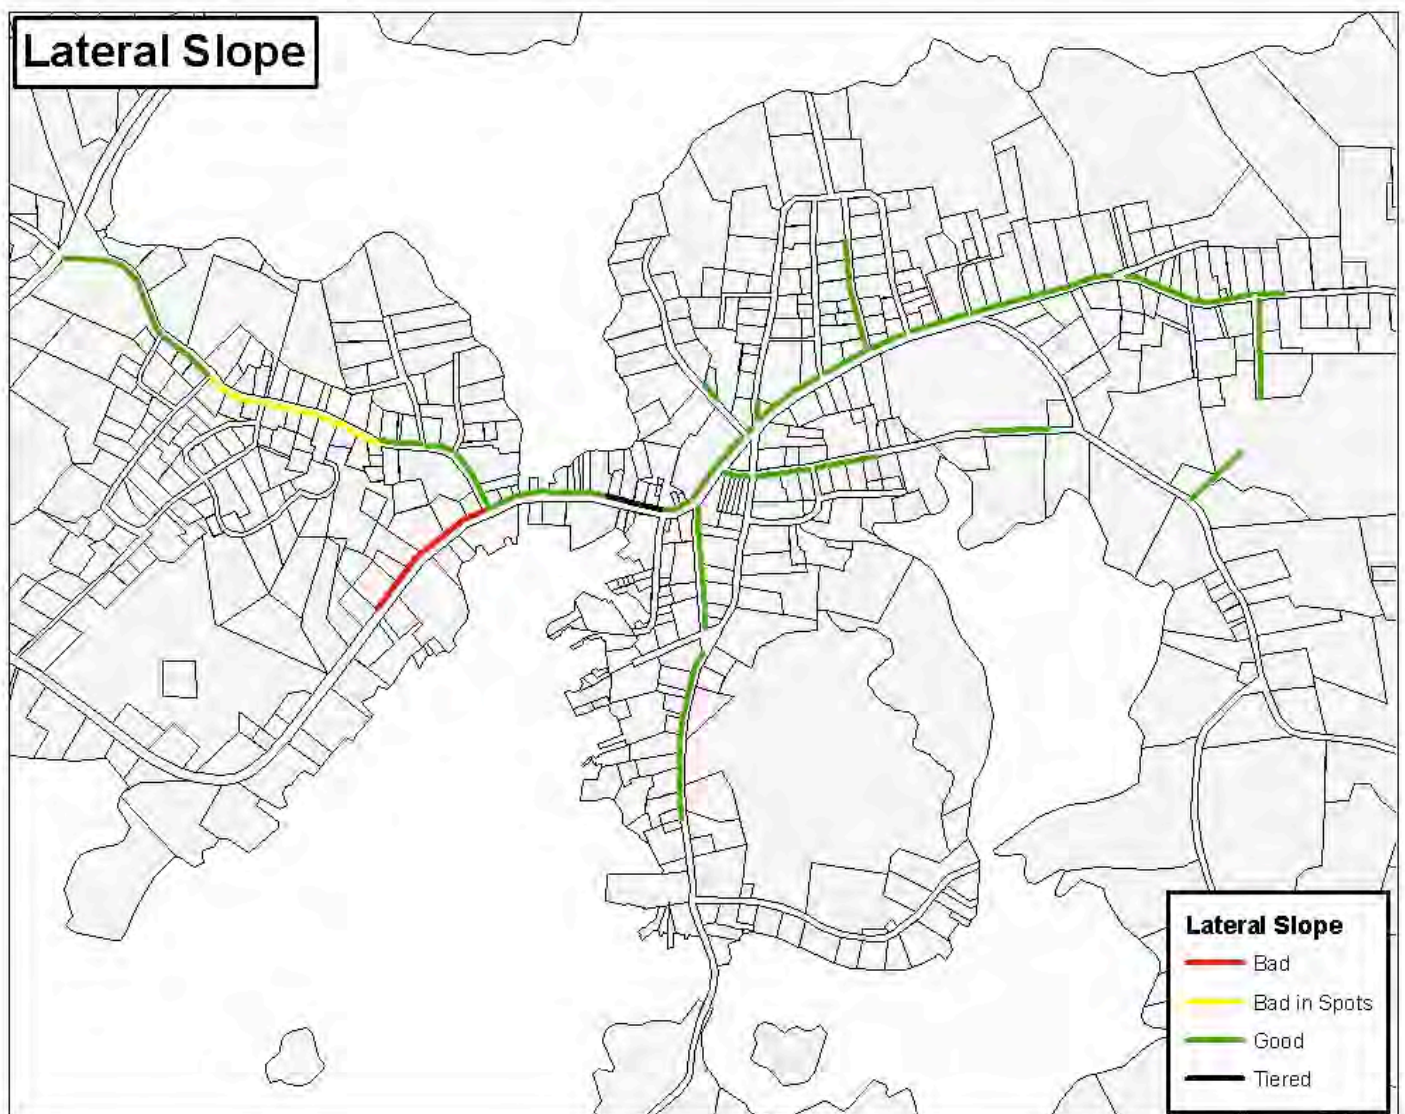
***Figure 5: Lateral Slope Map***

In general, the lateral slope of sidewalks in Vinalhaven is not a problem, with exception of two areas. Along High Street the sidewalk has been intentionally sloped to create a ‘curb’. This method of curbing is actually counterproductive to the proper function of the sidewalk, for the safety reasons mentioned above and also because the angle of the slope significantly reduces the sidewalk’s width. In other words, if the walk drops directly off to street level, the walk can effectively be much wider and safer.

The other area of concern is along West Main Street where numerous driveway cuts and one long section along a parking lot give this sidewalk an uneven lateral slope which is very steep in places. Also of note is the sidewalk in front of the post office, which has been tiered to alleviate the problem of requiring a slope. This particular situation may create problems around handicapped accessibility.

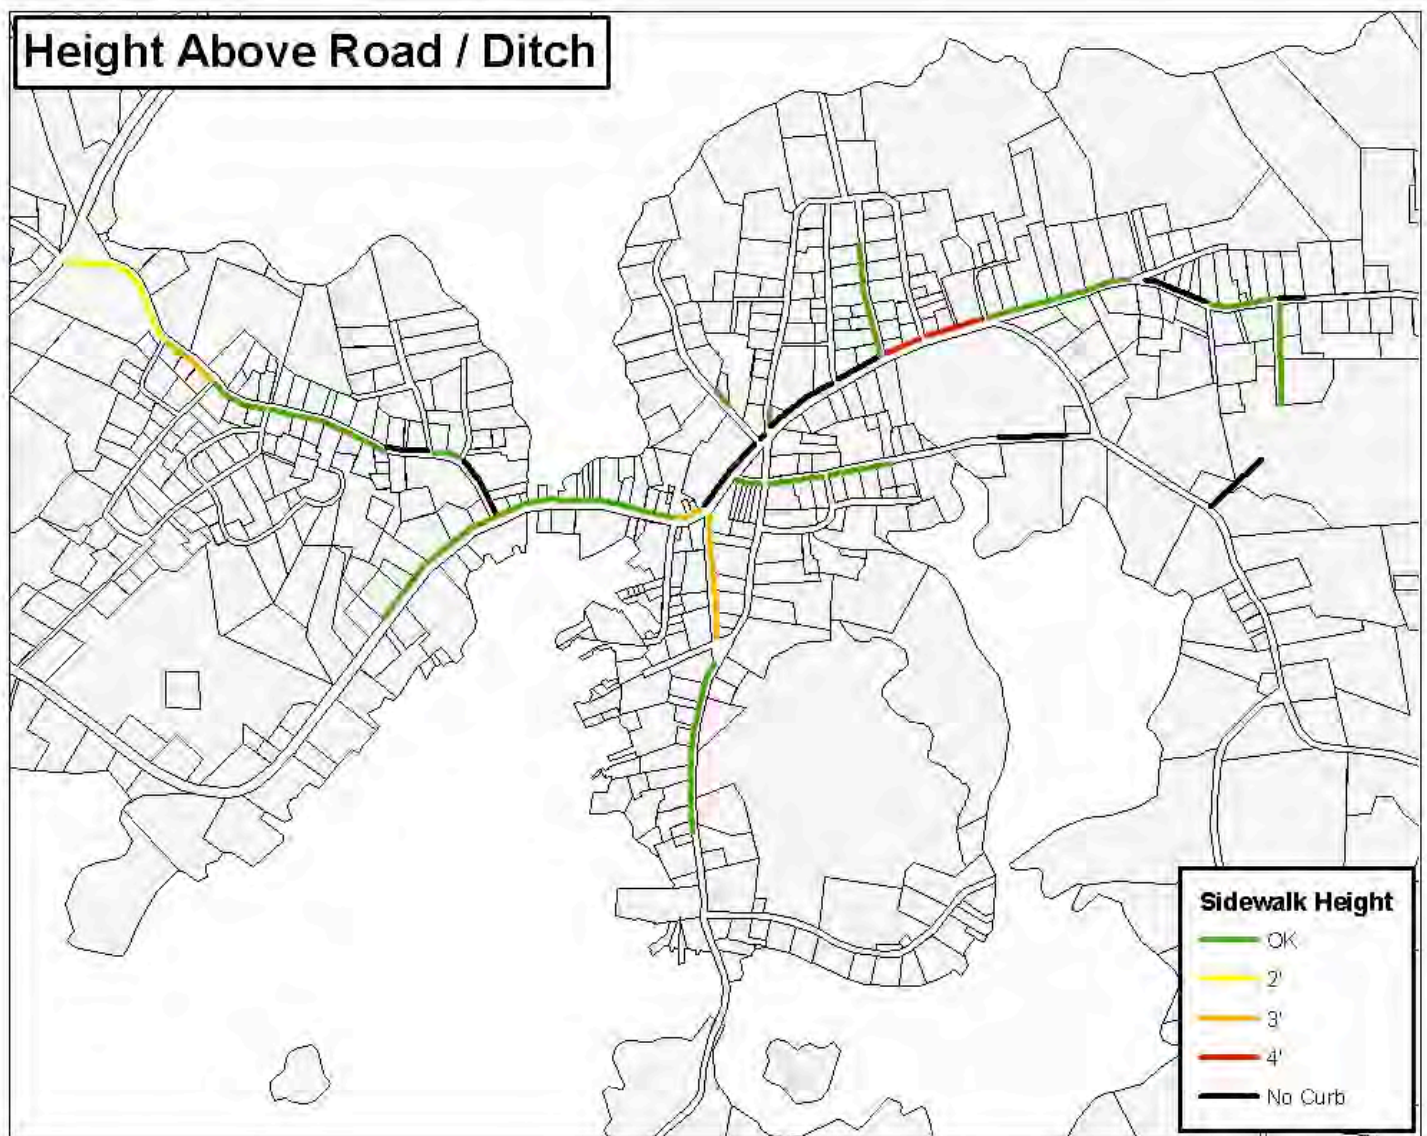
***Figure 6: Sidewalk Height Map***

There are a few areas of concern in this regard. The foremost is the stretch of sidewalk between Cottage Street and Clayter Hill Road. This sidewalk is dangerously high above the drainage ditch below. Sidewalks in other areas, such as along Water Street and the western end of High Street, are also set dangerously high above drainage ditches. Additionally, the section of sidewalk along Main Street across from Clamshell Alley is very high above the road, and visibility in this area is quite limited. This is another area where a redesign of the sidewalk could drastically improve safety.

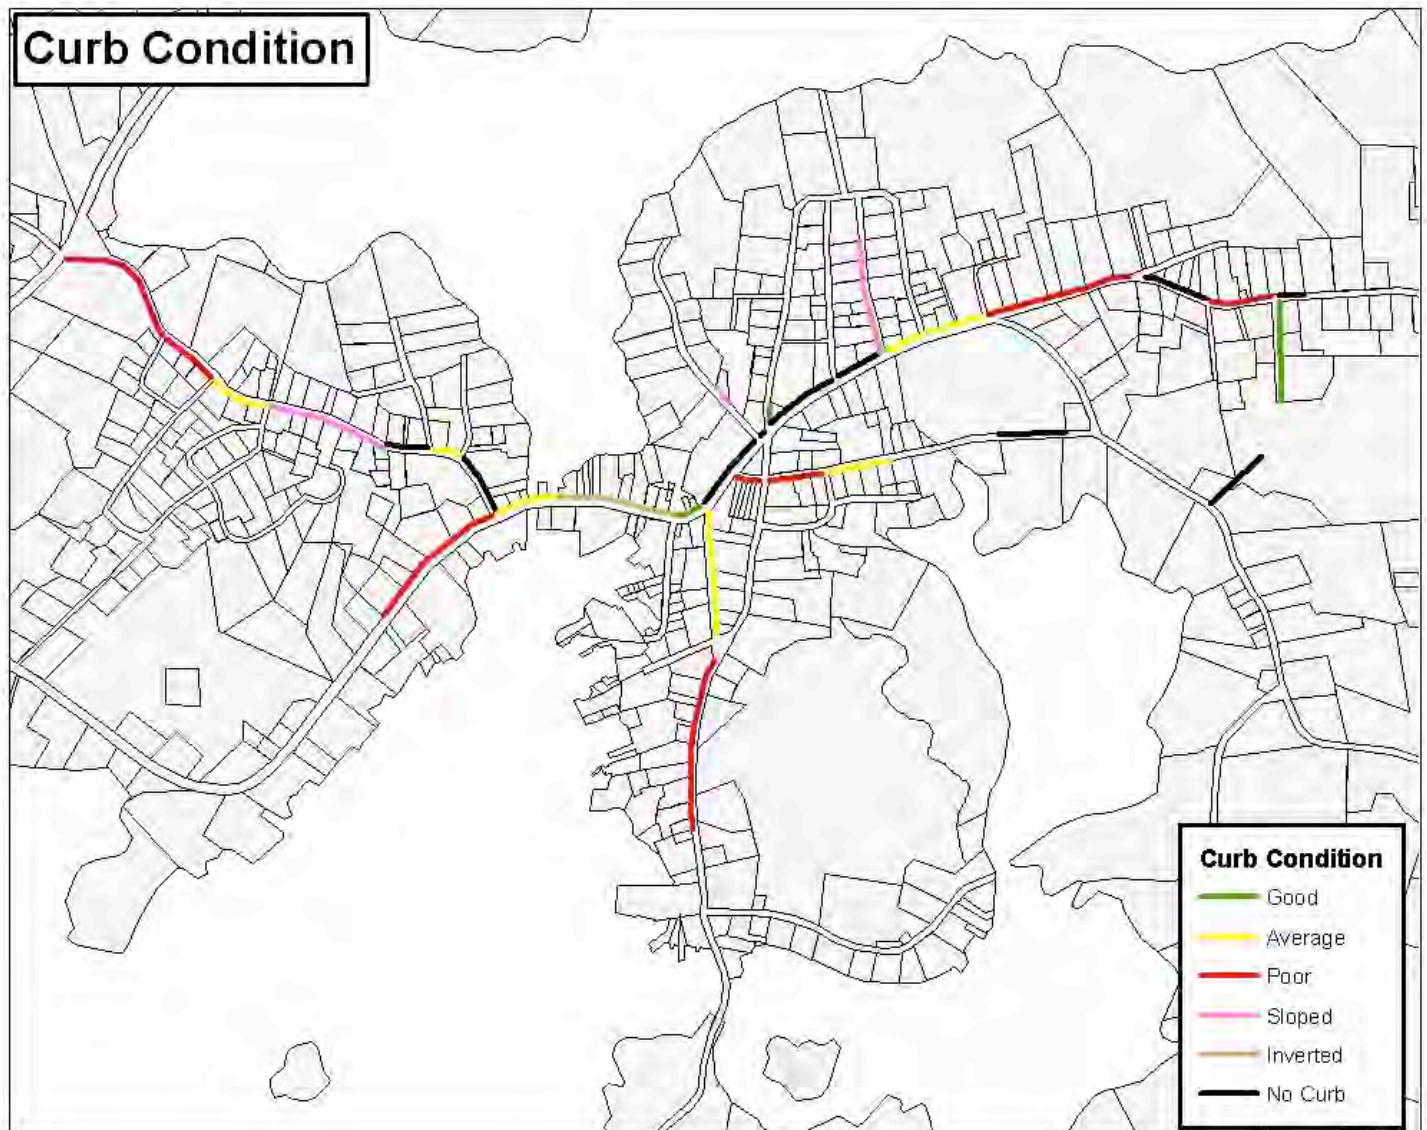
***Figure 7: Curb Condition Map***

Curbs come in many shapes and sizes on Vinalhaven. As previously mentioned, there are sections of sloped curbing which may be dangerous to the sidewalk user. There are also ‘inverted’ curbs, where the sidewalk’s surface is below the top of the curb surface (seemingly done this way because of storefront doors Downstreet), which can lead to drainage issues. In many places in town, there is simply no curb, or a curb that has become significantly shorter as the roads haven been resurfaced. In general, areas with no curb are the worst in terms of being covered with gravel or being used as a defacto part of the road. While being covered in gravel may sound harmless, a thin coat of gravel atop a sloped asphalt surface can be very slippery! And merely sweeping off the sidewalk area is not an effective long-term solution. These areas would function much better with appropriate curbing.

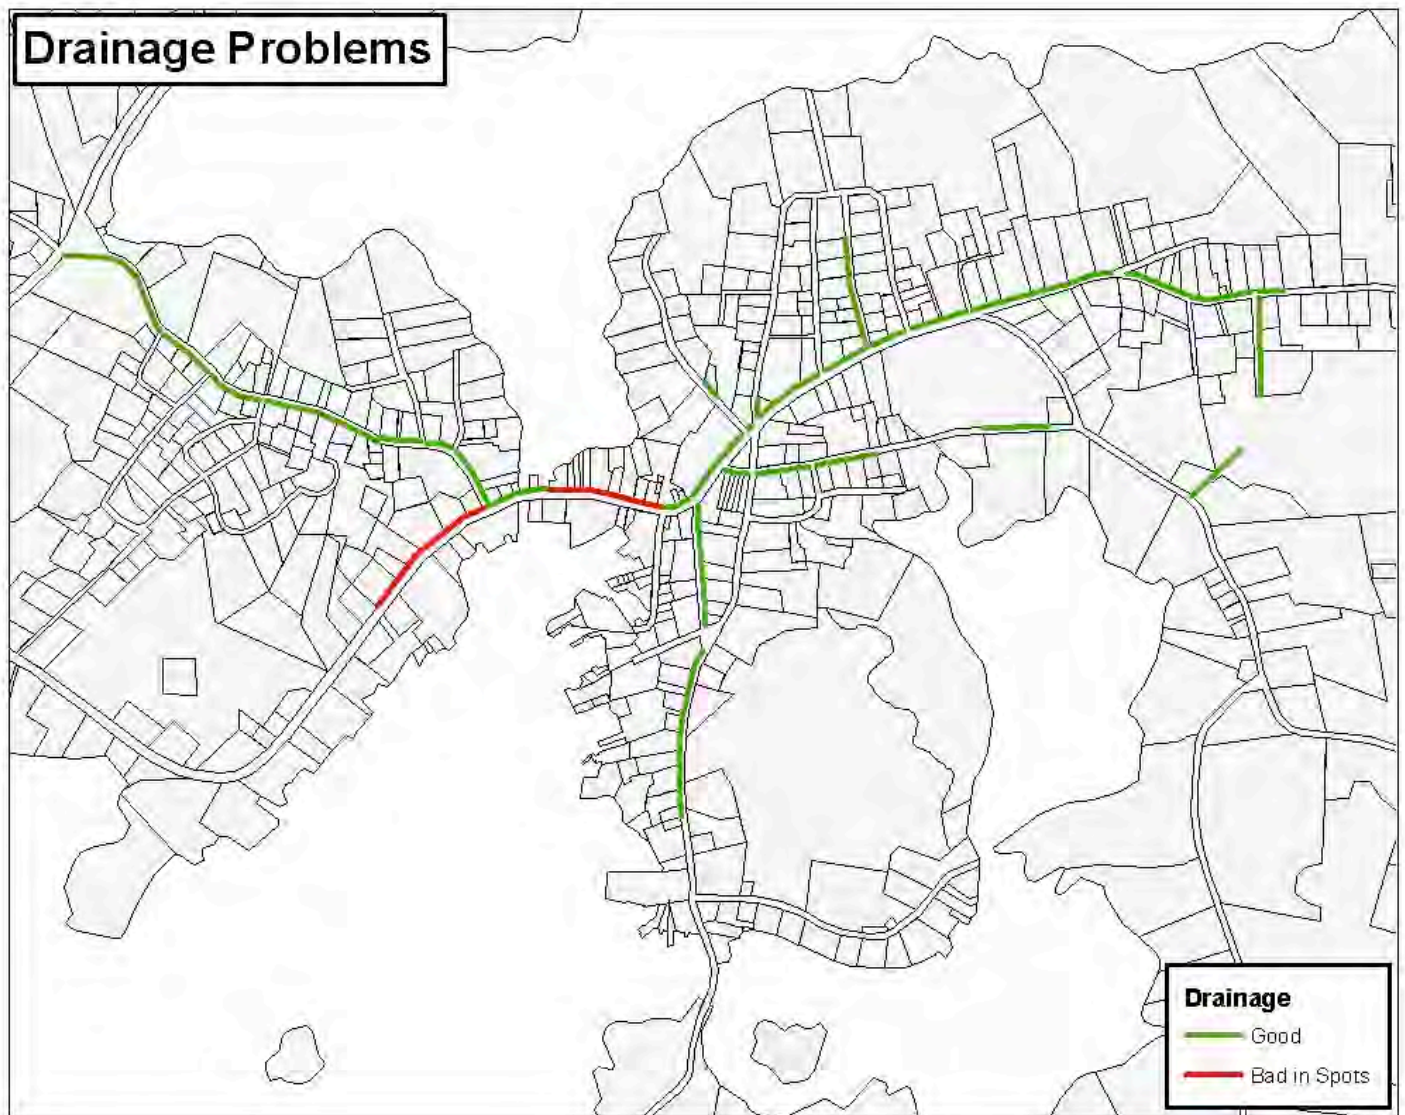
***Figure 8: Drainage Problems Map***

**Drainage:** In general, drainage is not a problem for the sidewalks on Vinalhaven. There are only two areas that are at times problematic, and these areas only have a few localized spots of concern. The two areas of concern are through the Downstreet area, where the ‘inverted’ curb tends to hold water on the sidewalk instead of shedding it into the street, and along West Main Street where the uneven surface of the sidewalk tends to hold water in pockets throughout its course. A reconstruction of the latter with proper curbing and a smoother surface would easily remedy this problem.

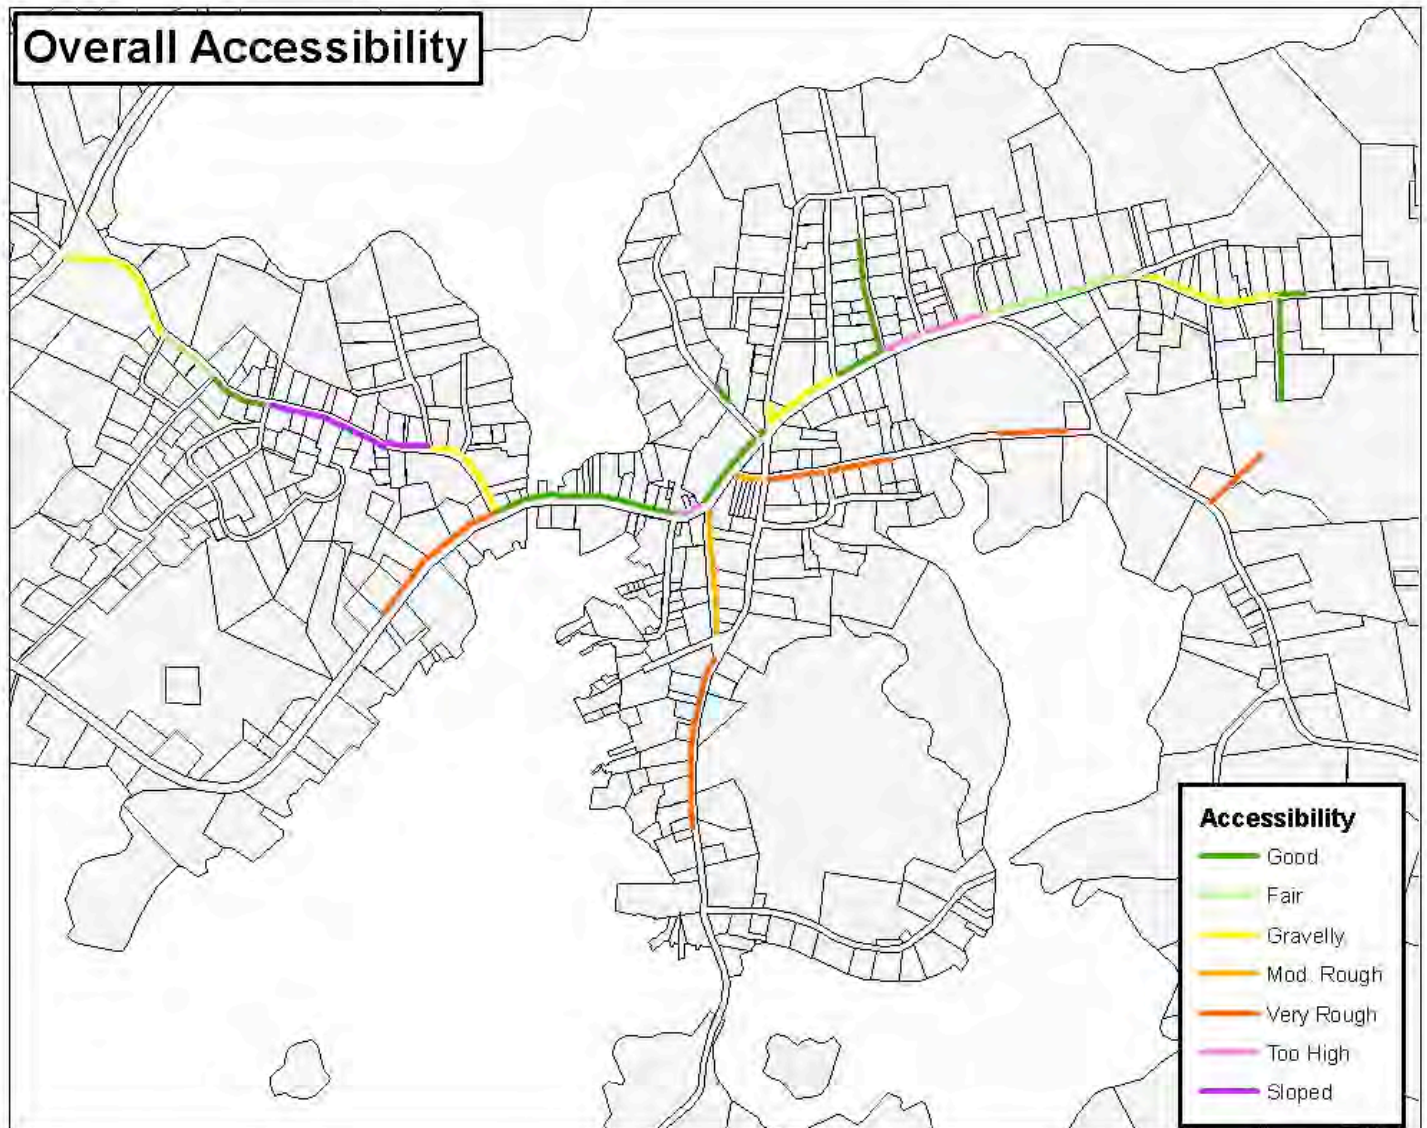
***Figure 9: Accessibility Map***

**Accessibility:** Accessibility can be thought of as really the composite of the entire condition assessment. This variable picks out areas based on their surface condition, height, lateral slope, and amount of road debris. Basically anything that could make negotiating the sidewalk difficult for an elderly pedestrian or someone in a wheelchair is captured here.

The important piece to see on this map is how little of the Island's sidewalk network actually can be classified as good or fair. Many areas need a simple resurfacing, but other areas will require the addition of appropriate curbing to keep gravel and road debris off the sidewalk before they can be considered appropriately accessible.

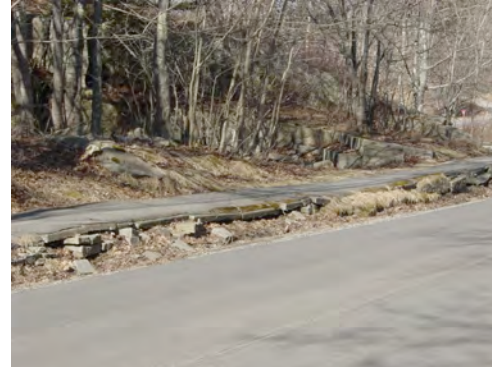
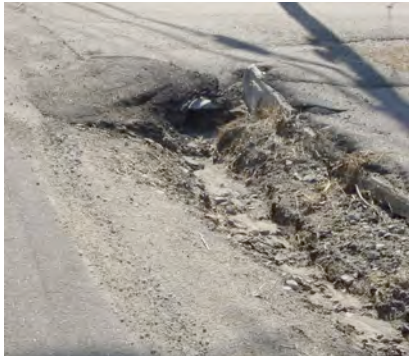
### ***High Street – Triangle to Ingerson St.***

This stretch of sidewalk is wide enough to accommodate its use. The surface in this area is rough in spots, but acceptable overall. The sidewalk is quite gravelly in places, particularly toward its north/west end. It is set above a sizeable drainage ditch and its base appears weak in places. This picture shows the base of this section of sidewalk literally falling out from under its surface

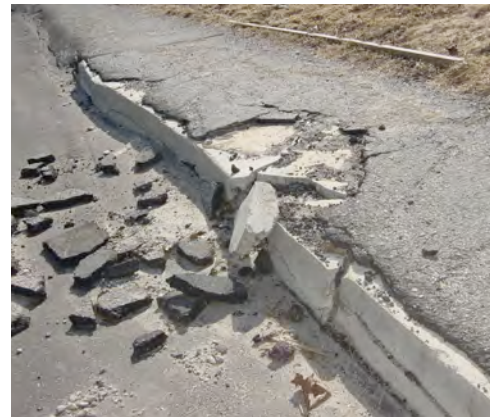
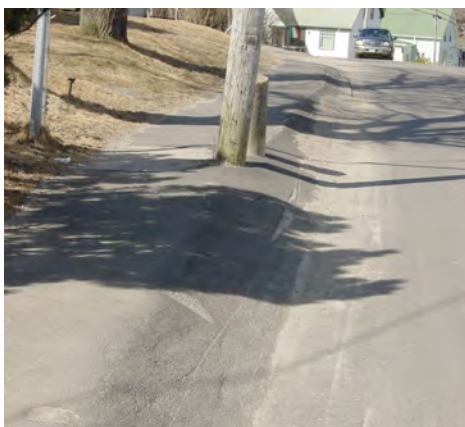
### ***High Street – Starr St. to Mountain St.***

This short stretch of sidewalk is set rather high above a drainage ditch. The surface is generally good, though the sidewalk is discontinuous with the walk coming from the opposite direction at the Ingerson Street Intersection. This picture shows the drainage ditch along this stretch of High Street.

This section is in decent shape, barring one area of recent damage to the surface which could likely be repaired. Sloping curb begins in this area and can be quite steep. This picture shows the area of plow damage. Concrete curbing could prevent such damage in the future.

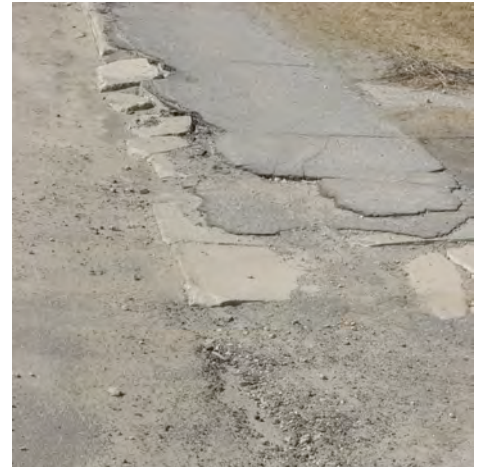
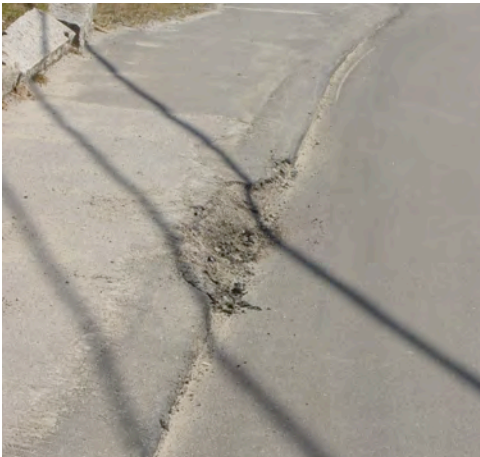
***High Street – just before Summer St. to Summer St.***

This is the worst area for sloping curb, and the resulting reduction in sidewalk width. Also note the telephone poles are installed into the sidewalk, which is also a hazard. This section lies along a very steep part of the hill on High Street. The visibility in this area is low and traffic tends to be fast.

This small area of sidewalk is in very rough shape and should be repaired. Also notable is that the sidewalk abruptly changes sides of High Street at this location. It appears as though sidewalk could be continued along the south side of High Street down to Main Street, instead of crossing over to this point. This would bring continuity to the sidewalks and would help residents of the John Carver Apartments access Downstreet.

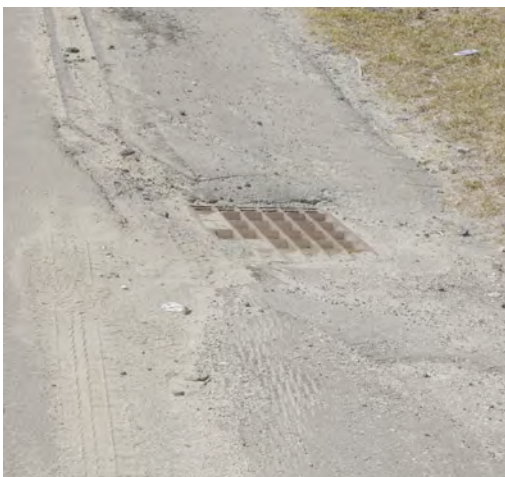
***High Street – Lakeview St. to Main St..***

This is another short stretch of sidewalk. It is in relatively good condition, except for a small area where the curb is crumbling. This could become a problem spot in the future if it is not repaired.

This section of sidewalk is not at all separated from the street, and as such is very gravelly and is basically used as part of the street – people drive over the sidewalk area and park atop it at times. This is a steep area and the gravel here can at times be precarious.

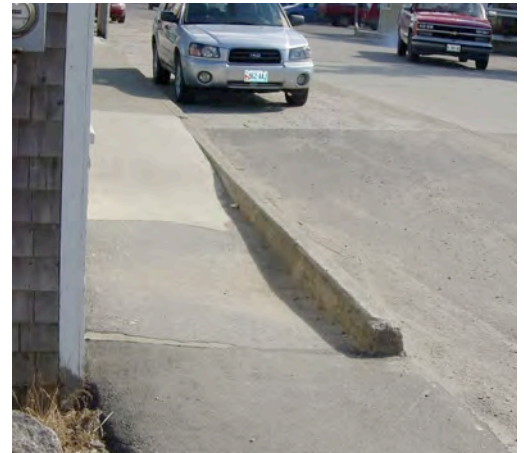
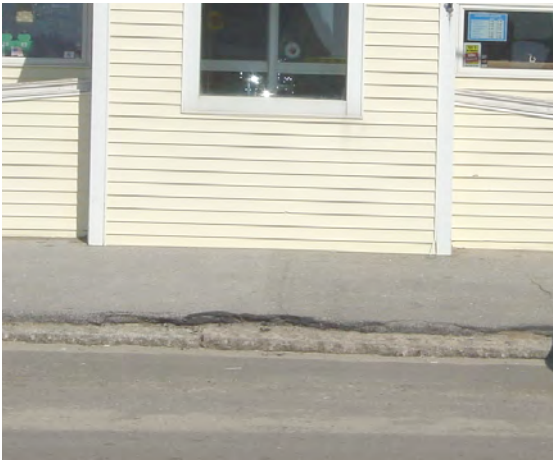
### ***Main Street – High St. to Mill Race***

This is one of the roughest sections of sidewalk in Vinalhaven. Ironically, it is also one of the most used, as it is along the route to the Ferry Terminal. The roughness is caused by a generally uneven surface, multiple driveway cuts, and the placing of storm drains in the sidewalk, as shown at left. Repairing this area of sidewalk should be a high priority.

This sidewalk is a bit narrow, but otherwise functions well. The only issue with this sidewalk is an occasional drainage problem where the surface of the sidewalk drops below the top of the curb. This area is shown in the picture at right.

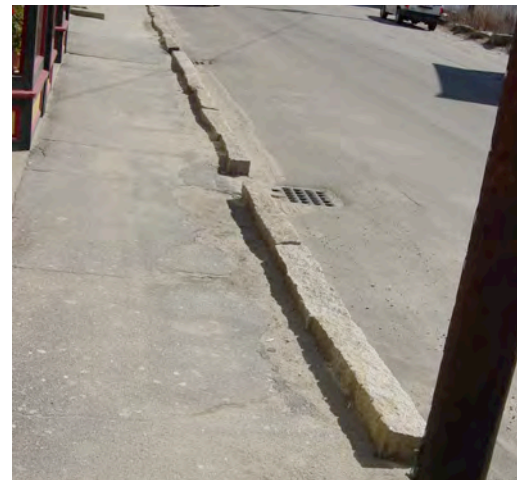
### ***Main Street – Post Office to Clamshell Alley***

This is probably the most used section of sidewalk in town, and it is in good shape. The only problem of note is that the curb directly in front of Carver's Harbor Market is beginning to chip away. In addition, the sidewalk was damaged at Windy Way during the Market's recent expansion project.

This is another well used section of sidewalk in good condition. Again, drainage problems are known to occur in the area where the curb is inverted. Despite the drainage issues, this curbing works well to keep road debris off the sidewalk and keeps drivers from parking atop the walking area.

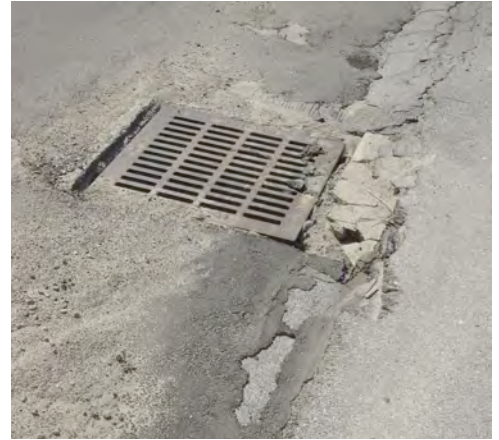
### ***Main Street – Water St. to Carver St.***

This area is generally in good repair, but is perched high above Main Street at a point where visibility is very poor. The storefronts in this area are several feet higher than the road's surface, and the sidewalk is placed to meet these storefronts. The Town should explore its options for lowering this sidewalk to a safer height while still maintaining appropriate access to these storefronts.

This section is generally in good shape, though a little narrow for its amount of use. Most notable about this section is that its curb has literally been swallowed up by the many layers of paving on Main Street. In the picture you can see an area where the curb is crumbling. You can also see the original curb nearly completely covered by the asphalt on Main Street.

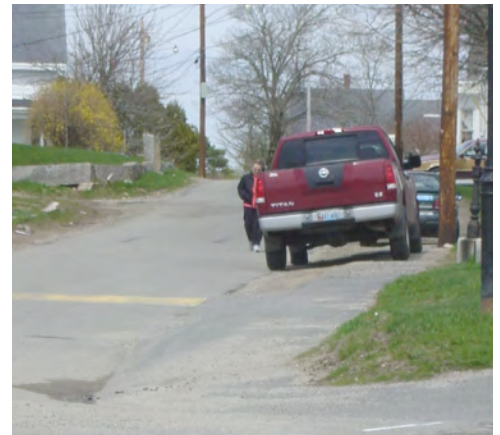
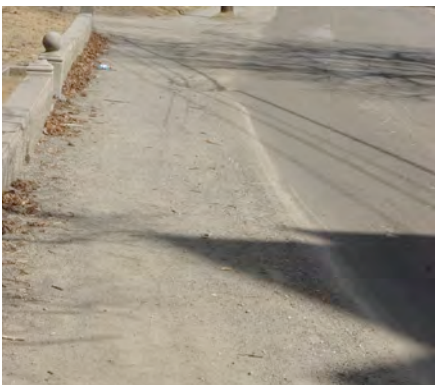
### ***Carver St.***

At one time a good sidewalk was located along this street. However, the sidewalk has become completely covered by turf and is currently undetectable. The town should attempt to restore this sidewalk.

This is another very short and dead-end piece of sidewalk, placed assumedly to sever the library. However, this sidewalk is used as a parking area for the library far more than it is actually used as a sidewalk.

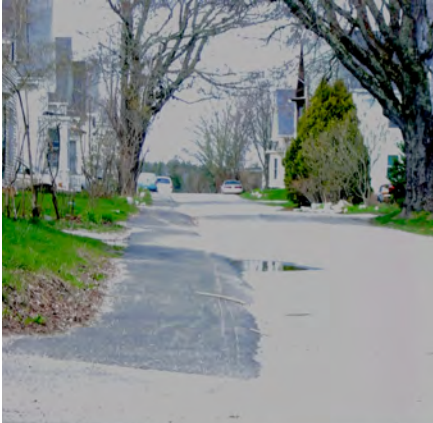
### ***Main Street – Brighton Ave. to Pleasant St.***

This area of sidewalk is in good condition in all but one regard – it is completely covered in gravel and road debris. This is undoubtedly because of the lack of appropriate curbing along this stretch. A curb could greatly improve the function of this area, as well as its appearance.

Similar to the preceding section, this section lies directly along Main Street and is very gravelly. A curb emerges at the eastern end of this section which cleans up the gravel quite a bit. The actual structure of this section is good, only the lack of curb creating any hazards.

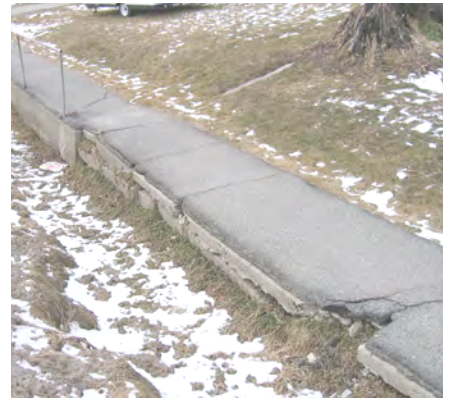
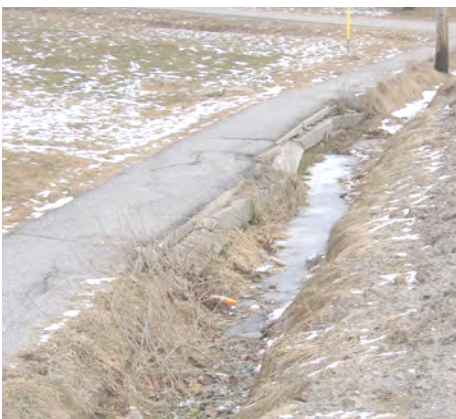
### ***Main Street – Pleasant St. to Cottage St.***

This stretch appears to be quite new and is in great condition. However, the ‘curb’ here is nothing more than the sidewalk sloping down into the street, which can be problematic (as previously discussed). It is doubtful this sidewalk receives much use on this quiet residential street.

The most apparent problem with this sidewalk is its elevation above the adjacent drainage ditch and the fact that the granite cribbing composing its base is slipping out from under it. This sidewalk needs to be rebuilt very soon, which will present the opportunity to reduce its elevation.

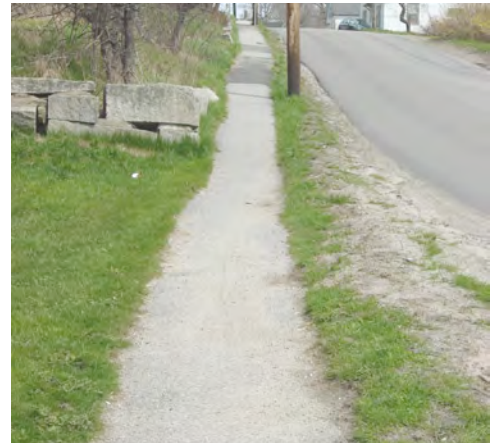
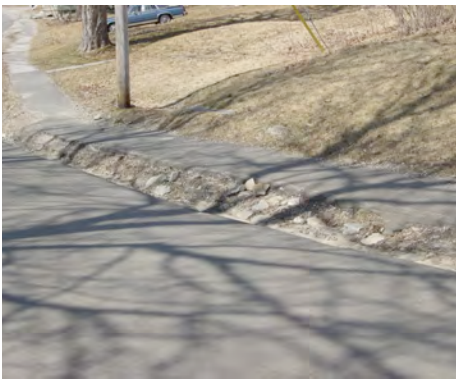
***East Main St. – Clayter Hill Rd. to Beaver Dam Rd.***

This is a continuance of the above stretch, and probably the worst part of the base problem. The sidewalk here is alarmingly high above the drainage ditch. This section of sidewalk is also in dire need of reconstruction.

This section is generally in good condition, however, there is one area of the base which looks problematic. Telephone poles are installed into this sidewalk and obstruct the path of travel. This sidewalk is used by many children on their way to school each day.

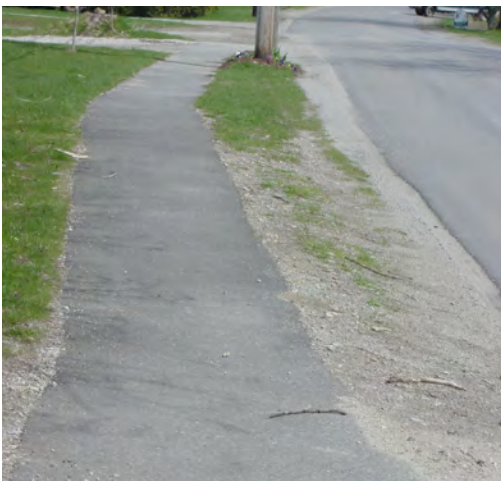
***East Main St. – Ava St. to Arcola Ln.***

The sidewalk here is generally in good shape though it is gravelly. The ditch along this section is particularly rough, which again suggests that perhaps a curb and catch basin would better serve the drainage situation here.

This section is very similar to the section before it in all regards. This section receives a lot of use by schoolchildren each day.

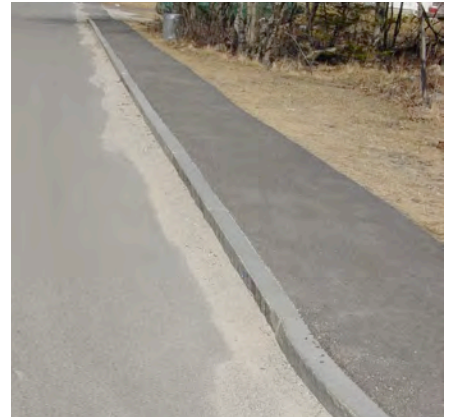
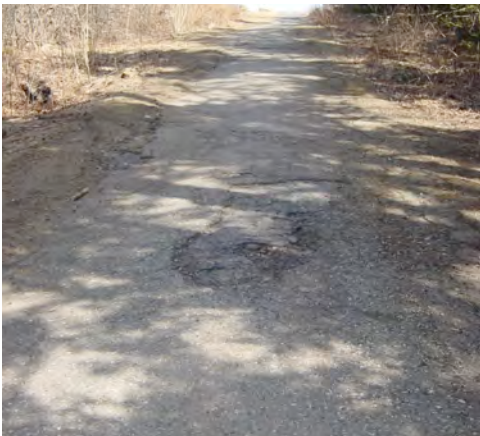
### ***Arcola Lane***

This is a very short area of sidewalk, but it is in good condition. It extends only a short distance east of the school crosswalk. It is doubtful that it receives much use.

This section is perfect – has appropriate curbing, is an even width throughout, is free of obstructions, has an even lateral slope, is not interrupted by driveway cuts, and is very smooth. This is a good example of what sidewalks could be like throughout town. Notice how the curbing keeps the sand and gravel on the road instead of on the sidewalk.

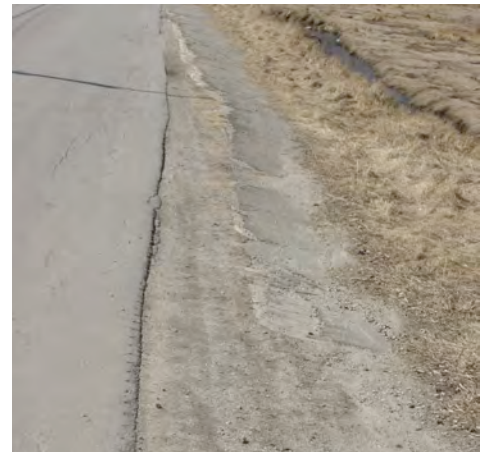
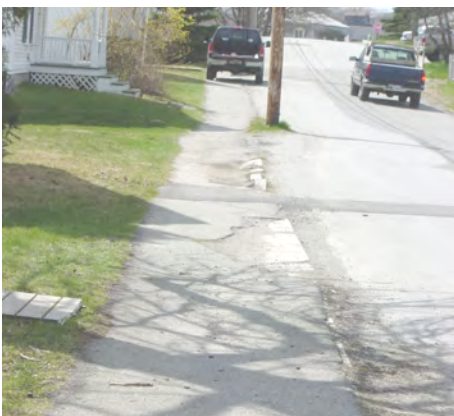
### ***School Street at Ballground***

This is a short segment between the school and East Boston Road. It is actually not within the Town's jurisdiction, but it is a vital piece of the sidewalk network. It is in very rough condition and receives a lot of use. Unfortunately the road it leads to does not have a sidewalk of its own. Rebuilding this section and extending a sidewalk along East Boston Rd. should be explored.

This section of sidewalk is in very poor shape – it is barely holding together. It also begins out of nowhere and ends abruptly in the middle of nowhere. It is doubtful that this receives any use, as people walking in the area generally walk on the road. Luckily traffic is relatively light here, but it does tend to move quickly.

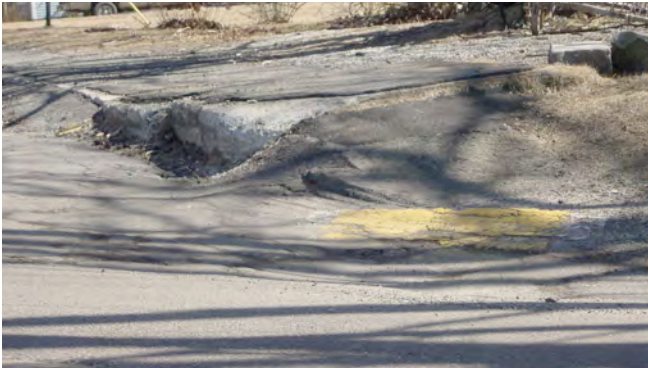
***School Street – Frog Hollow Rd. to Atlantic Ave.***

This area is in fair condition, with some drainage issues in spots. Again, it seems that most people walking in this area choose to walk in the road. A better sidewalk along the length of School Street might change this.

This area is in fair condition – the surface is rough near Frog Hollow Road, it is gravelly near Atlantic Avenue (because there is no curb). This area receives quite a bit of use from people going to & from the school and the East Boston Neighborhood.
