# **VINALHAVEN SIDEWALK COMMITTEE**

## **CONDITION ASSESSMENT AND MAINTENANCE & DEVELOPMENT PLAN**

**Prepared by  
Vinalhaven Sidewalk Committee  
Spring 2006**

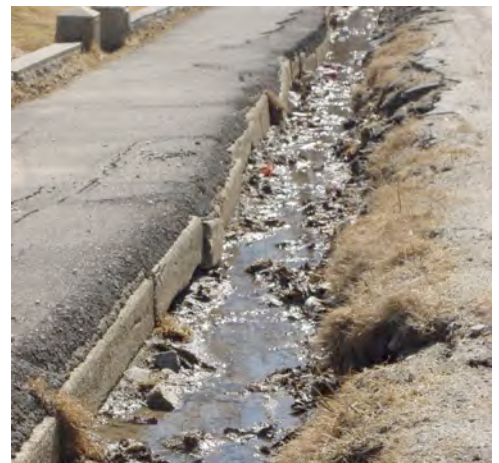
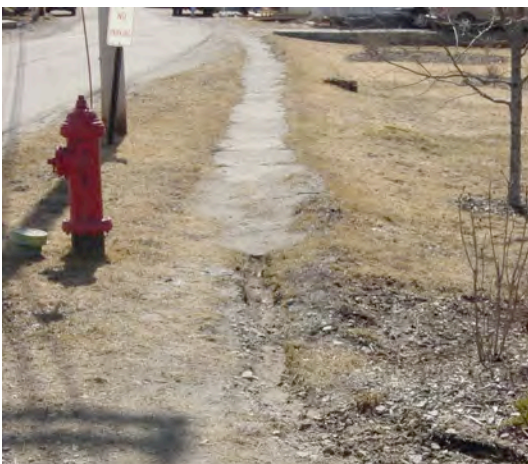
***Water Street – Main St. to Atlantic Ave.***

This is a very short and rough stretch. The most problematic feature here is the ramp onto the sidewalk from Main Street – it is very steep and rough and forces most pedestrian traffic directly into School Street instead of onto the sidewalk.

This section is largely in good shape, except that at each end it becomes rough and very gravelly. Along its course it follows a deep drainage ditch. Removal of this ditch would make this walk much more safe and pleasant and would allow for a slight widening of Water Street.

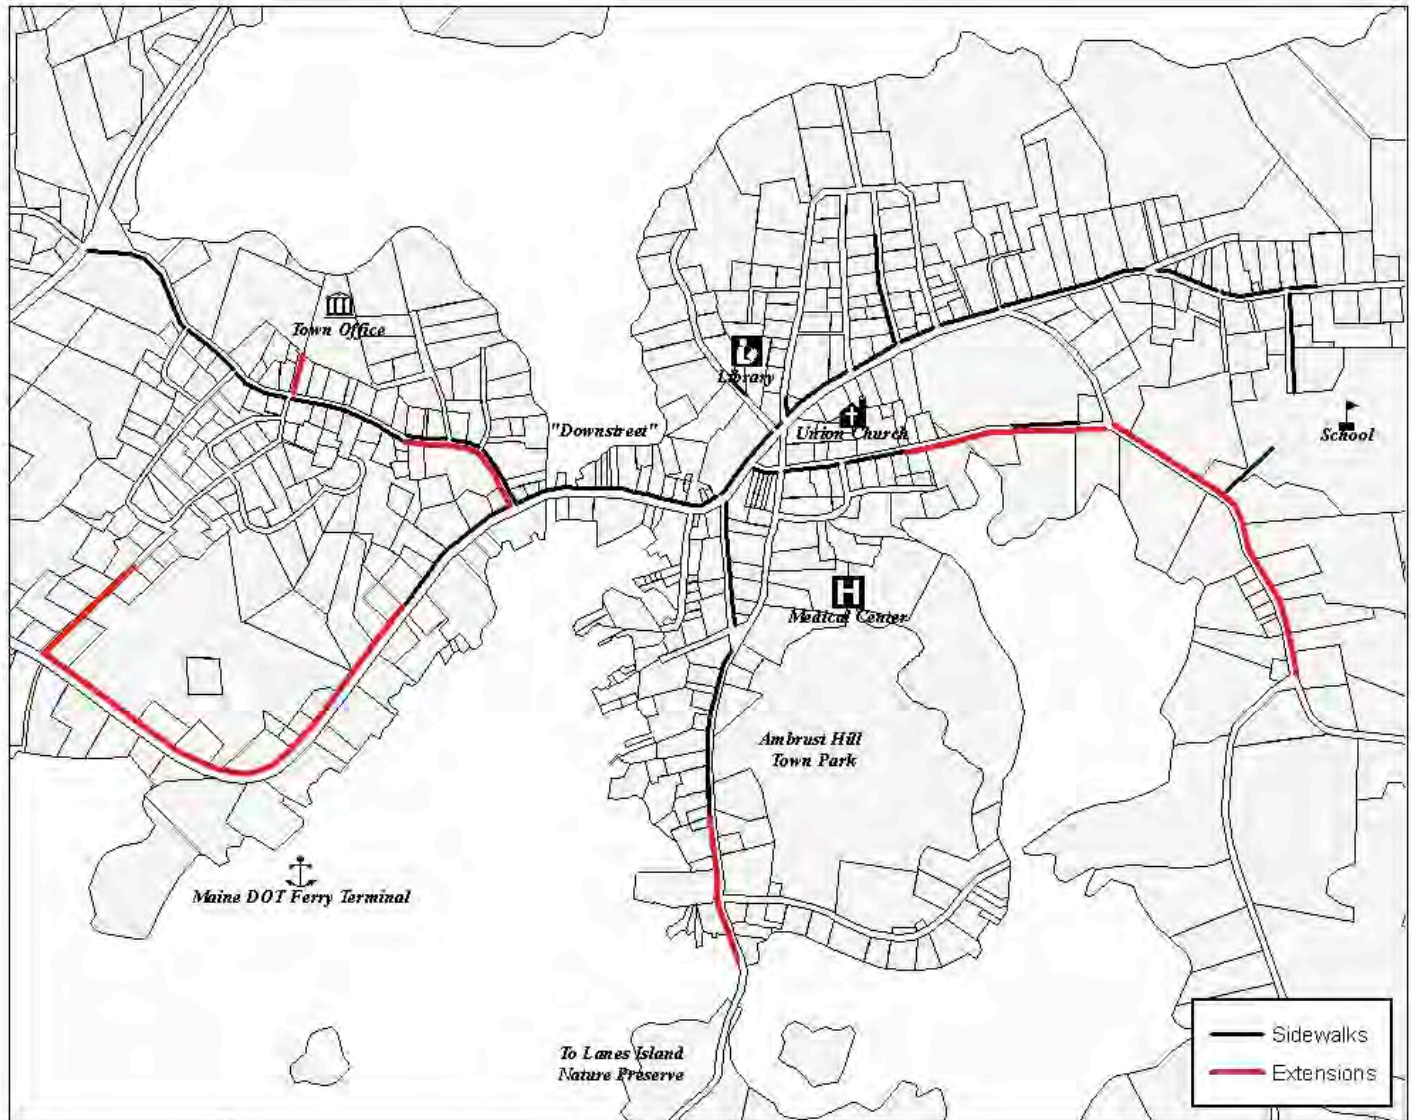
**Figure 10: Recommended Sidewalk Extensions**

**Ferry Terminal** – Six times a day several people walk to and from the Ferry Terminal, particularly in the summer when the several can turn to scores. This is undoubtedly the most important site that is not currently connected to the village’s sidewalk network. To make matters worse, West Main Street can be busy and at times and congested with walkers, bikers, semi trucks, forklifts, and regular vehicles. Clearly a priority.

**Vinalhaven School (Rear Entrance)** – This entrance to the school property is used by a large number of students every day. Sidewalks along the route to this end of the school end at Frog Hollow Road, leaving children a great distance to walk in the road. Traffic along the lower portion of School Street and East Boston Road tends to move quickly. This could also be the first phase in connecting the East Boston neighborhood.

**Lane’s Island Nature Preserve** - This park is well used, particularly during the summer months when the roads are busier. Many people walk to this park from the village, and the southerly portion of Atlantic Avenue is steep and very narrow and without a sidewalk. The bridge to Lanes Island is very narrow, so a sidewalk across the bridge is not feasible. But an extension of the sidewalk from the top of the hill on Atlantic Avenue down to the bridge would be a great improvement. Once on Lanes Island, the road widens and traffic drops.

**Vinalhaven Town Office** – While the Town Office is accessible via quiet streets, the most direct route is a short trip from High Street down a gravel lane alongside the Historic Society. A sidewalk placed here could improve pedestrian access to the Town Office greatly.

**East Boston Neighborhood** – A sidewalk here would connect this small neighborhood to the rear entrance of the school and the rest of the village. It could also provide access to the proposed skate park, if constructed.

**Round-the-Mountain Neighborhood** – This neighborhood will be served by the sidewalk extension to the Lane’s Island Bridge, if it is constructed.

**The Sands Neighborhood** – Not a large neighborhood, this is the entrance to the village from the west and traffic tends to speed through this area. The loop formed by High Street, Old Harbor Rd, Sands Rd, and West Main Street is a popular place for residents to walk for exercise. A connection to the Skin Hill neighborhood via Mountain Street Extension (a “paper street”) would allow those residents and people at the Town Office easier access to the Ferry Terminal. A Town Park and the Land Trust Offices are also in this area.

**High Street, South Side** – To keep the sidewalk from crossing street abruptly in the middle of a hill and to better serve the John Carver Apartments, an extension of the sidewalk along the south side of High Street down the hill to Main Street should be considered.
