Preliminary Design Report

Lane's Island Bridge #5270

Vinalhaven, Maine

WIN 021707.00

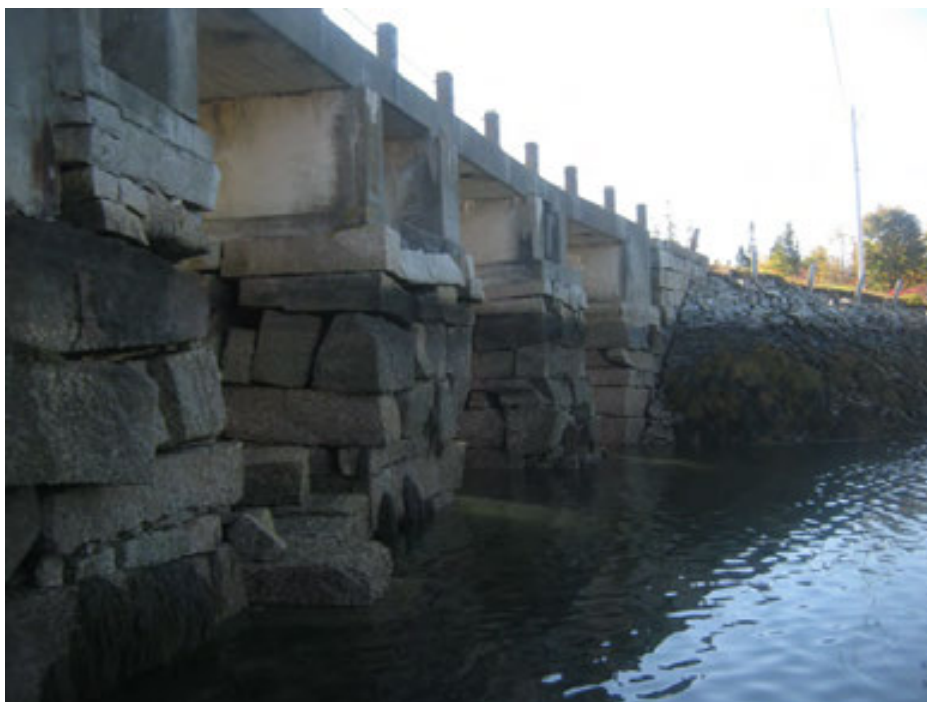
PHOTO 4

Description General view of piers showing missing stones and voids

- Proposed Repair Alternatives: The existing stone substructures will be repaired by filling larger voids with grout to stabilize the granite stones preventing further shifting and stone loss. Some loose or shifted stones will be stabilized by pinning in place. The following alternatives were considered for grouting the abutments and piers:

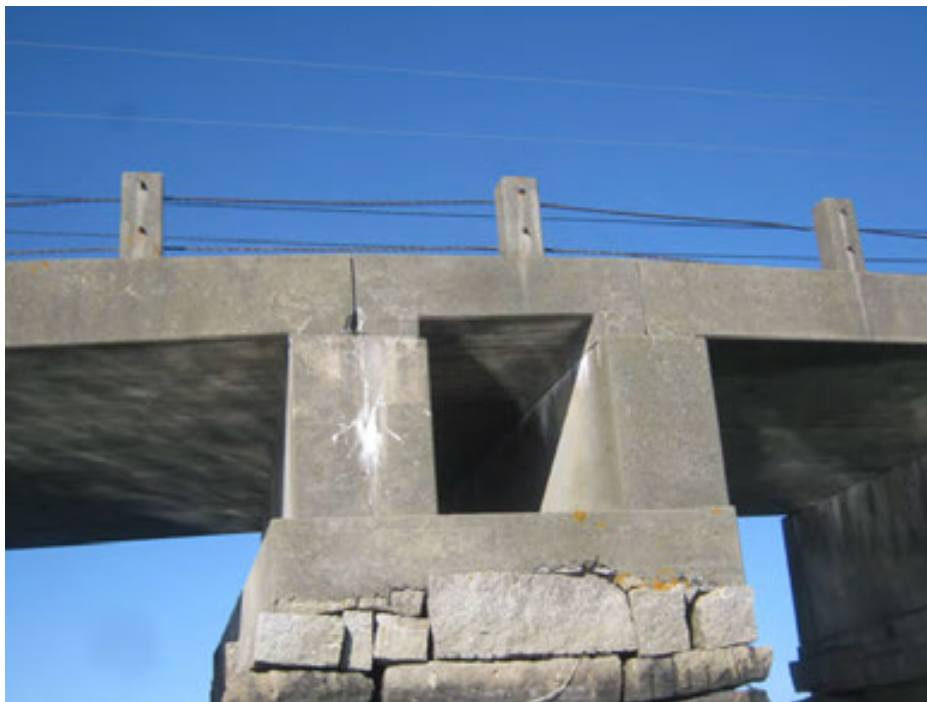
PHOTO 14

Description View of pier caps on SW pier showing some cracking and efflo

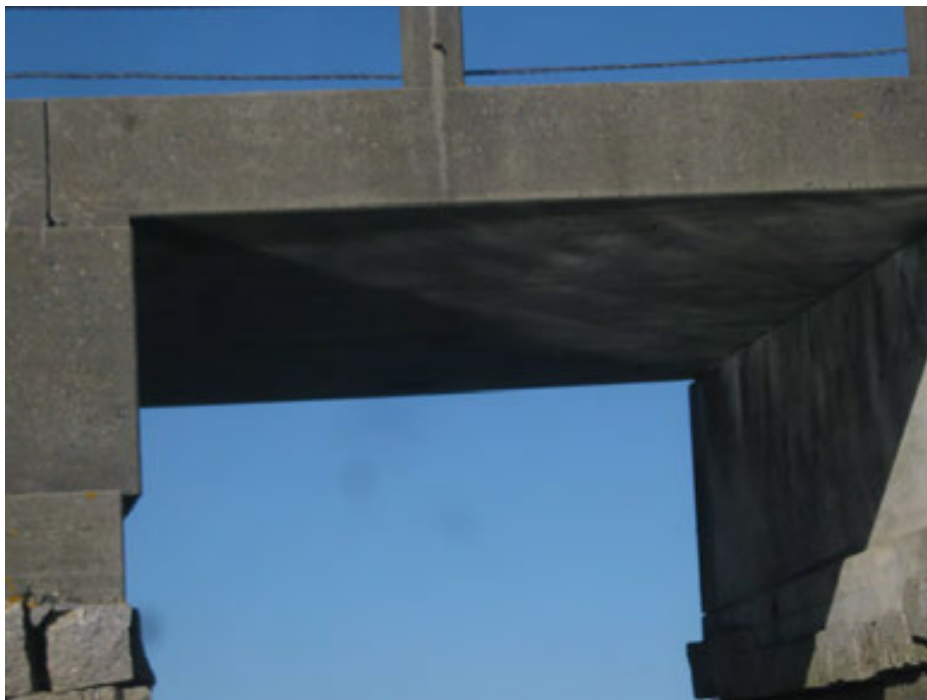
PHOTO 15

Description View of center span soffit showing cracking and efflo

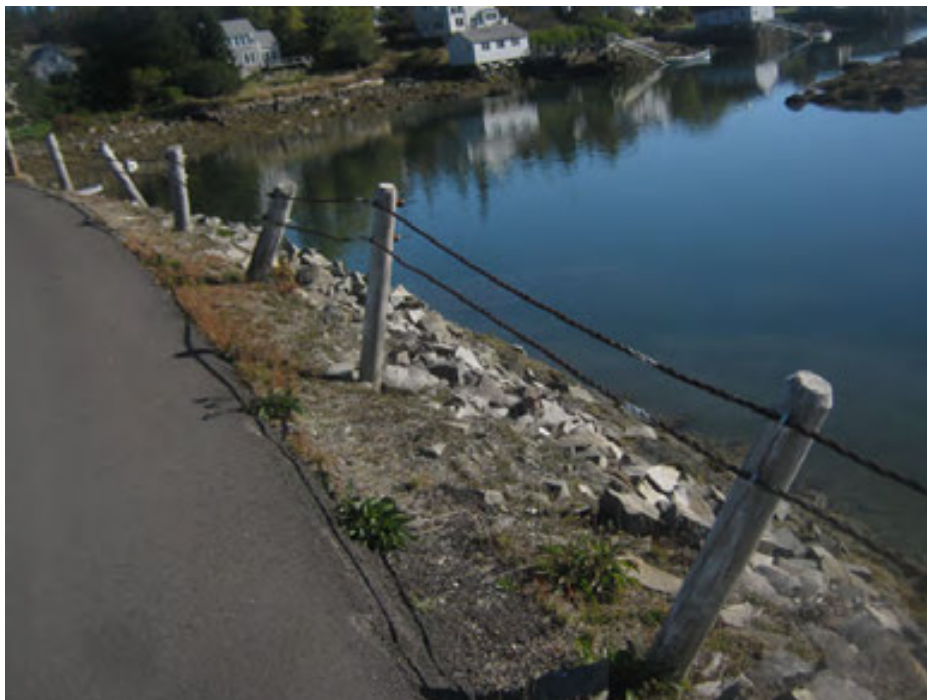
PHOTO 17

Description View of cable guard rail failing

- Replace approach railing with 31" W-Beam Guardrail; Cost: \$32,000

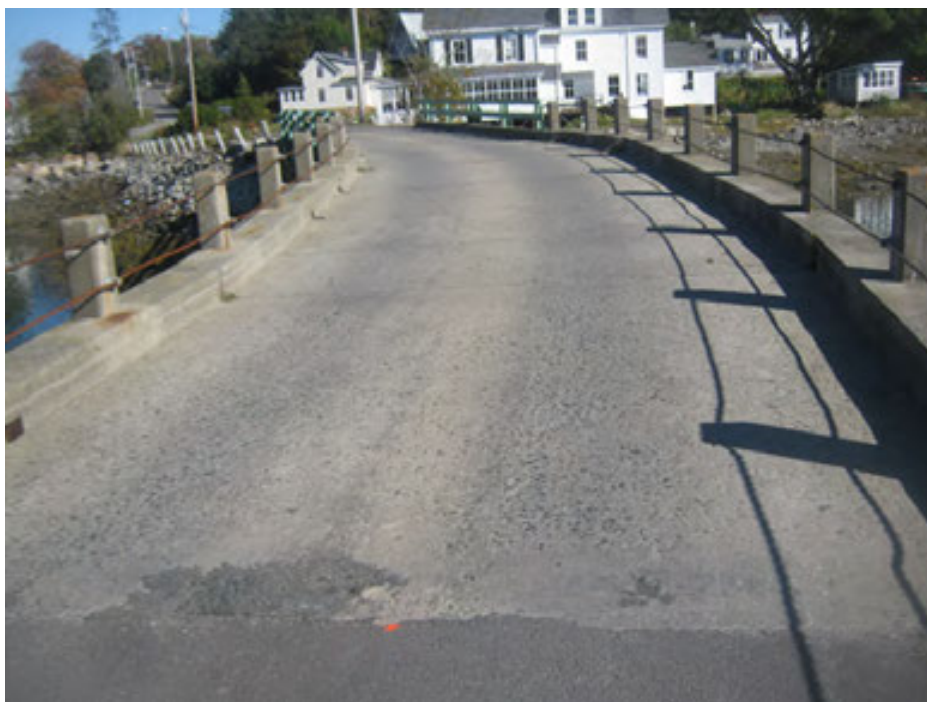
PHOTO 18

Description View of wearing surface showing some patching

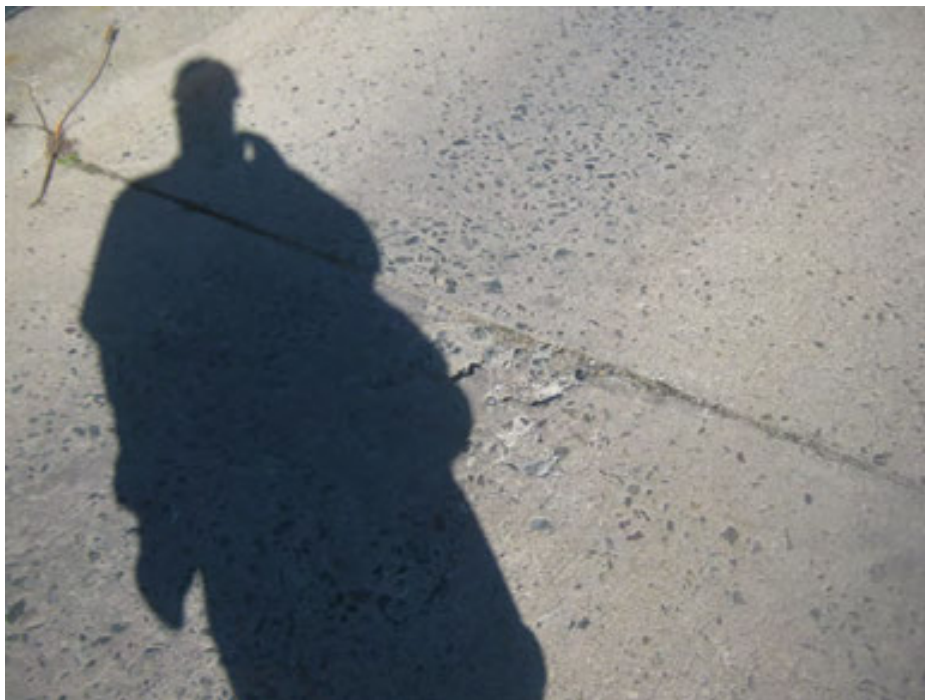
PHOTO 19

Description View showing some spalling at deck joint

- Proposed Repair Alternatives: The existing bridge joint material will be removed to a depth of 3". A backer rod will be installed. A pourable elastomeric sealant will be used within the limits of the roadway. A silicone based joint sealant will be used at the curbs. The pourable elastomeric sealant can be easily installed at minimal cost. The installation of gland seal, compression seal, or any other similar expansion devices are not required for thermal movement and are considered too expensive due to the associated deck end replacement work that would be required for installation.

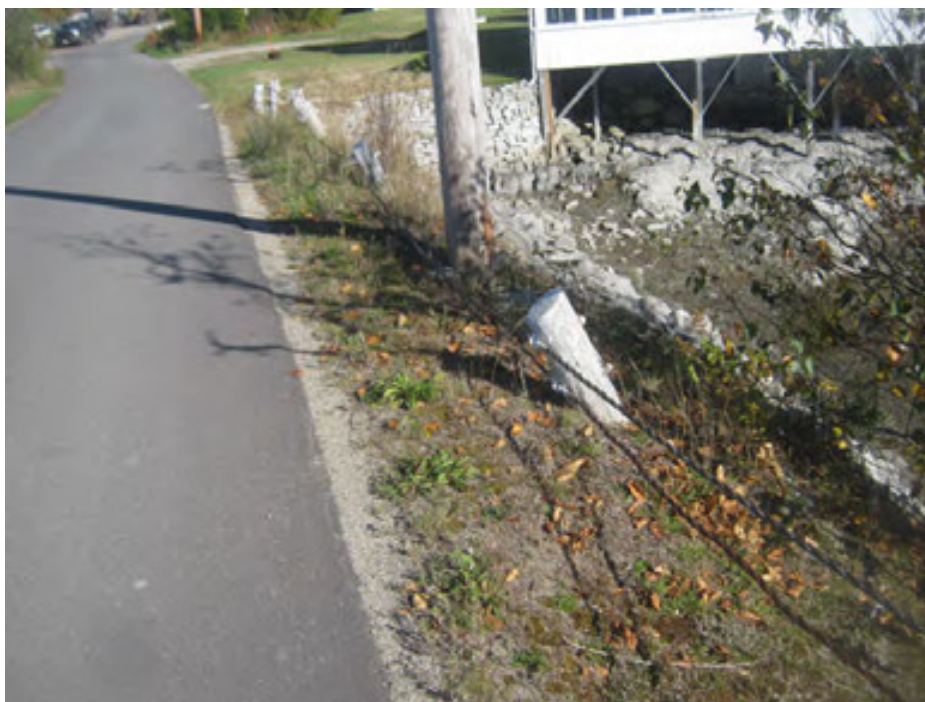
PHOTO 20

Description View of failed cable guard rail

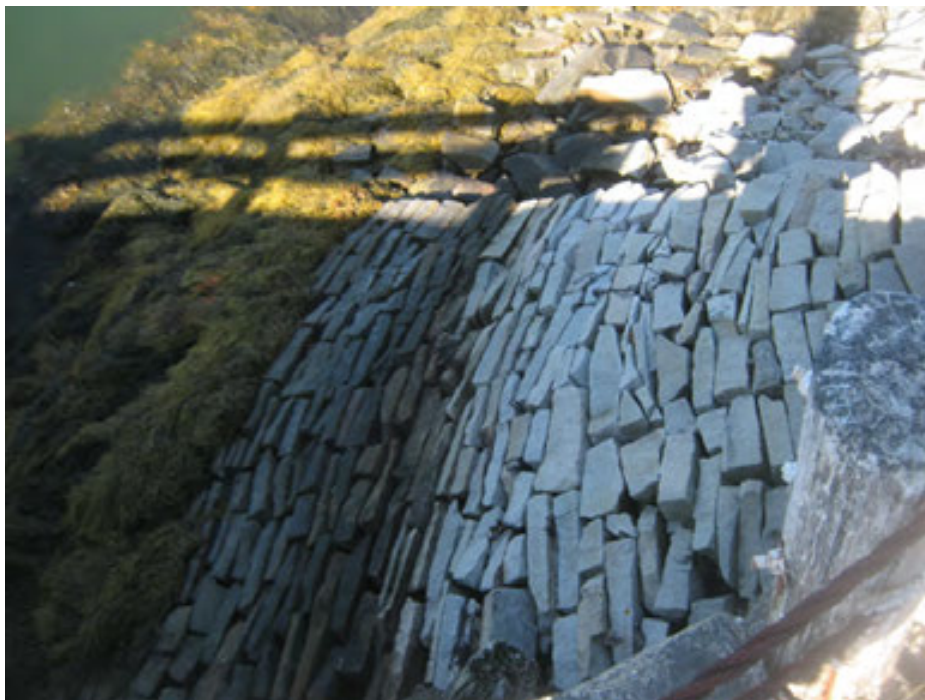
PHOTO 22

Description View of embankment stones showing some shifting

- Proposed Repair Alternatives: The eroded and sloughing slopes and posts that have lost support will be spot repaired by filling in with plain rip rap. Severely eroded shoulders will be built up with crushed stone slope protection only to the face of the proposed rail. This will provide a consistent grade between guardrails and help support the new guardrail posts.

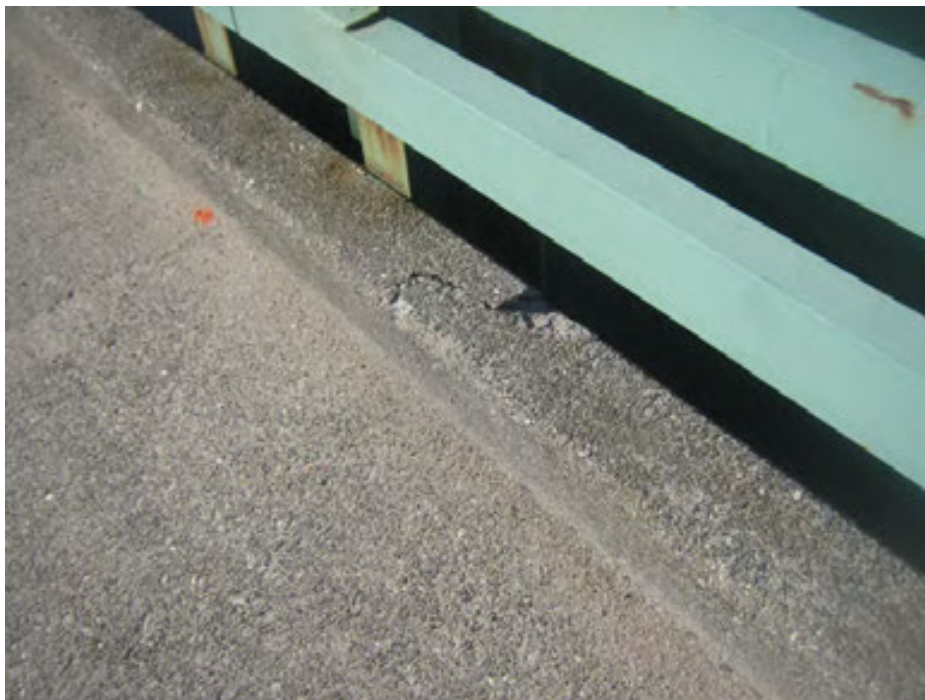
PHOTO 23

Description View showing small spall and crack in curb.

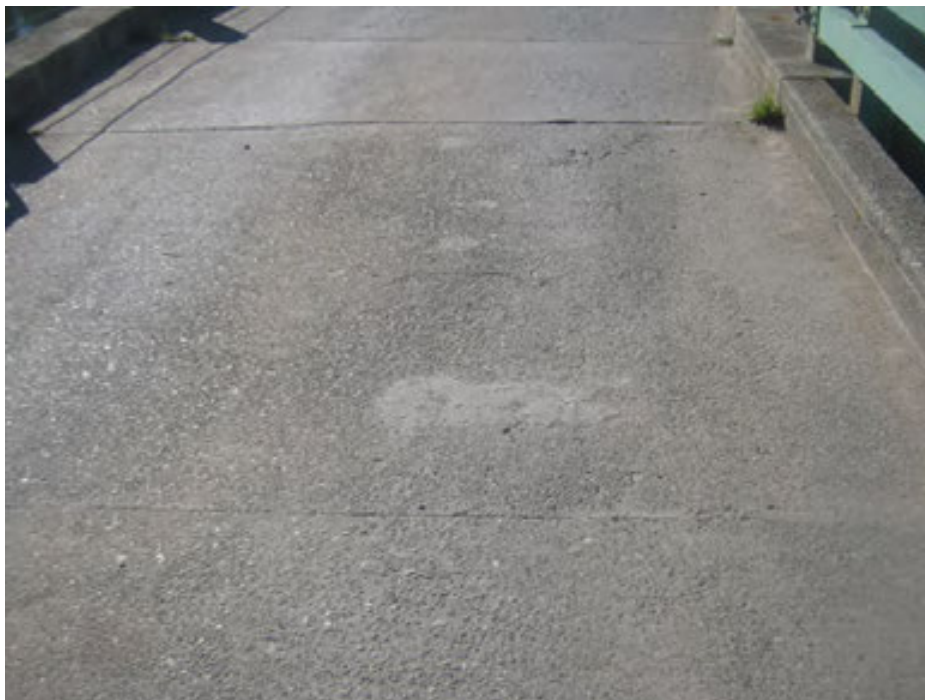
PHOTO 24

Description View showing patch in wearing surface
