**TOWN OF VINALHAVEN
CARRYING PLACE BRIDGE REPLACEMENT
PRELIMINARY DESIGN REPORT**

Carrying Place Bridge
Maine DOT Bridge #: 0601

Calderwood Neck Road
over
Tidal Waters of Fish Cove & Winter Harbor

November 6, 2017

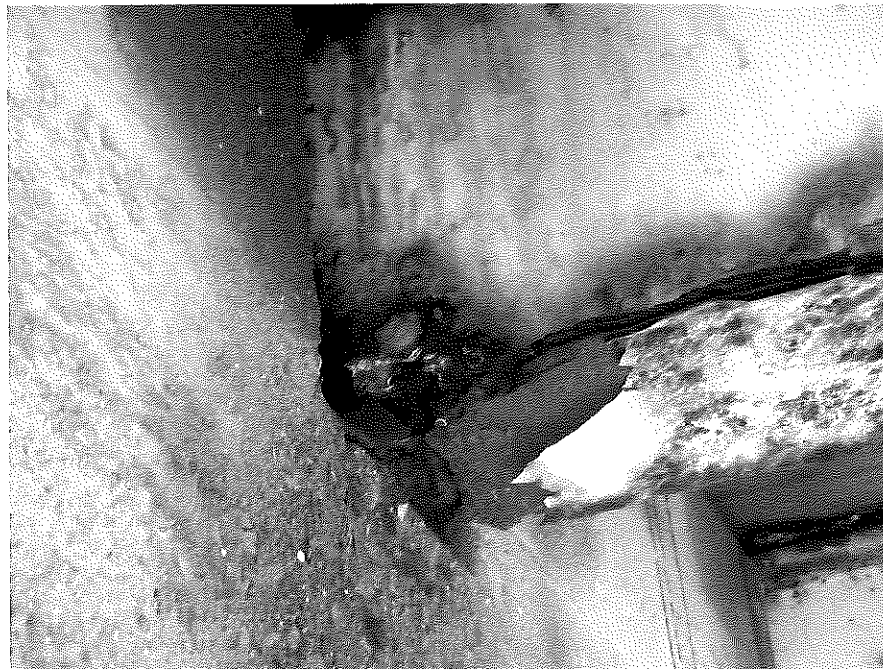
PHOTO 8 Condition

Description Westerly abutment, 2nd girder from US side. Holes in bottom flange and web.

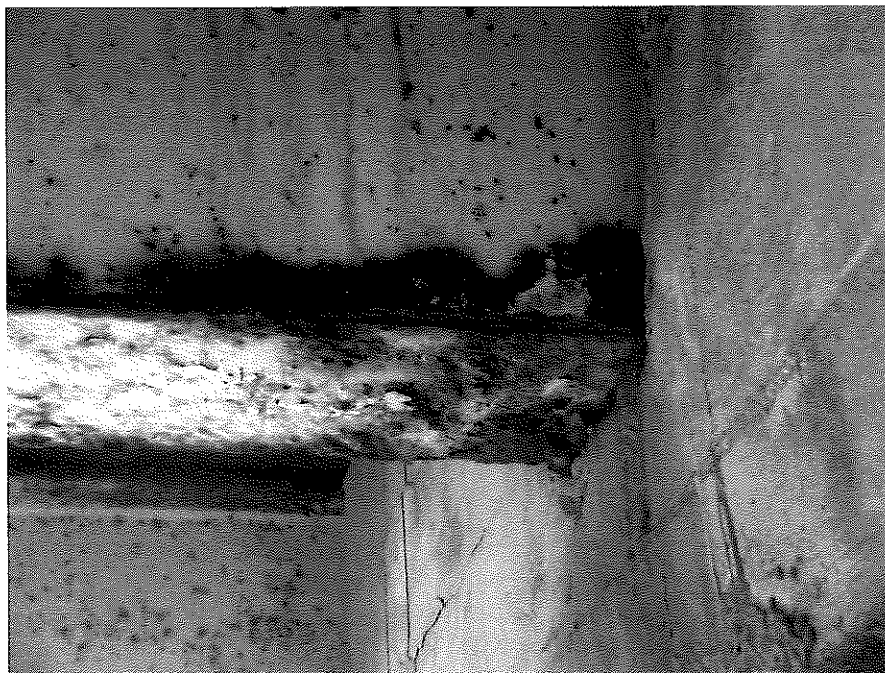
PHOTO 9 Condition

Description Westerly abutment, 5th girder from US end. Holes in bottom flange.

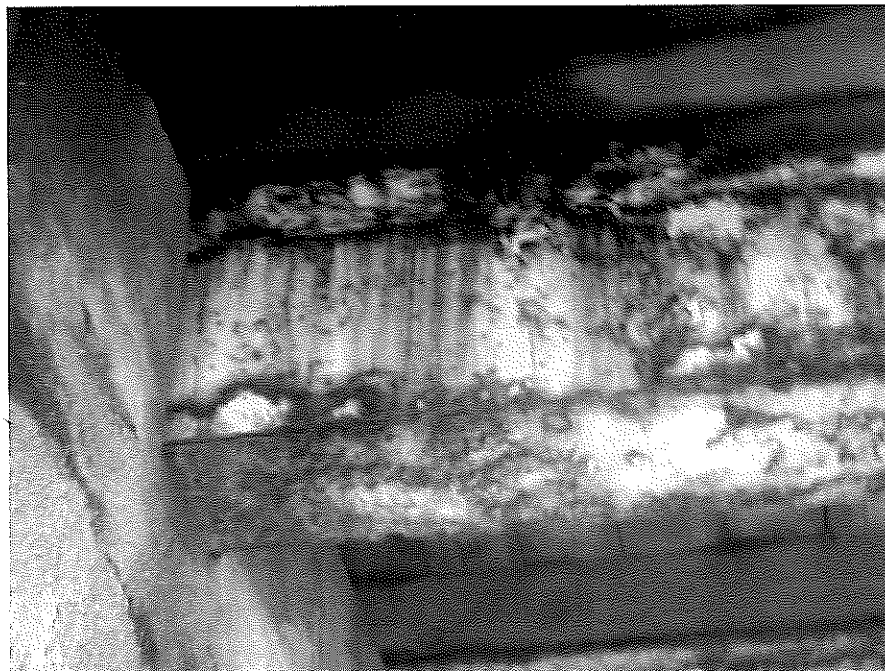
PHOTO 10 Condition

Description Easterly abutment, 3rd girder from US side. Thinning of bottom flange to knife's edge.

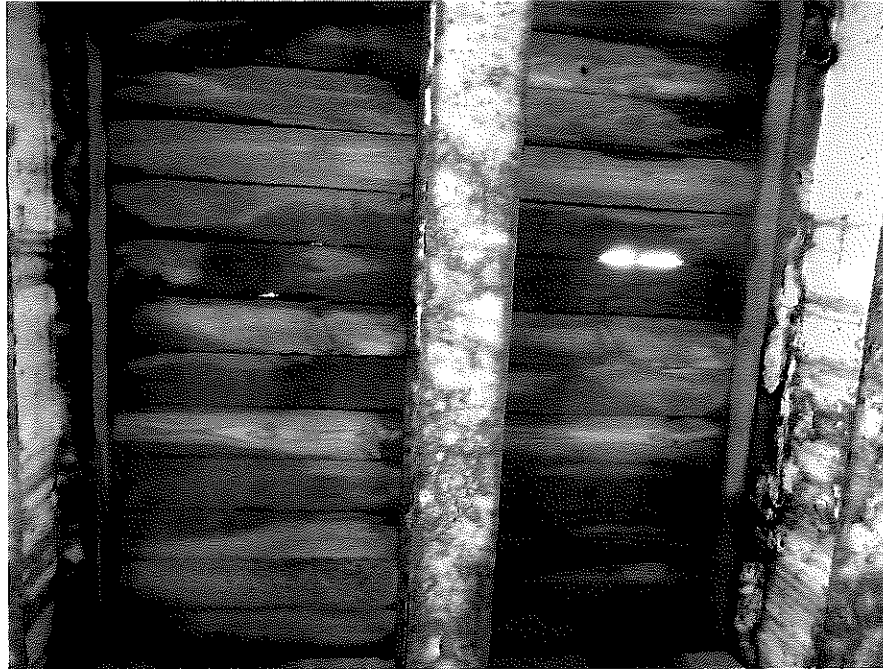
Deck is made up of 8x8 wooden timbers nailed to a nailing strip placed longitudinally on the girders. No rot noticed either underside or on top however, there is heavy wear in the wheel paths up to 1/2" deep (photo). Many nail heads are exposed.

PHOTO 11 Condition, Other

Description Underside of deck. Note defects in timbers.

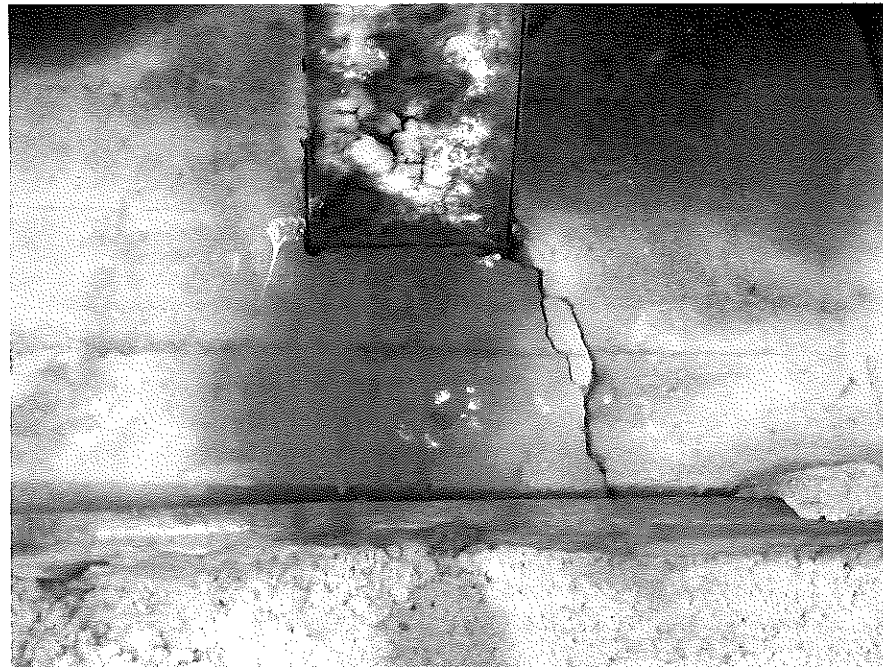
PHOTO 12 Elevation, Condition

Description Westerly abutment, 4th girder from US end. Note cracking in concrete cap.

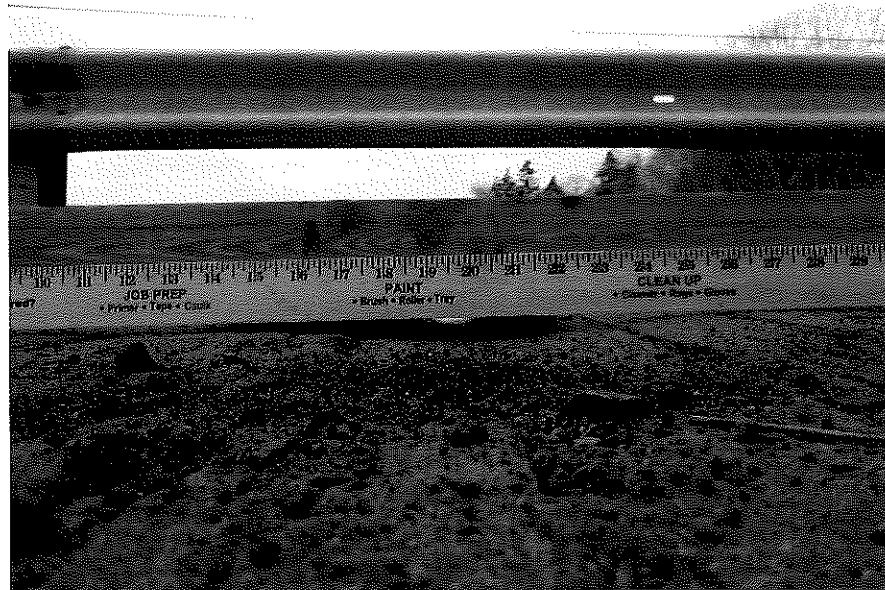
PHOTO 19 Condition

Description Typical wearing of deck in wheel path.

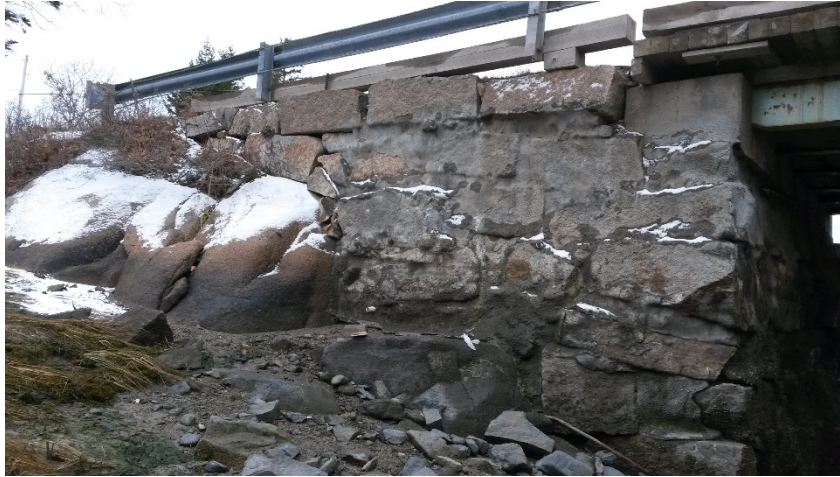
Rock Cribbing, up to 13 feet in thickness, is described as reddish gray granite blocks mixed with occasional sand with little silt classified as SM in accordance with the USCS. Granite blocks range in thickness of 1 to 2 feet with various stacking. Voids are present within the cribbing. Shotcrete facing is present along portions of the outer granite blocks.

Granite Block Cribbing (Portions with Shotcrete) – Southwest Abutment
