20 December 2019

Project Number: 3611191238

**Subject: Vulnerability Assessment and Resilience Planning, Ferry Terminal, Vinalhaven, Maine  
Penobscot Bay Working Waterfront Resiliency Analysis  
State of Maine, Department of Marine Resources**

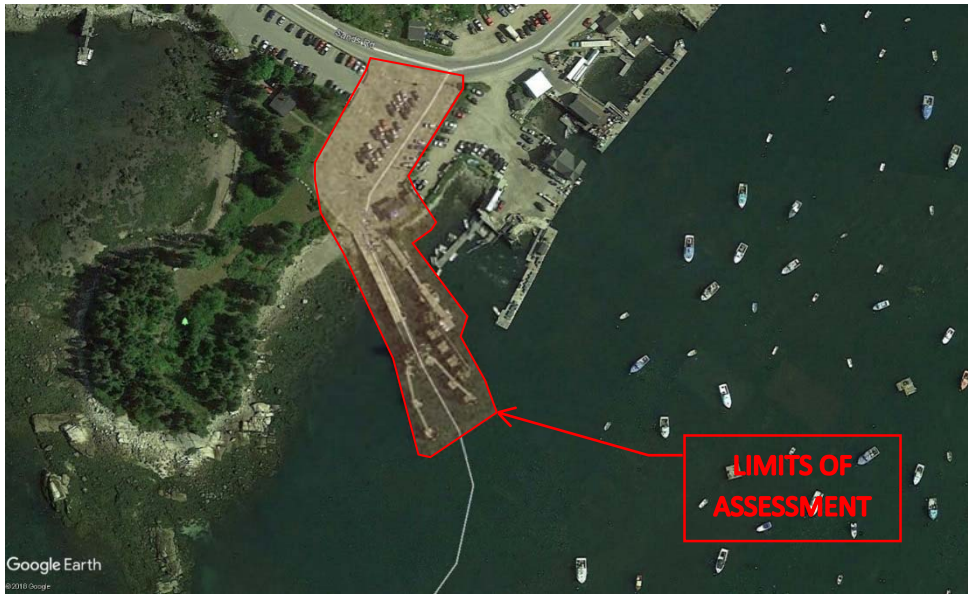
**Photograph No. 1:**

**Overview of Site**

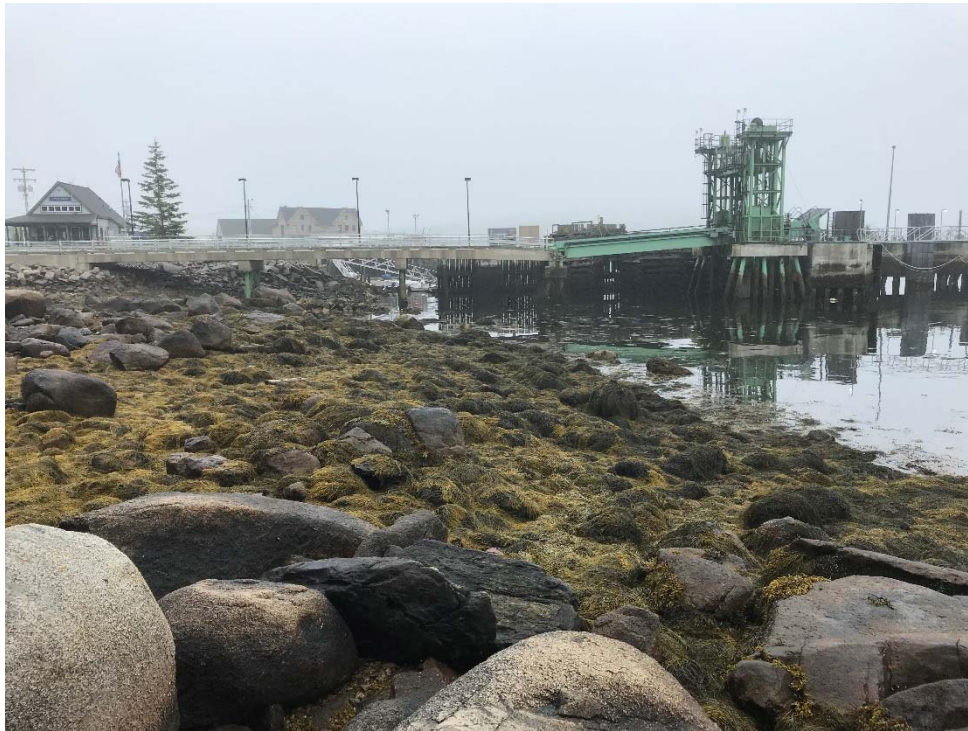
**Photograph No. 2:**

**Overview of site from west side.**

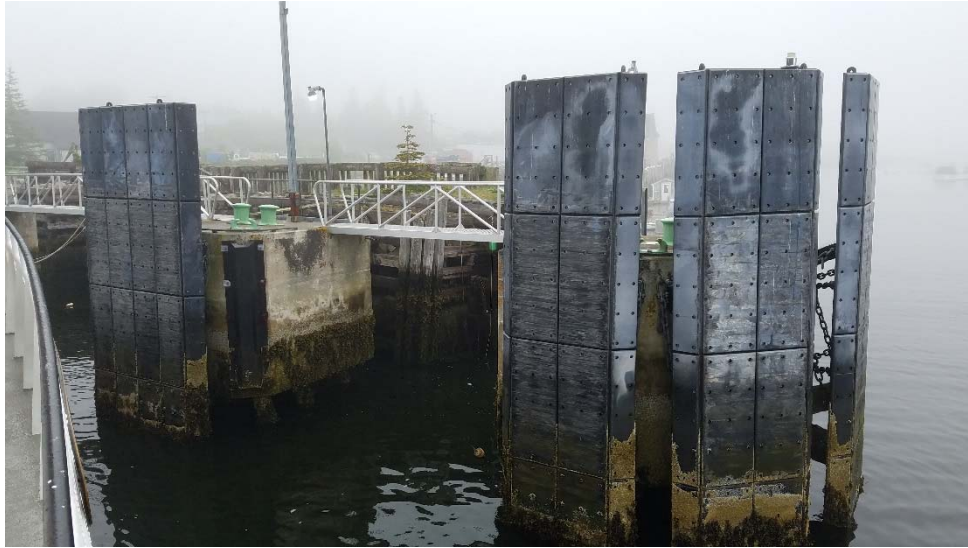
**Photograph No. 3:**

**View from ferry including concrete pier, fender system and mooring bollards on dolphins No. 5 and 6.**

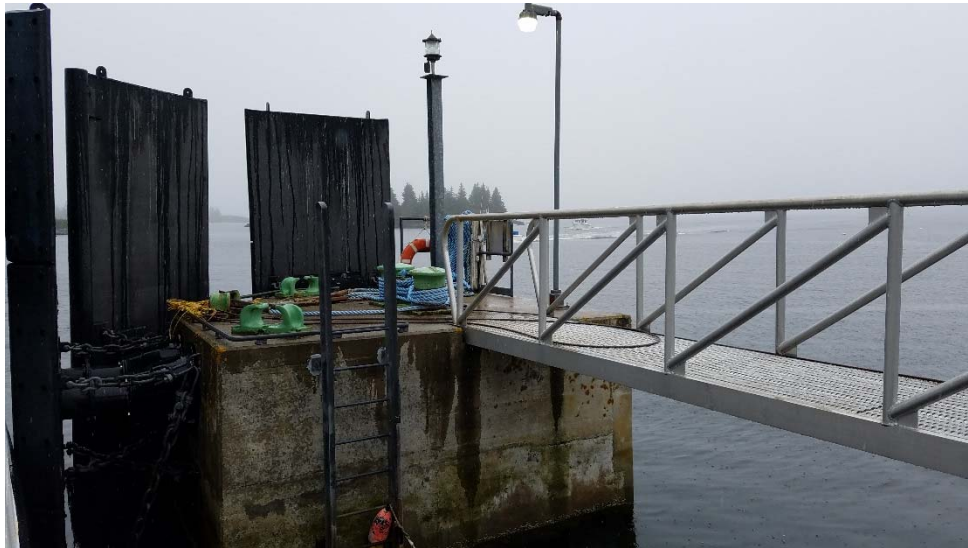
**Photograph No. 4:**

**View of mooring bollard for dolphin No. 1 from back of fender panels.**

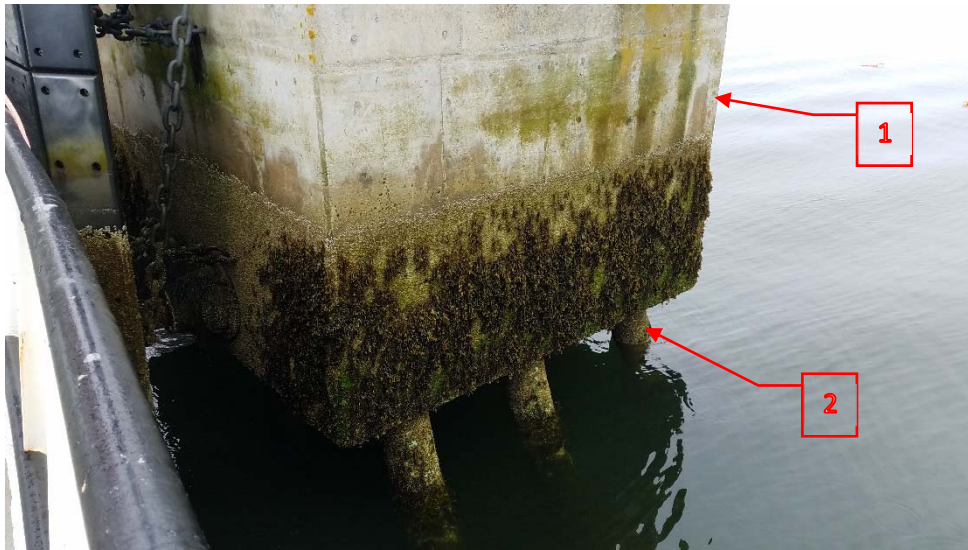
**Photograph No. 5:**

Close-up of (1) concrete pier and view of (2) concrete piles below.

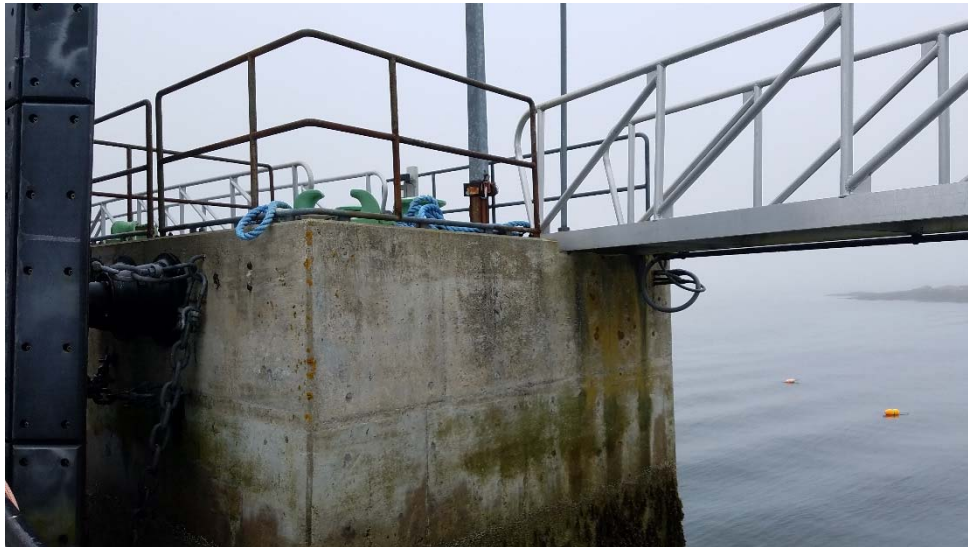
**Photograph No. 6:**

View of top of pier and gangway attachment to pier.

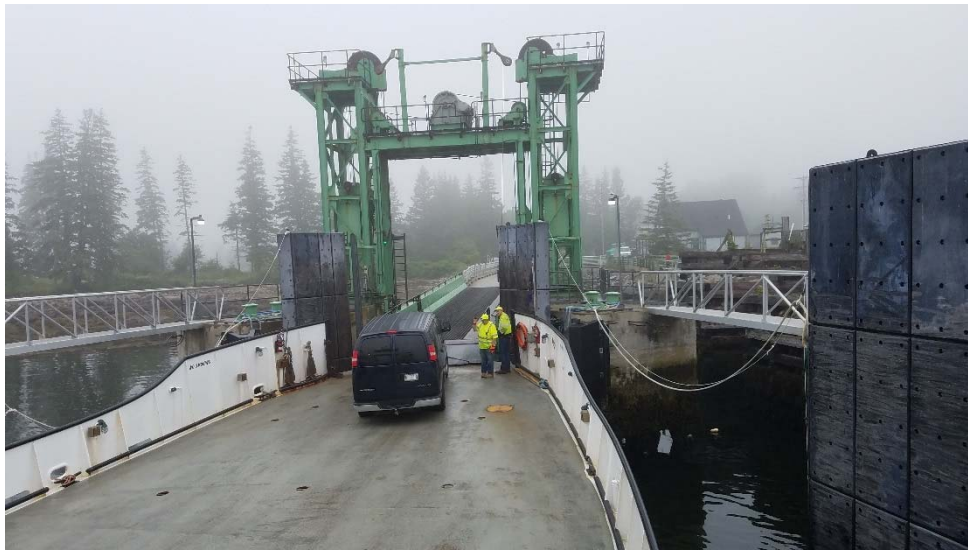
**Photograph No. 7:**

**View of transfer bridge operation from ferry. Showing bridge tower and fender system on dolphins No. 3 and 4.**

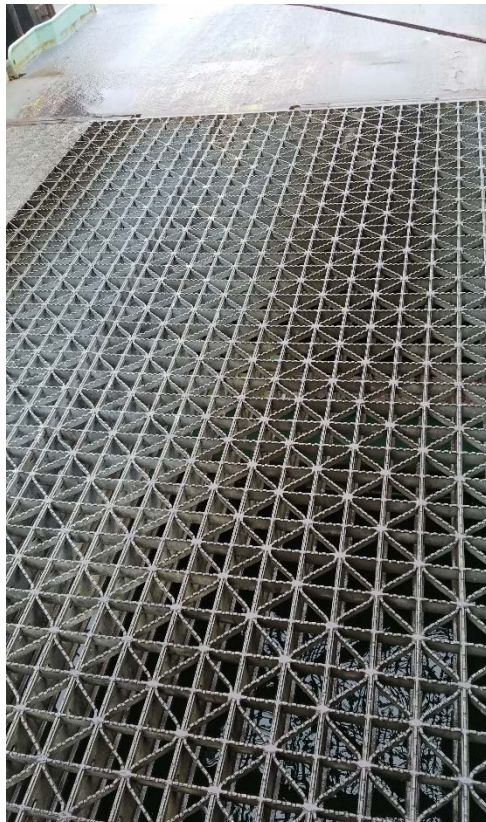
**Photograph No. 8:**

**View of transfer bridge grating noted. Appears in good condition.**

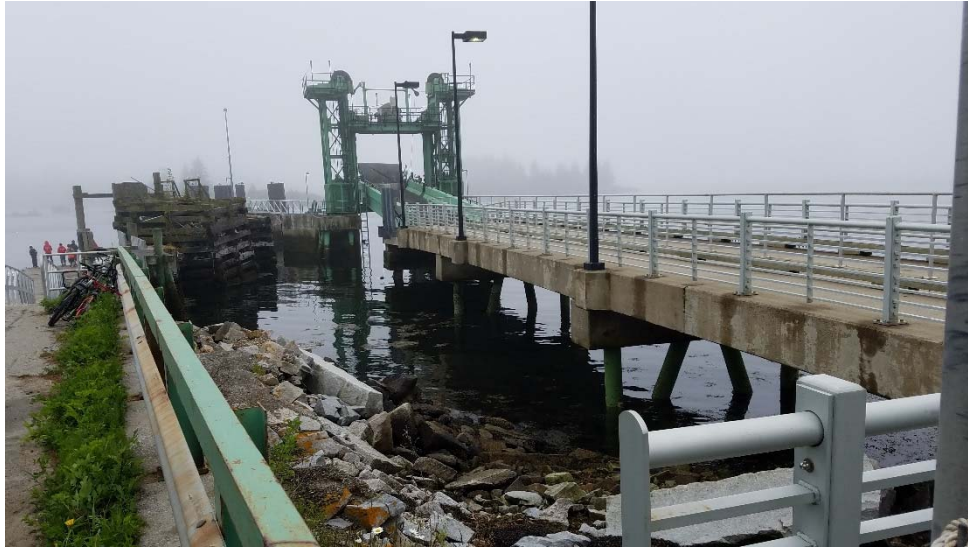
**Photograph No. 9:**

**View of main approach bridge from east side.**

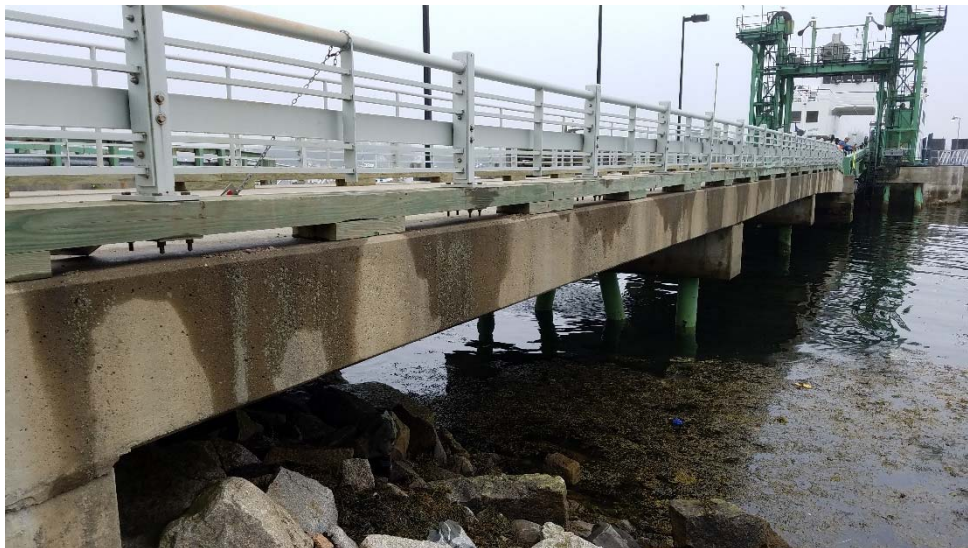
**Photograph No. 10:**

**View of main approach bridge from west side.**

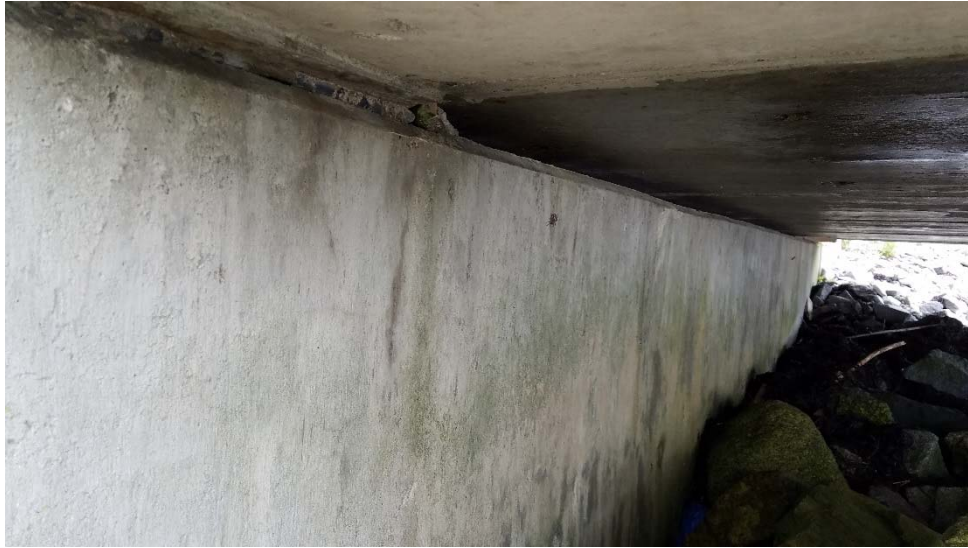
**Photograph No. 11:**

**View of abutment at north end of main approach bridge.**

**No obvious signs of corrosion or efflorescence.**

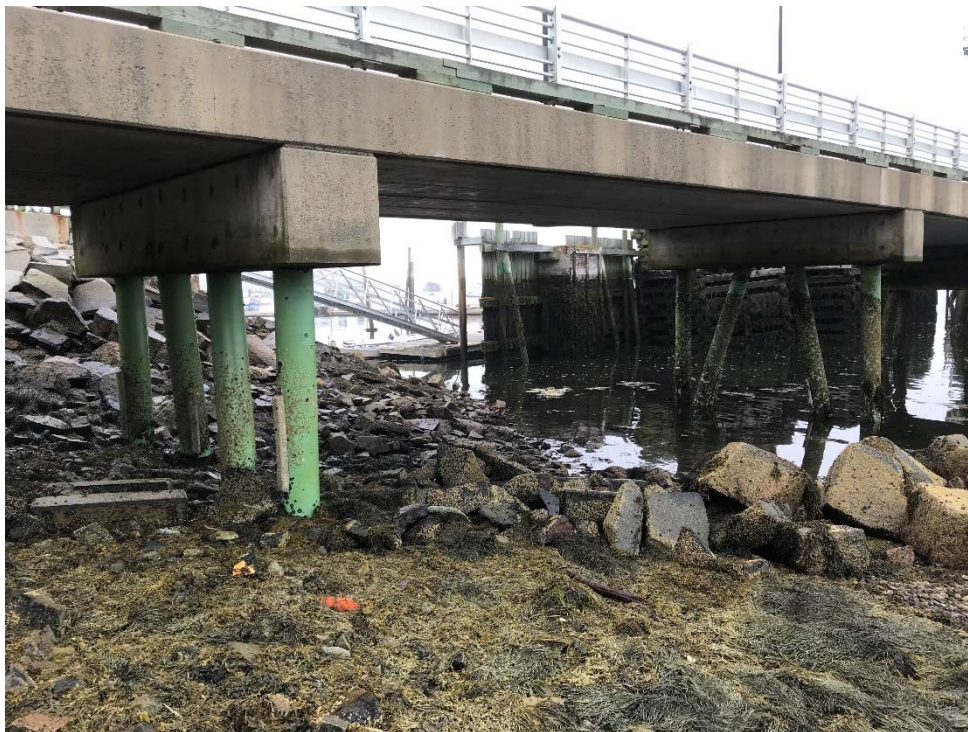
**Photograph No. 12:**

**View at west side of approach bridge during lower tide.**

**View of pipe piles. Piles appear in decent condition from view of exposed areas. Recoating may be necessary to avoid deterioration of material. Condition of anchor connection to rock could not be observed.**

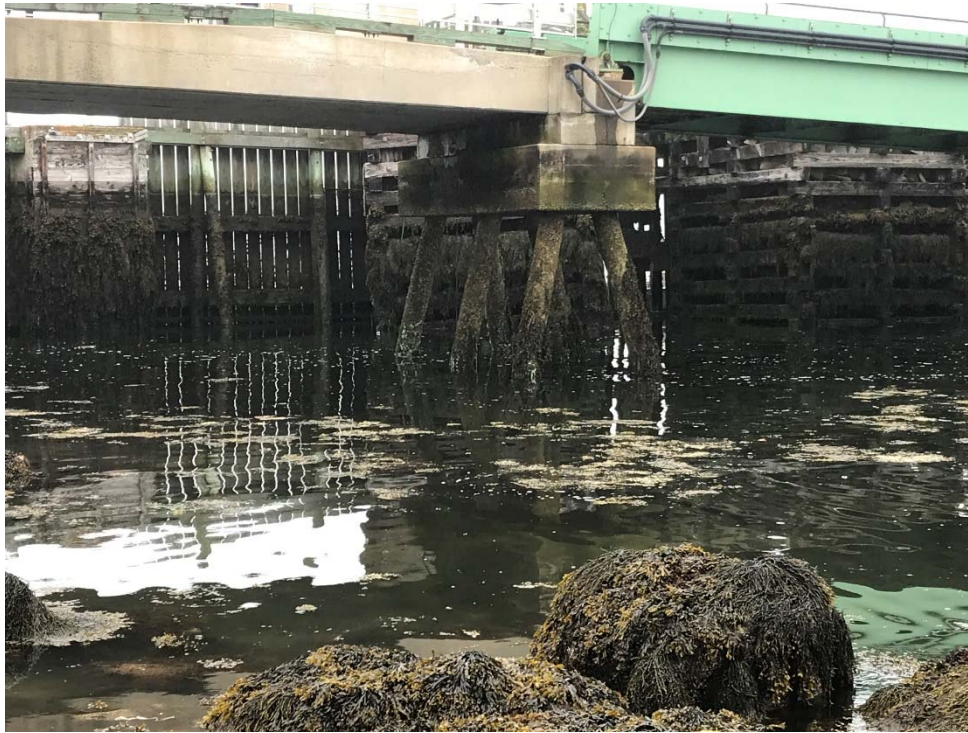
**Photograph No. 13:**

**View of Pier 3 for support of main approach bridge and transfer bridge from west side.**

**No signs of serious deterioration noted from this vantage point. Closer examination of concrete pier and support is recommended.**

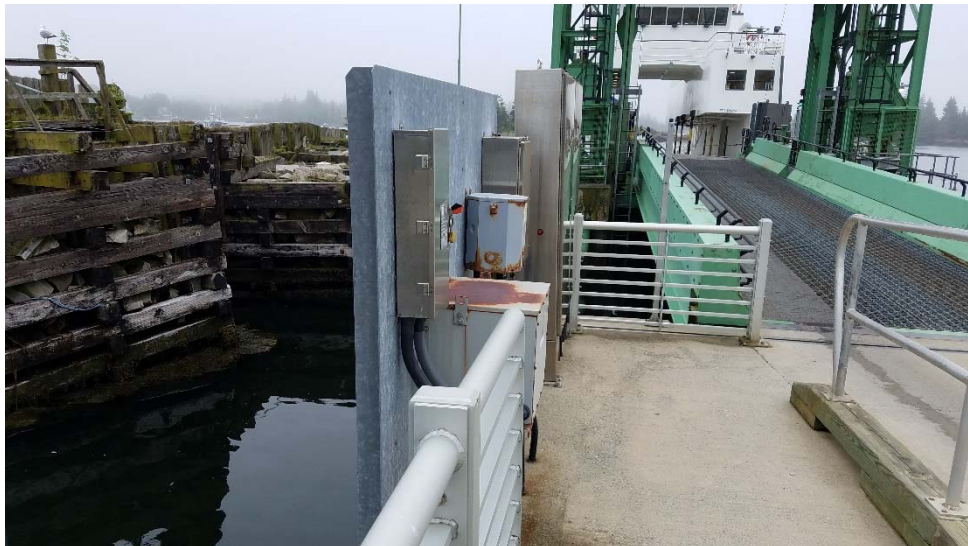
**Photograph No. 14:**

**View of main bridge to transfer bridge transition. Support conditions were inaccessible for viewing.**

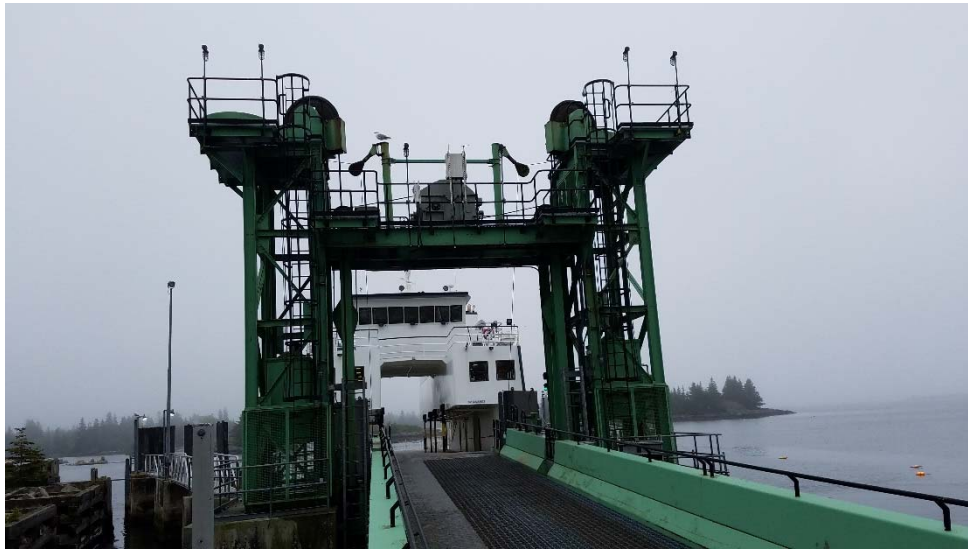
**Photograph No. 15:**

View of transfer bridge hoisting assembly and framing.

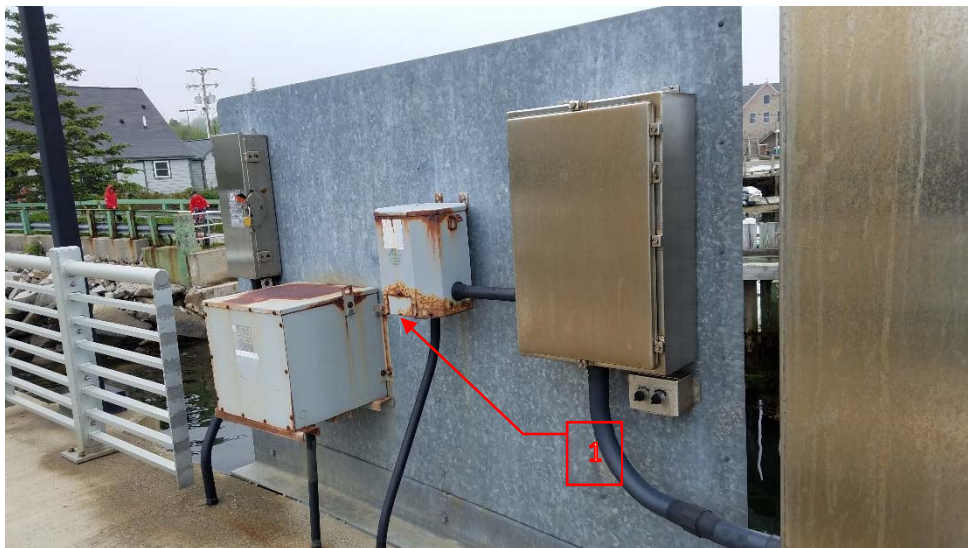
**Photograph No. 16:**

The main bridge is a prestressed concrete deck on pipe piers and a concrete abutment. Per the design drawings, the piers are supported on rock via rock anchors (**Photographs 9 – 14**). During our site visit, the transfer bridge system functioned as intended. The electrical power provided to the bridge is located near pier 3 on the main bridge. We did not attempt to open or inspect any electrical panels; however, we did identify corrosion of some panels (**Photograph 16**).

View of electrical equipment at east end of main bridge.

1. Corroded electrical box appears to have loss material due to delamination.

- Replace electrical/utility box at ferry bridge. Design and Construction **\$5,000.**

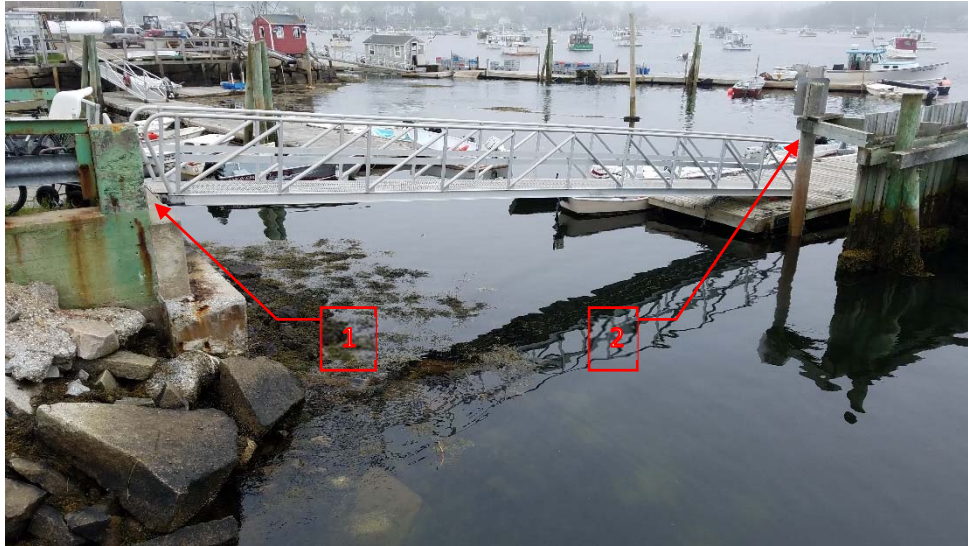
**Photograph No. 17:**

BFE or the 1% Stillwater. However, we anticipate that the mooring pile connection, or attachment of the mooring piles to the wave attenuator, will be the greatest points of weakness given the age and condition of the connection.

**View of floating dock and gang way.**

- 1. Gangway attachment to existing abutment.**
- 2. Timber pile as support for floating dock, braced to crib.**

- Confirm the gangway attachments and mooring pile attachment to crib are sufficient to resist the design loading and repair or replace as needed.

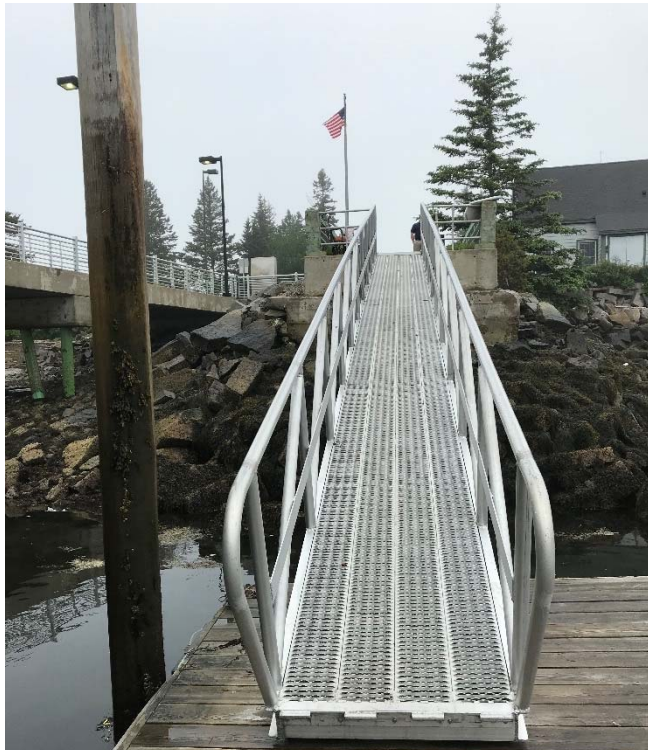
**Photograph No. 18:**

**View of floating dock gangway facing north.**

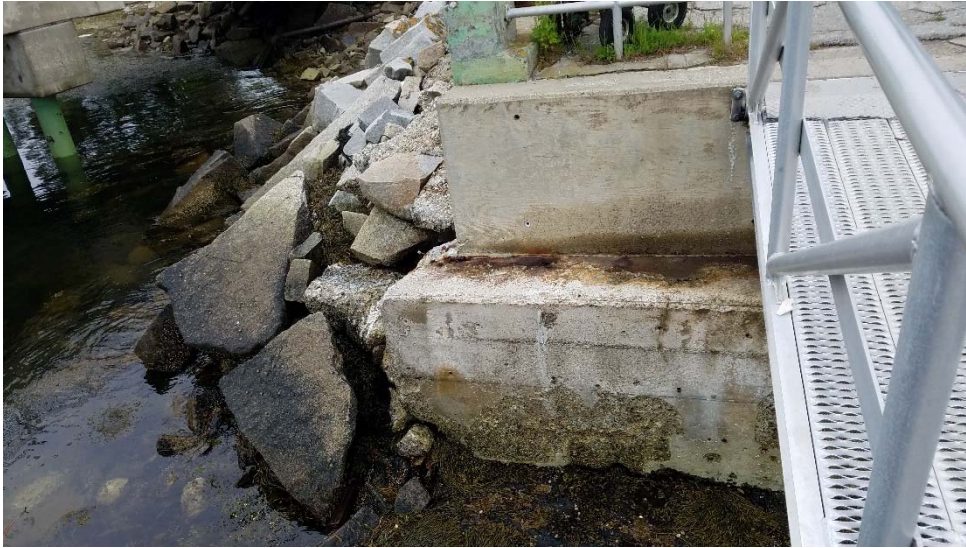
**Photograph No. 19:**

**View of attachment of gangway to abutment at south side.**

**Attachment of gangway to concrete appears in decent condition.**

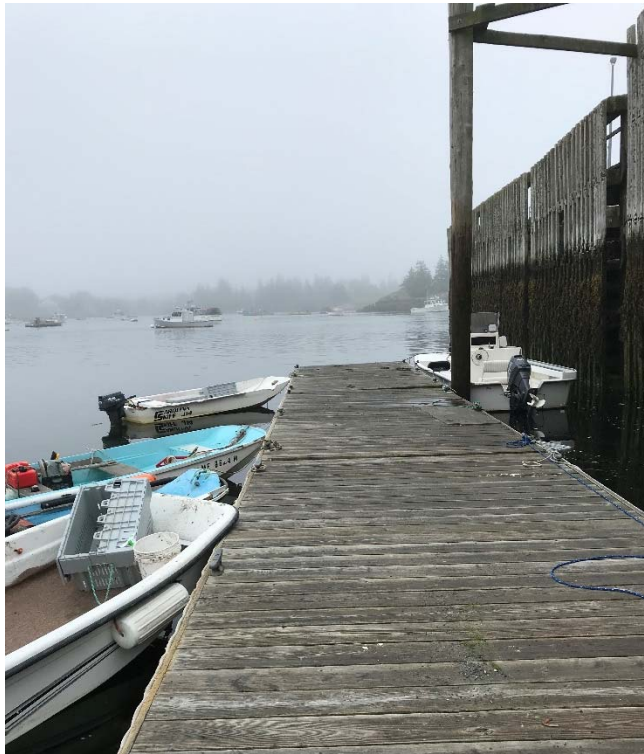
**Photograph No. 20:**

**View of floating dock.**

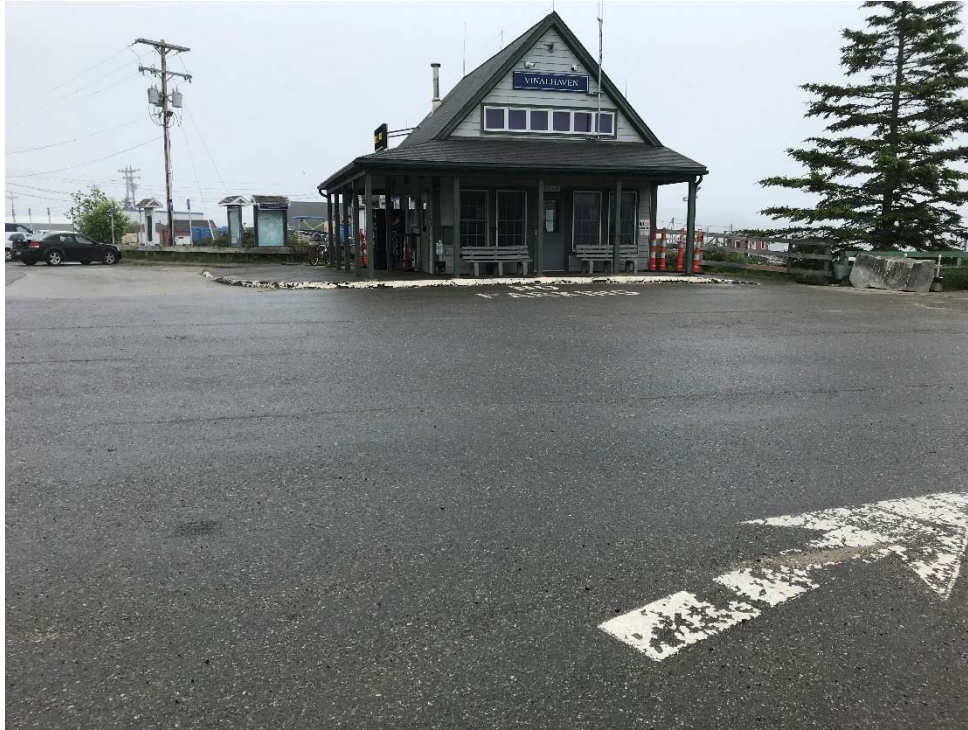
**Photograph No. 21:**

**View of west side of ferry services building**

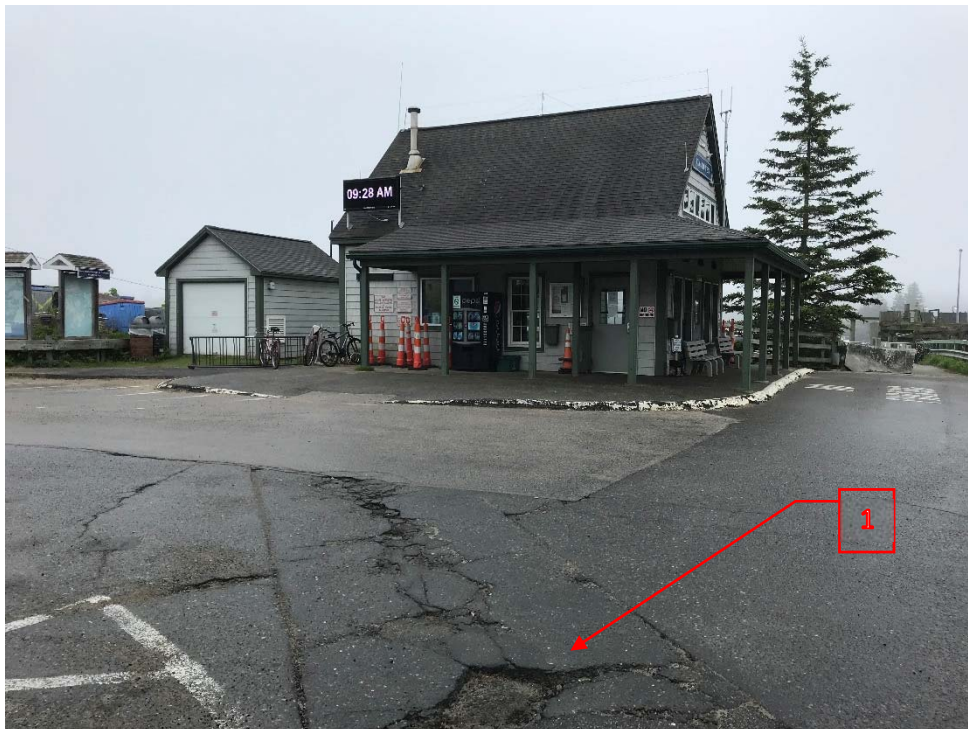
**Photograph No. 22:**

**View of north side of ferry services building**

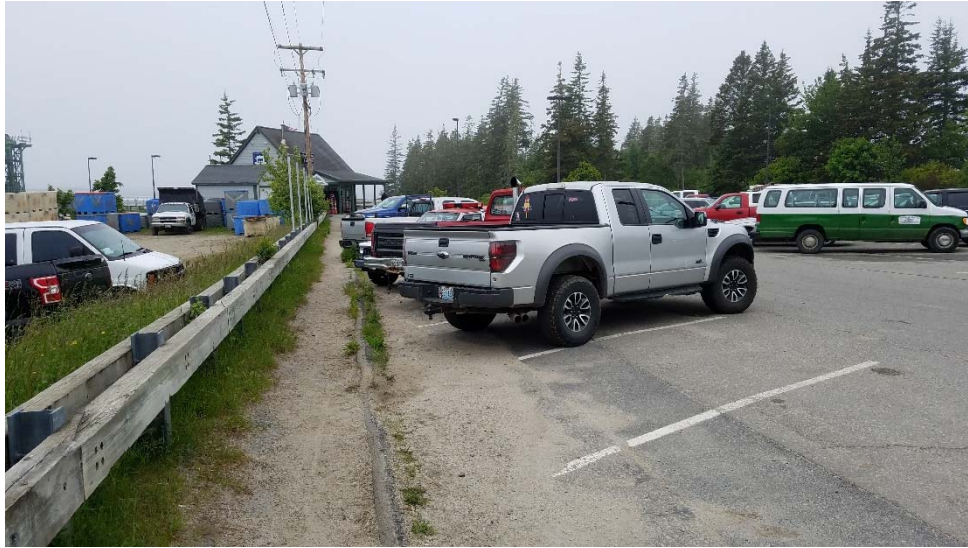
**Photograph No. 23:**

**View of parking area at northeast corner looking south**

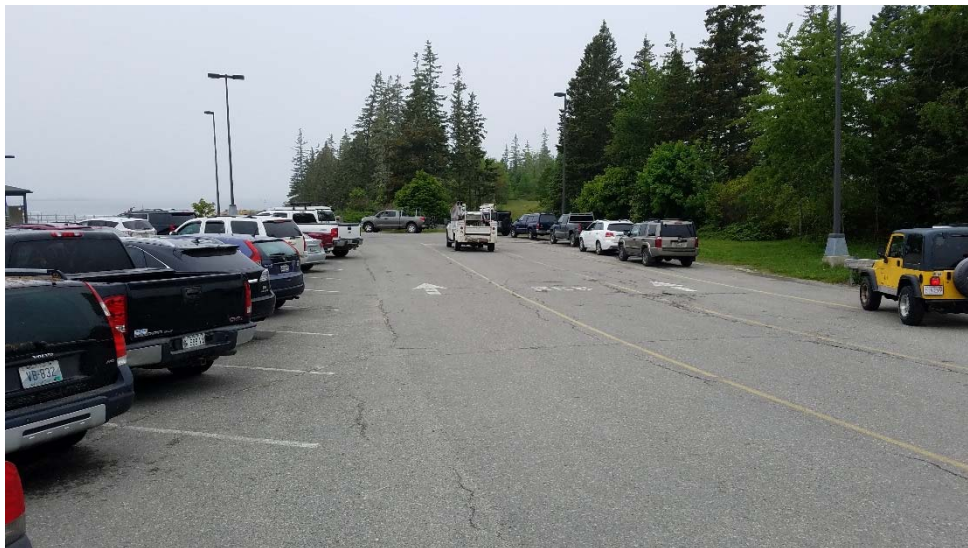
**Photograph No. 24:**

- Delamination and cracking of asphalt (**Photographs 22, 24 & 25**) - the parking lot top coat appears to be moderately weathered with signs of surface delamination and 1/8 inch or greater cracks. Repair patches have been observed throughout indicating maintenance work.
- Wood deterioration (**Photograph 27 – 29**) - Wood framing at wave attenuator (crib) structures exhibit moderate to severe weathering.
- Corroded Electrical Box (**Photograph 14 & 16**) – Metal electrical / utility box has corrosion on the exterior, and one appears to have experienced delamination of the cover.

**View of parking lot at northwest corner looking south.**

- No pressing concerns were identified beyond regular maintenance required due to normal wear and tear.

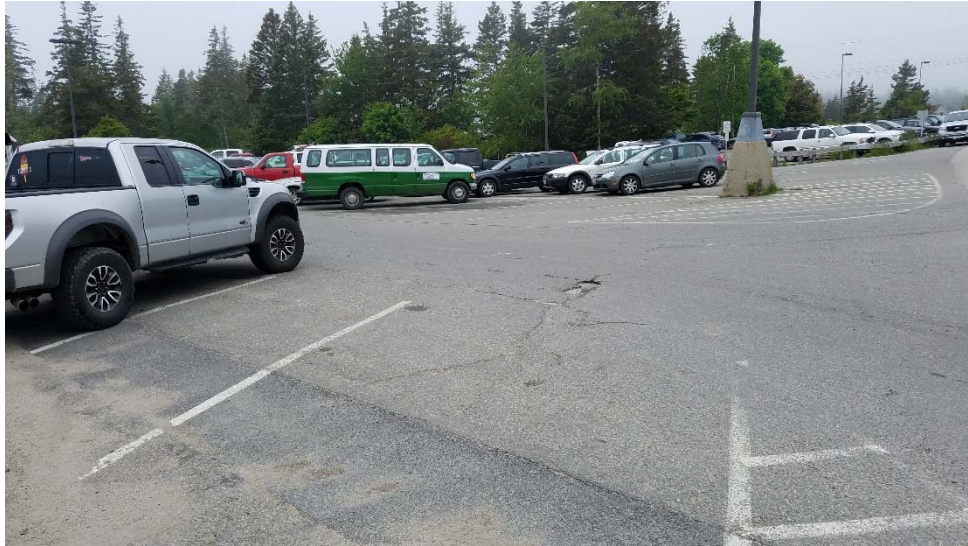
**Photograph No. 25:**

**View of entrance to site and parking.**

**Signs of surface delamination at top coat.**

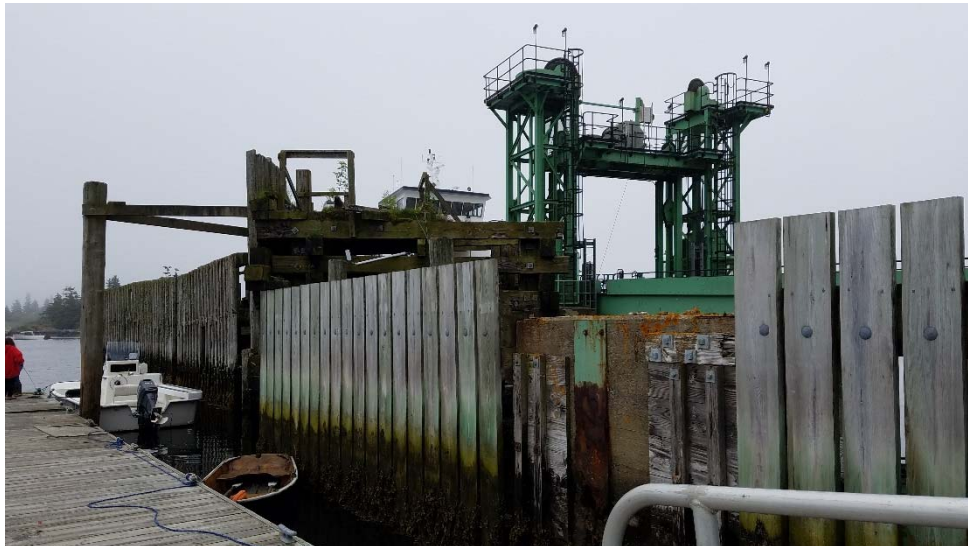
**Photograph No. 26:**

**View of Breakwater crib from north side looking south.**

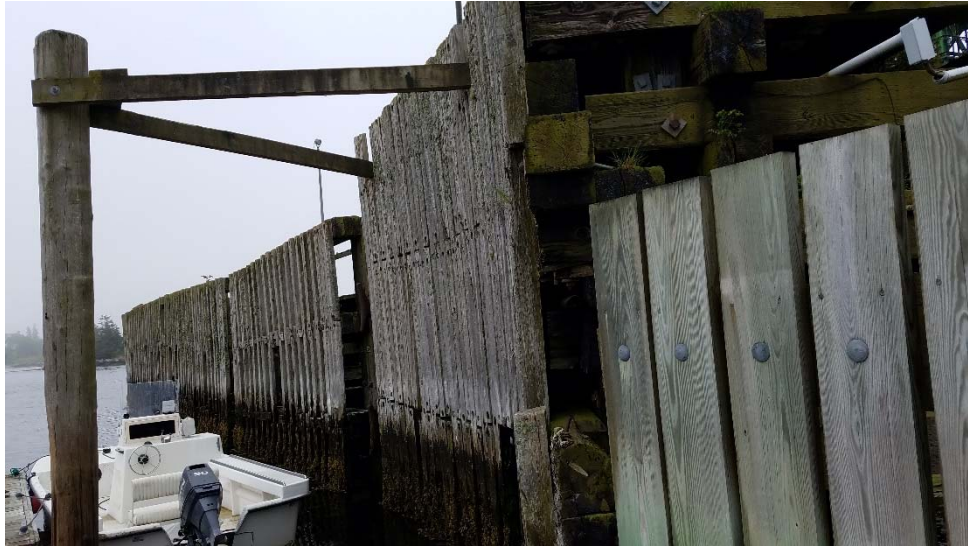
**Photograph No. 27:**

**Closer view of  
breakwater/crib.**

**Timber framing filled with  
large rocks.**

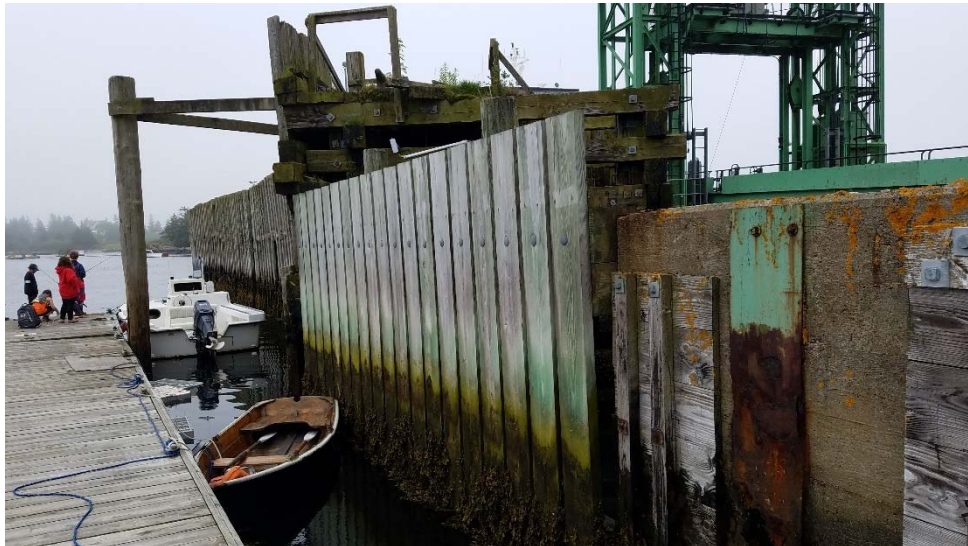
**Photograph No. 28:**

**Additional view of cribbing.**

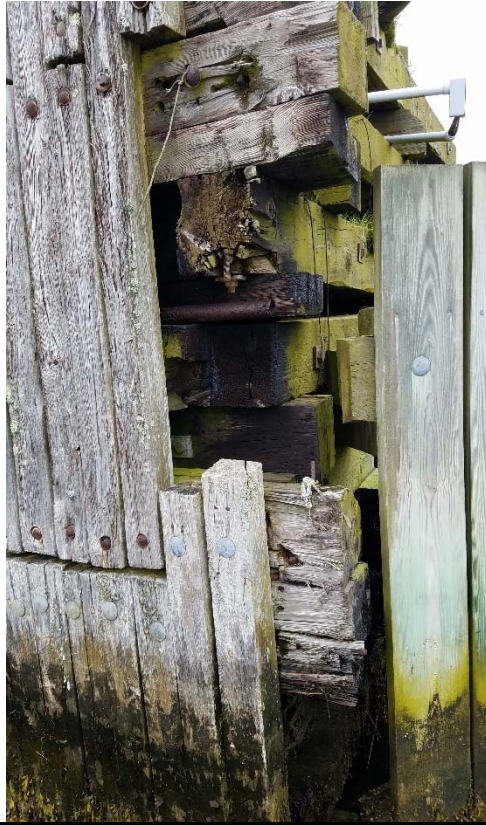
**Photograph No. 29:**

The five (5) crib structures, which are the remaining elements of the original terminal, now serve as wave attenuators to protect the floating docks and smaller boats at the north side of the terminal from wake waves generated by the ferry. The crib is constructed of a wood framed structure filled with large rocks and gravel. The structure has been installed for almost 70 years and the structural fill appears to remain in stable condition. The wood framing has, however, experienced moderate to major weathering and possibly rot as evidenced from the splitting and checks observed (**Photograph 26 – 29**).

**Close-up of crib indicating construction and condition of timber framing.**

**Moderate to major weathering noted.**

- Many members of the structure appear to have experience major deterioration and require replacement. Opportunity should be taking to perform detailed analysis of the structure's ability to support the design loading during any repair or retrofit effort. Deteriorated and damaged members should be replaced immediately following a detailed assessment.

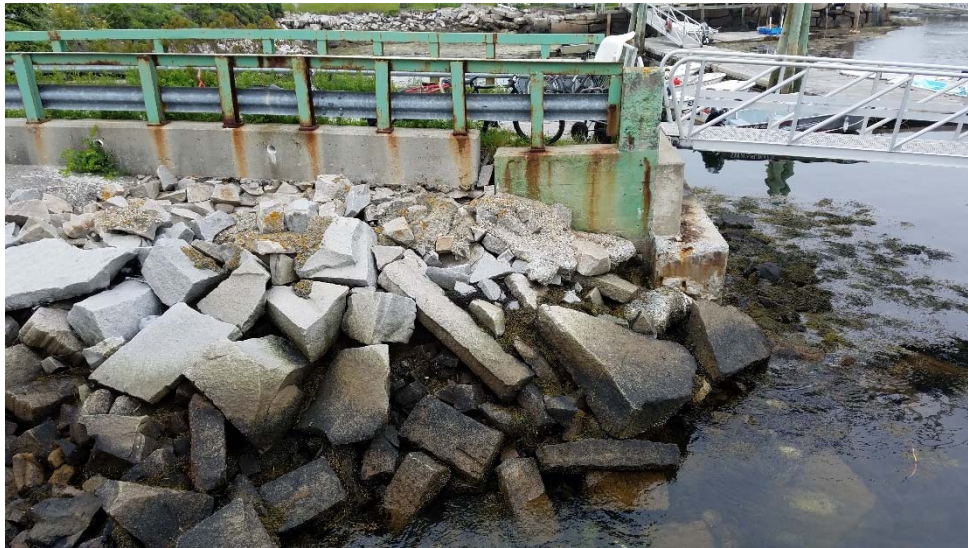
**Photograph No. 30:**

**View of shoreline projection near floating dock gangway.**

**Riprap noted beyond the abutment.**

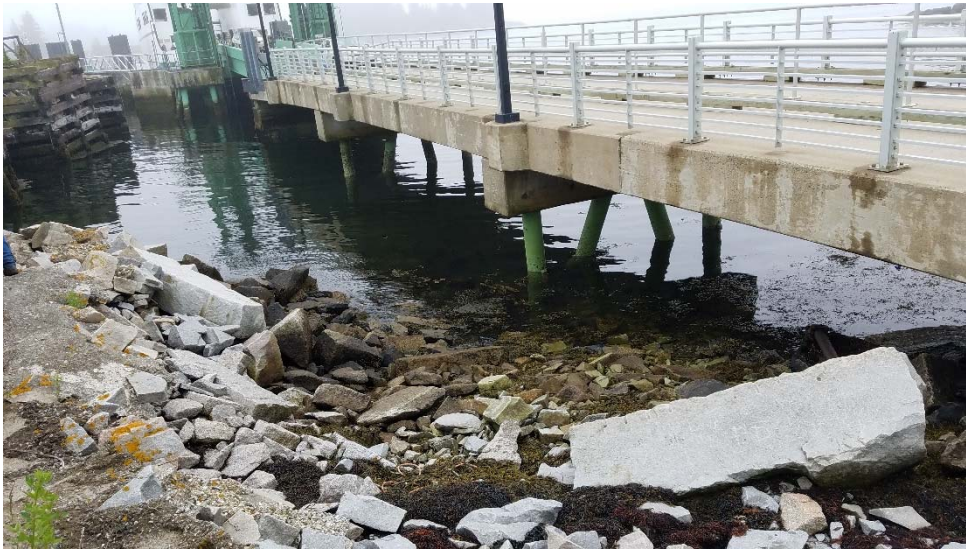
**Photograph No. 31:**

**View of shoreline protection near north bent of bridge.**

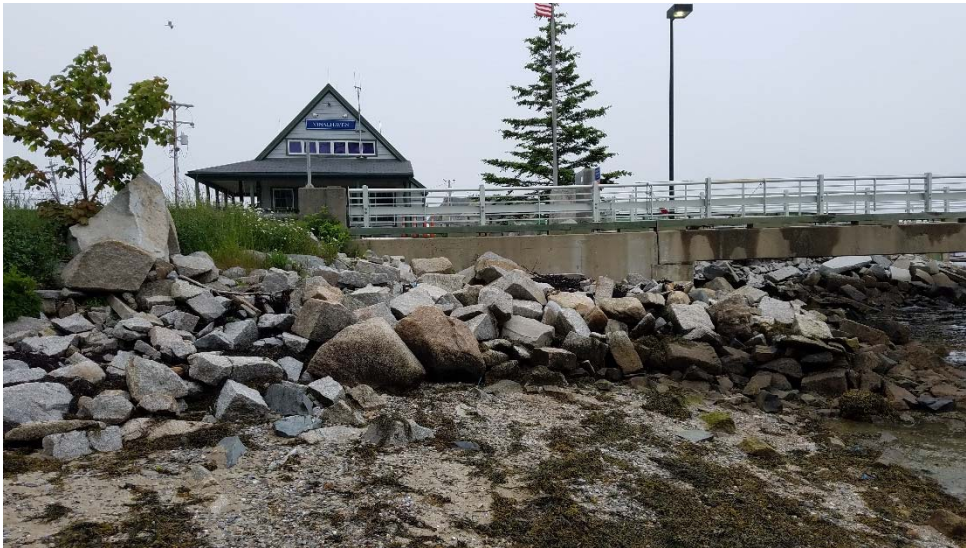
**Photograph No. 32:**

**View of revetment at west side of bridge.**

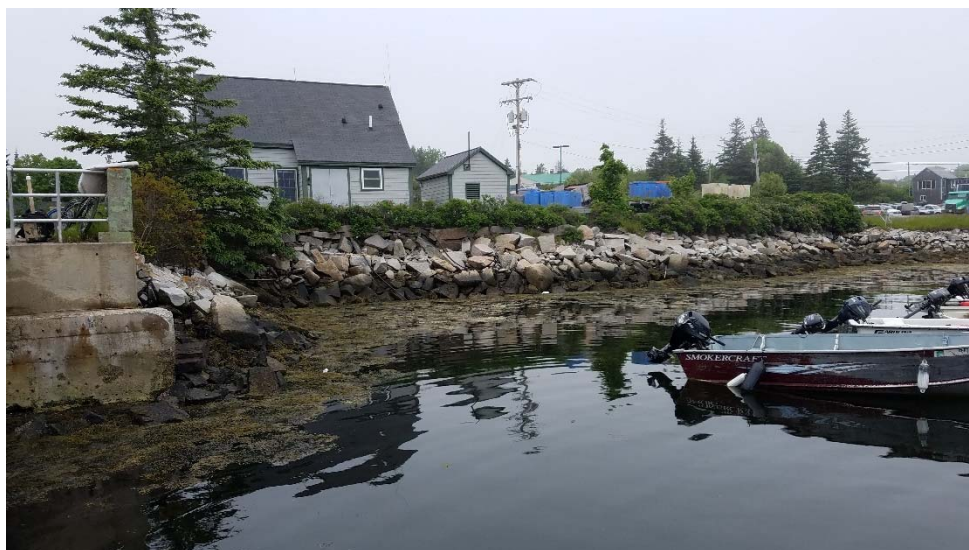
**Photograph No. 33:**

**Comment:**  
View of shoreline protection at the north side of the ferry terminal and floating dock.
