20 December 2019

Project Number: 3611191238

**Subject: Vulnerability Assessment and Resilience Planning, Ferry Terminal, Vinalhaven, Maine  
Penobscot Bay Working Waterfront Resiliency Analysis  
State of Maine, Department of Marine Resources**

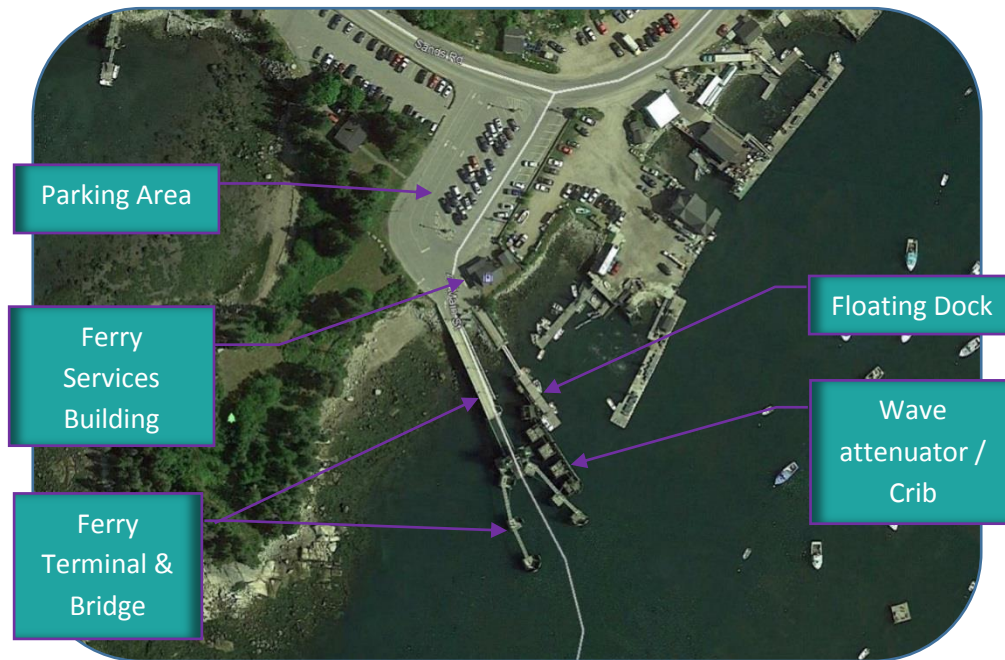
**Figure 1: Site Overview**

- The site consists of the ferry terminal, bridge, wave attenuator, floating dock, and parking area (See **Figure 1** below).
- The Ferry Services Building was built between 1999 and 2000 according to the as-built drawings.
- The crib wave attenuator/crib is constructed of timber framing and filled with large rocks and gravel.
- The original terminal was mostly demolished, however the concrete ramp which supports the floating dock remains.
- There is no formal ongoing maintenance plan in place; maintenance is addressed, as needed, when a deficiency is identified.
