Preliminary Design Report

Lane's Island Bridge #5270

Vinalhaven, Maine

WIN 021707.00

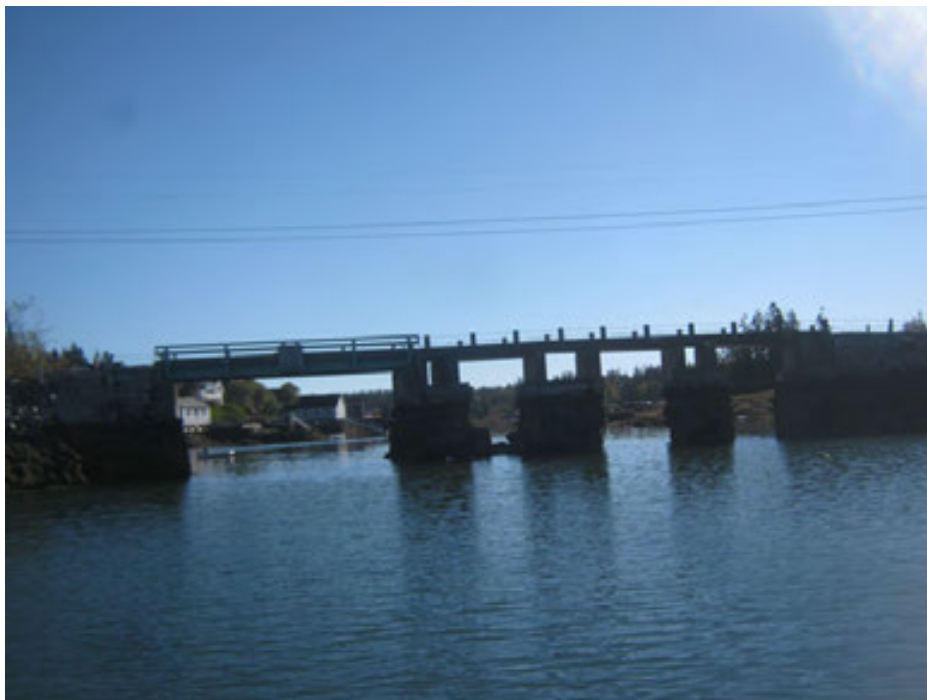
PHOTO 1

Description View of bridge from S side

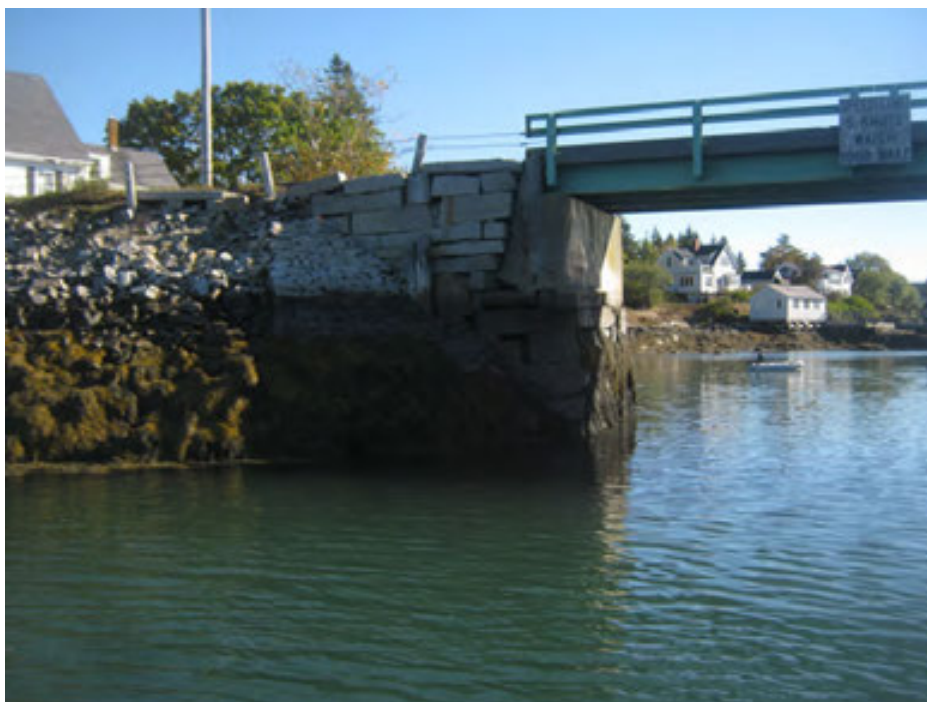
PHOTO 2

Description View of SW Abt

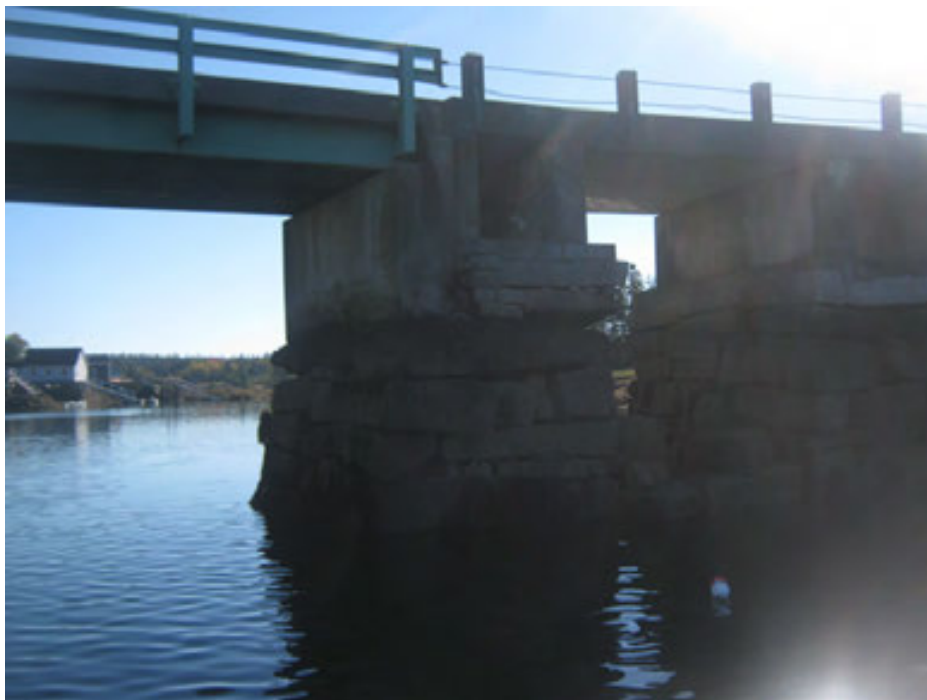
PHOTO 3

Description View of piers

PIERS: The dry stacked granite blocks with cast-in-place concrete caps bearing on marine sediment will be maintained. Larger voids in the granite piers will be filled with grout. Larger loose stones may be secured by pinning in place.

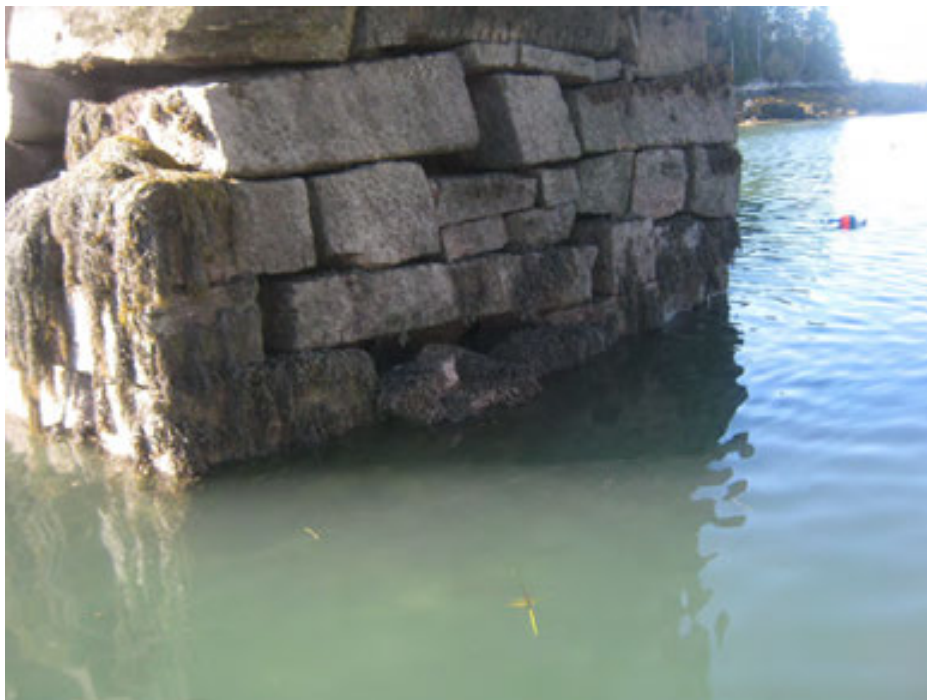
PHOTO 6

Description View of SW pier showing shifting stones and voids

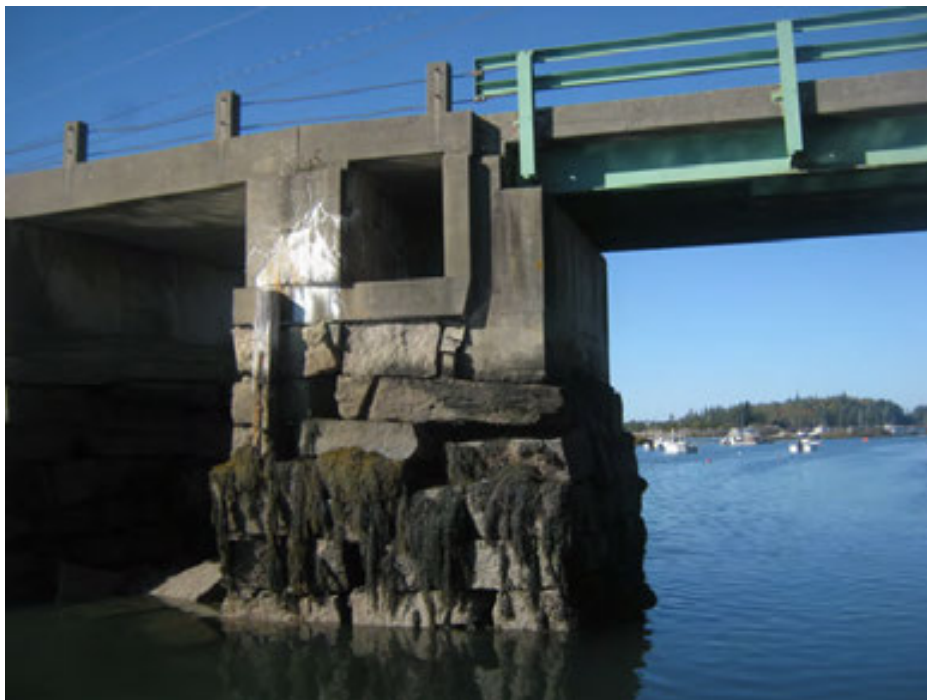
PHOTO 7

Description View of N end of SW pier showing voids in stones

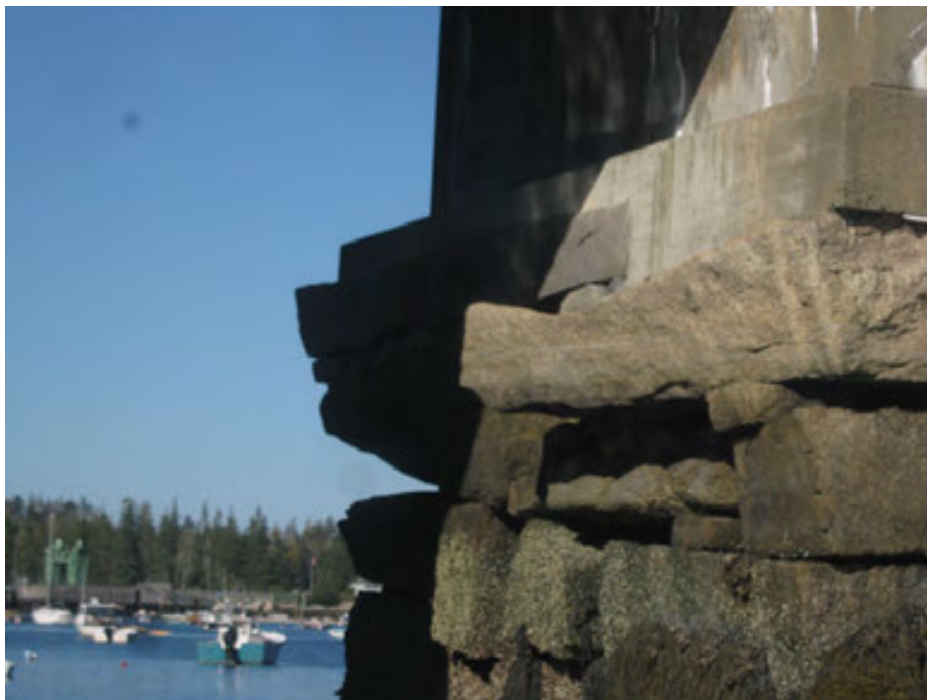
PHOTO 9

Description View showing stone shifting out of pier

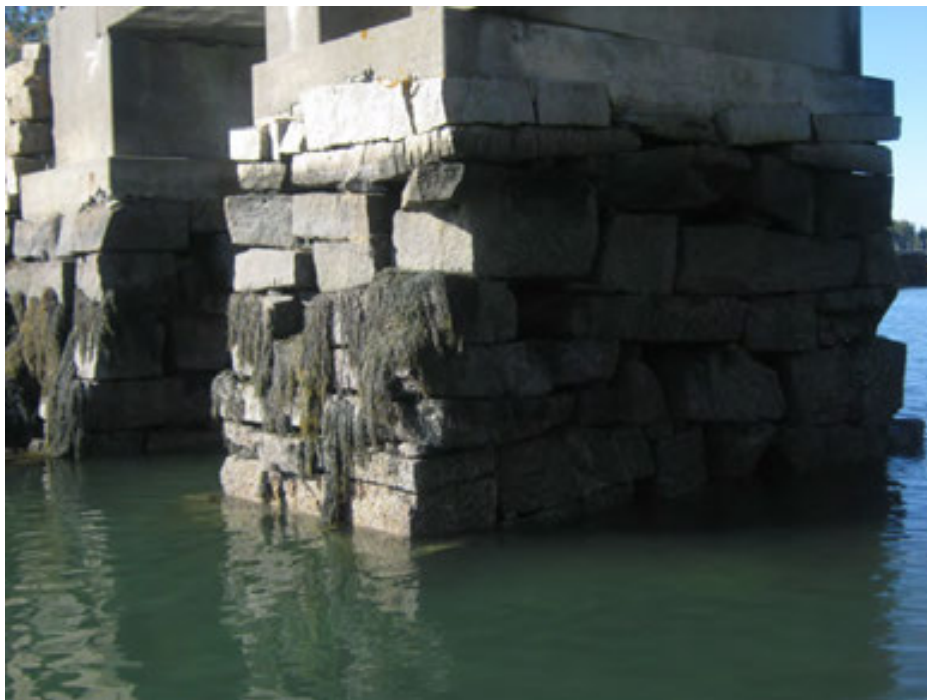
PHOTO 10

Description View of center pier showing shifting stones and voids

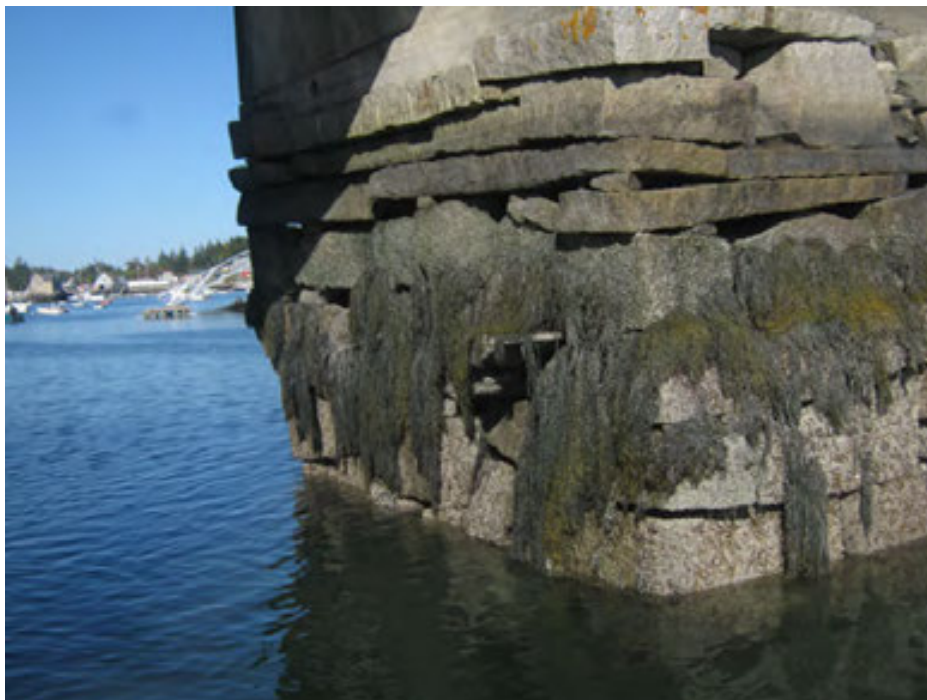
PHOTO 11

Description View of center pier showing shifting stones and voids

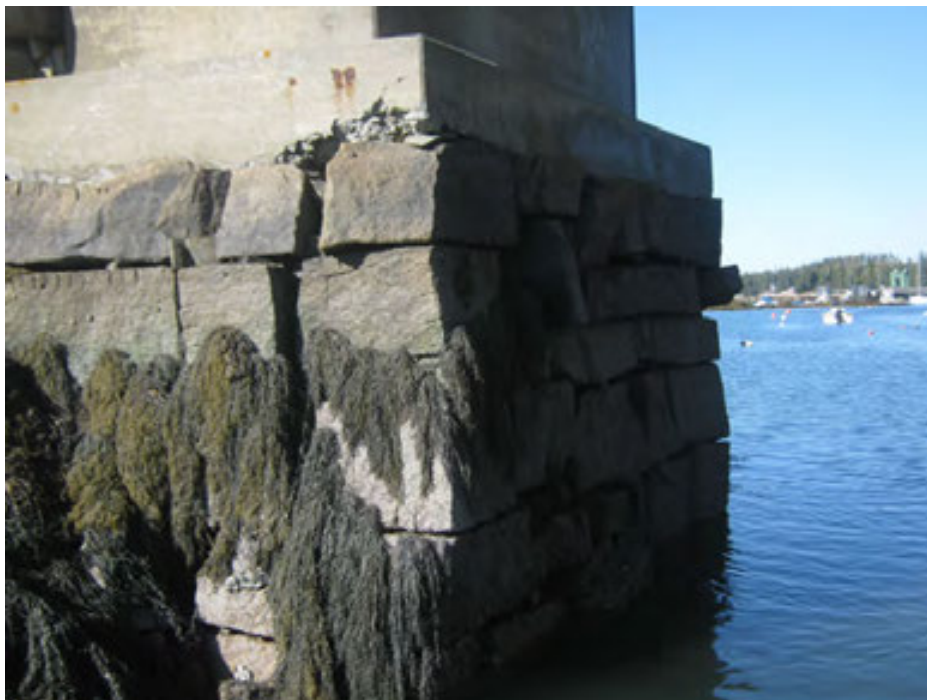
PHOTO 12

Description View of NE pier showing voids in between stones

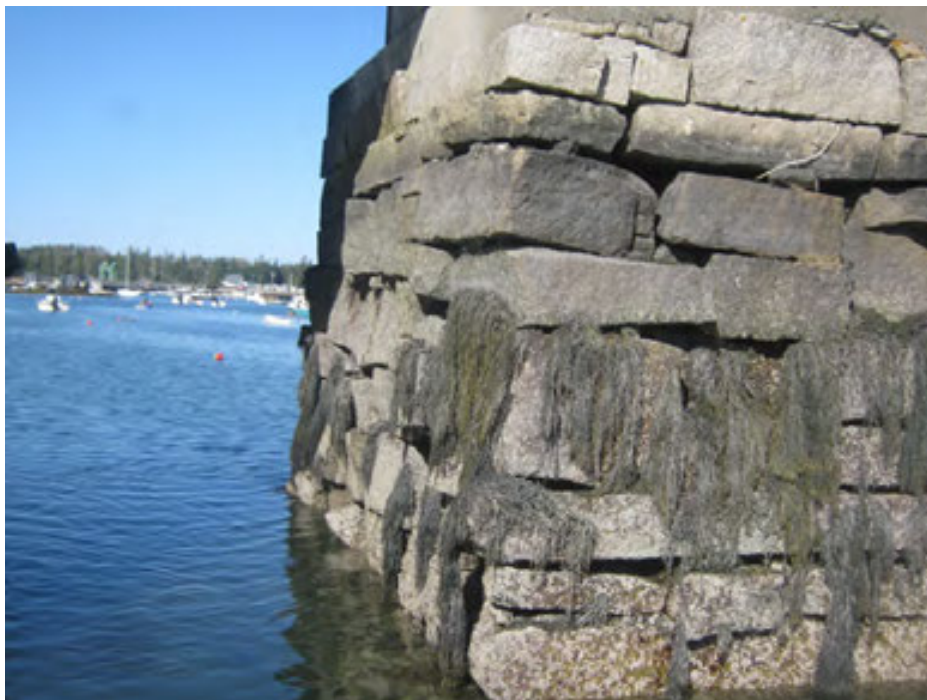
PHOTO 13

Description View of NE pier showing voids in between stones

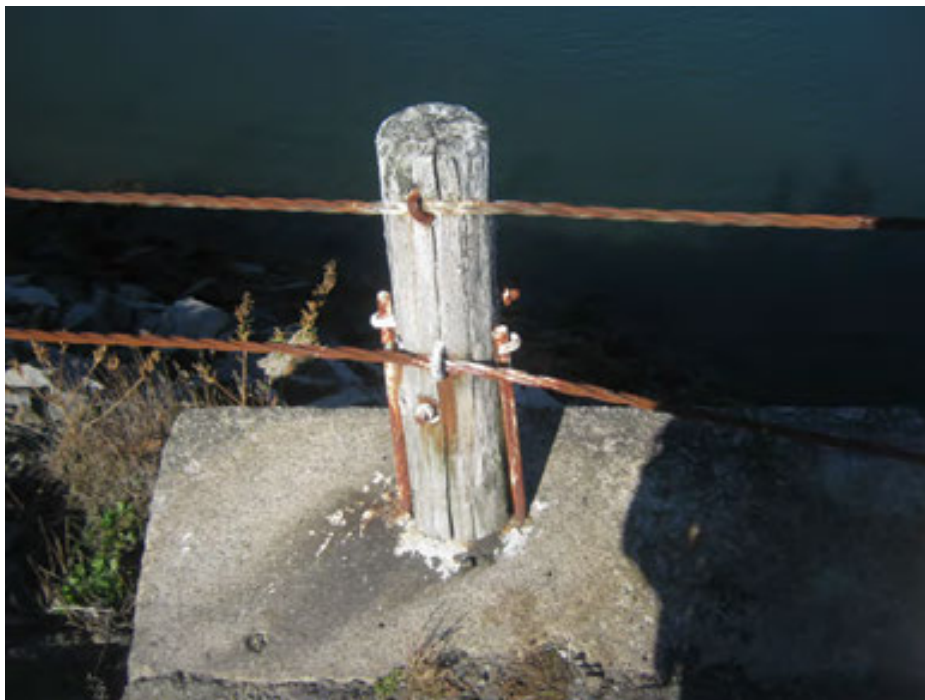
PHOTO 25

Description View showing rotted wooden rail post in concrete

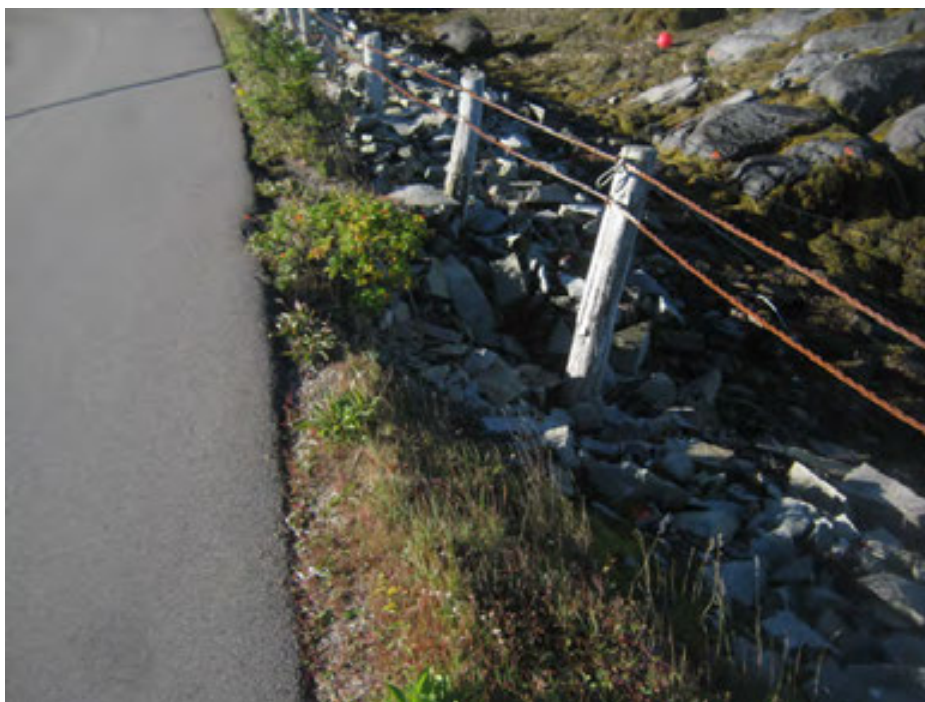
PHOTO 26

Description View showing leaning cable approach rail
