**TOWN OF VINALHAVEN
CARRYING PLACE BRIDGE REPLACEMENT
PRELIMINARY DESIGN REPORT**

Carrying Place Bridge
Maine DOT Bridge #: 0601

Calderwood Neck Road
over
Tidal Waters of Fish Cove & Winter Harbor

November 6, 2017

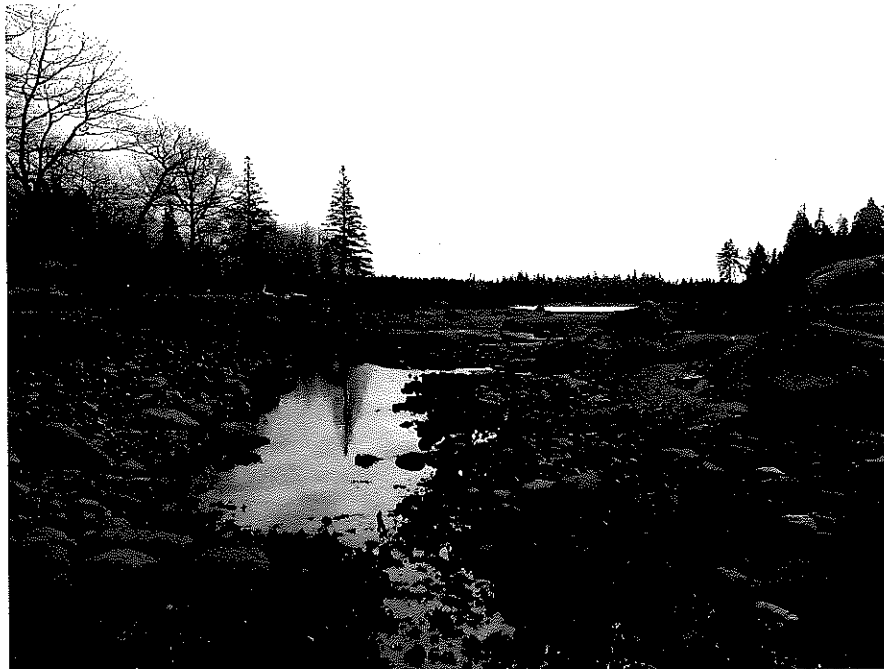
PHOTO 1 Elevation, Other

Description Looking downstream.

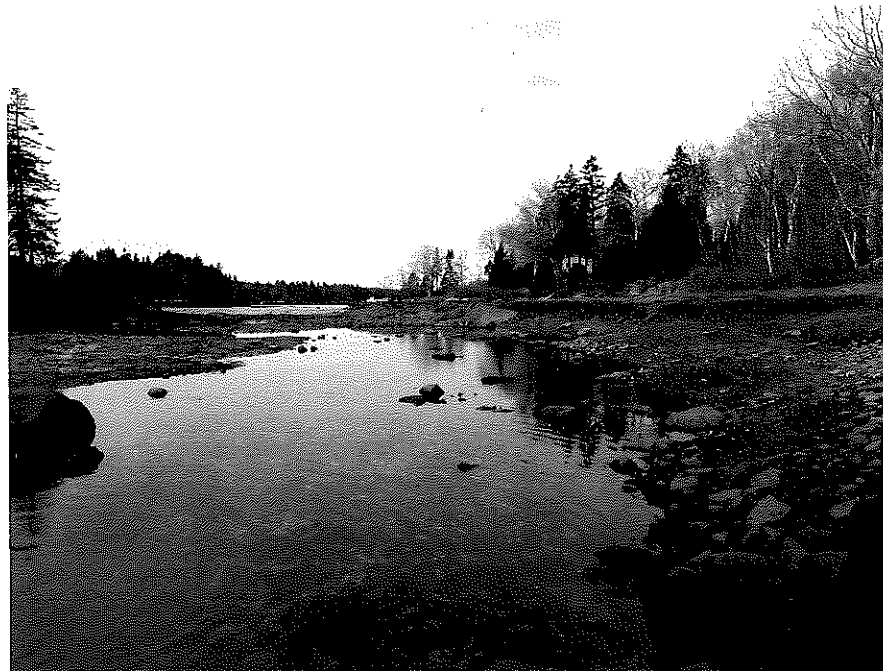
PHOTO 2 Elevation, Other

Description Looking upstream.

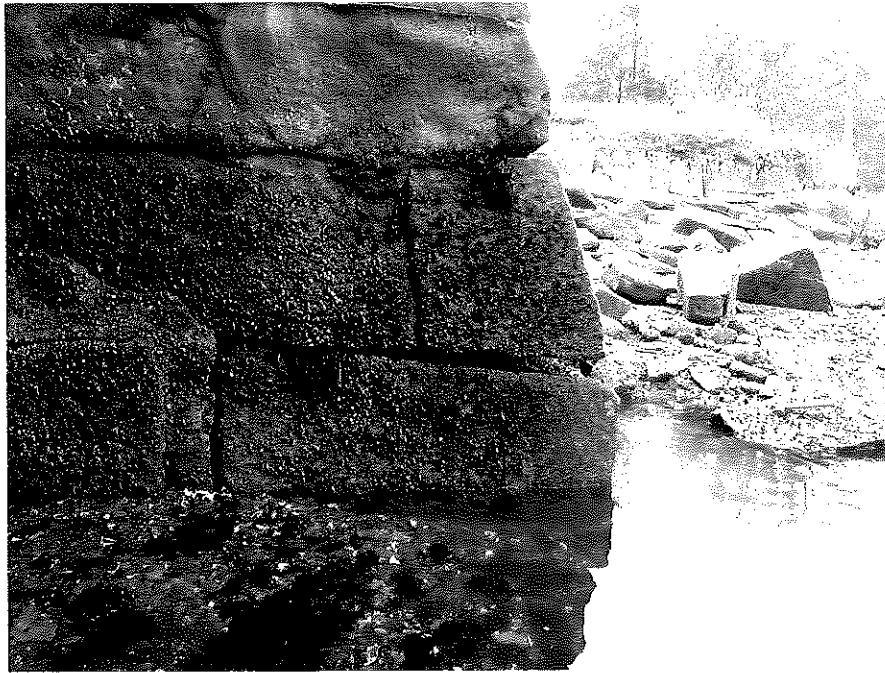
PHOTO 3 Elevation, Condition

Description Northwest corner, abutment.

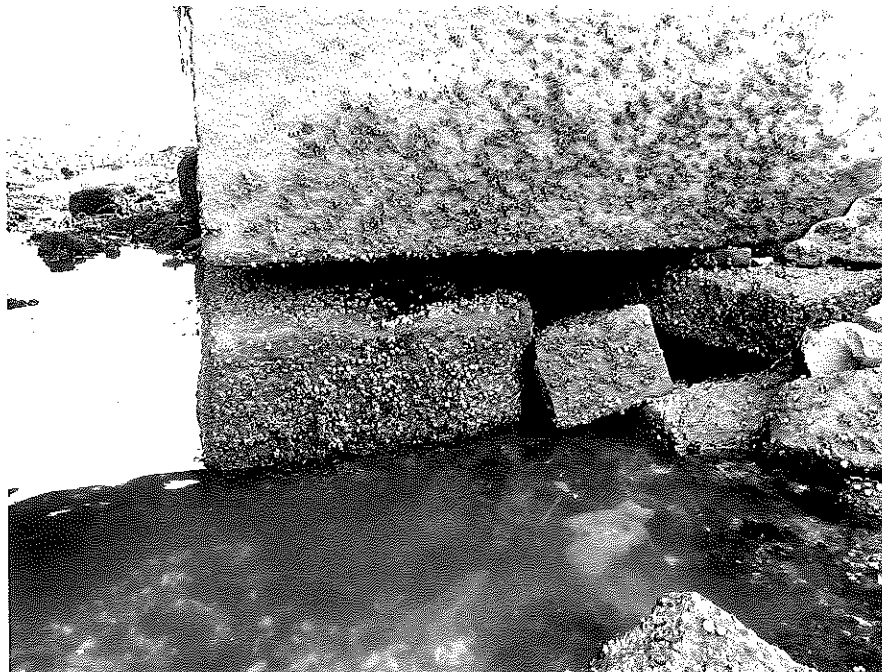
PHOTO 4 Elevation, Condition

Description Northwest corner, wingwall.

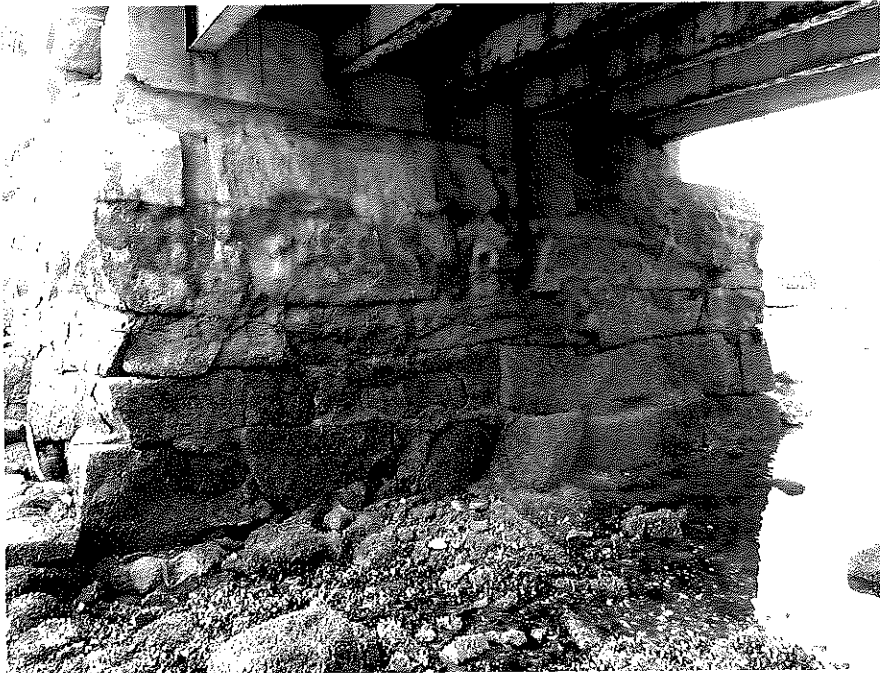
PHOTO 5 Elevation
Description Westerly abutment.

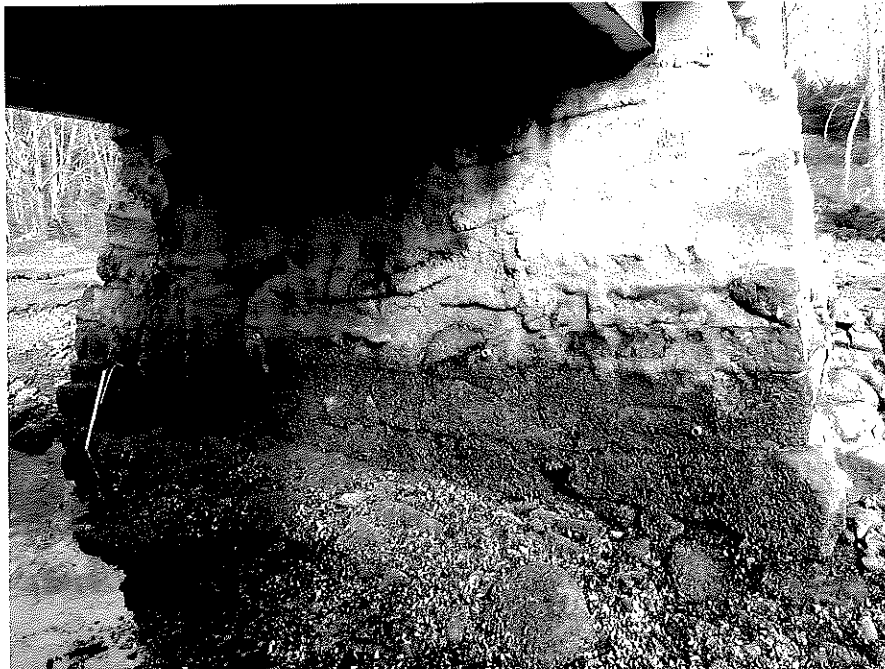
PHOTO 6 Elevation
Description Easterly abutment.

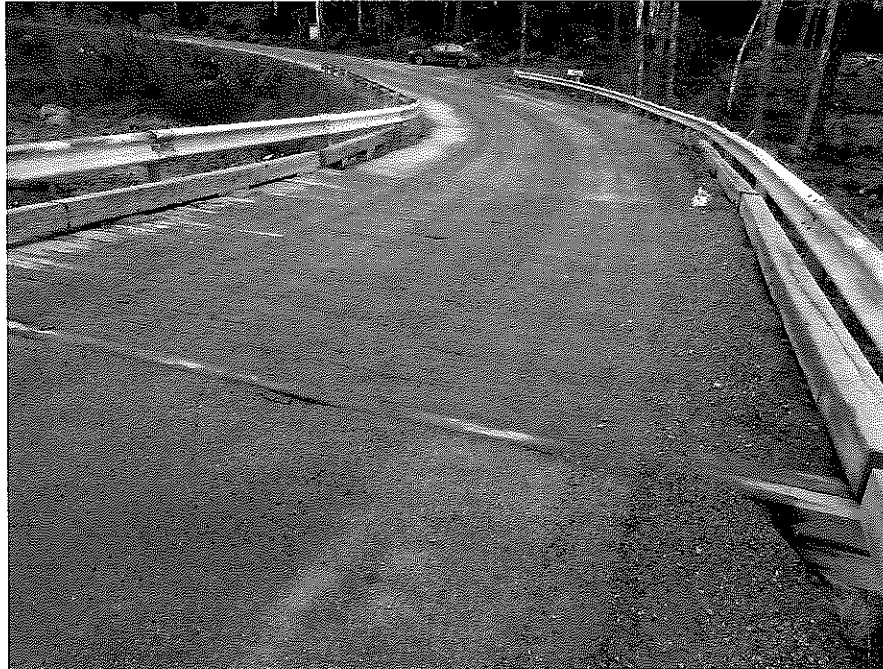
PHOTO 15 Elevation, Condition

Description General deck view.

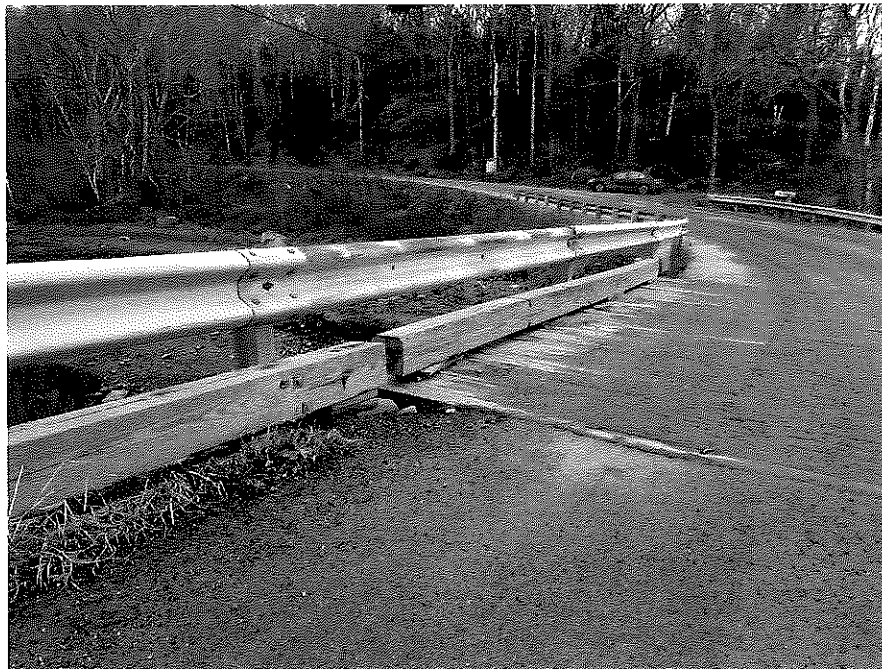
PHOTO 16 Elevation, Condition

No actual wearing surface on bridge. Approach roadway pavement in generally good condition. Guardrail is present although too high on the upstream side.

Description Typical railing view.

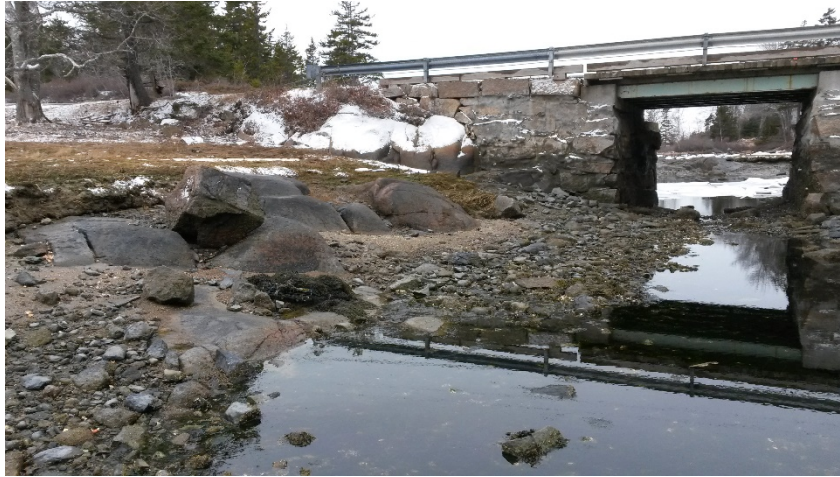
Carrying Place Bridge at Low Tide (South Side)

The existing bridge is constructed of steel I-beams, wood decking, and granite block abutments. The east abutment consists of elevated granite block or fill overlying saltmarsh. The west abutment consists of granite block overlying dipping bedrock. The saltmarsh includes grass to frequent cobbles at the tidal channel. The site topography along the abutments are further described as follows:

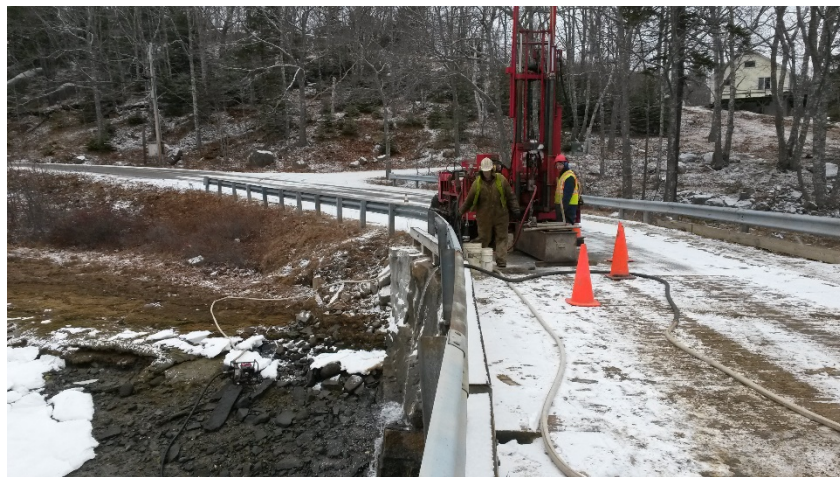
Northwest Abutment - Steep Fill to Grass Mud to Cobble Channel

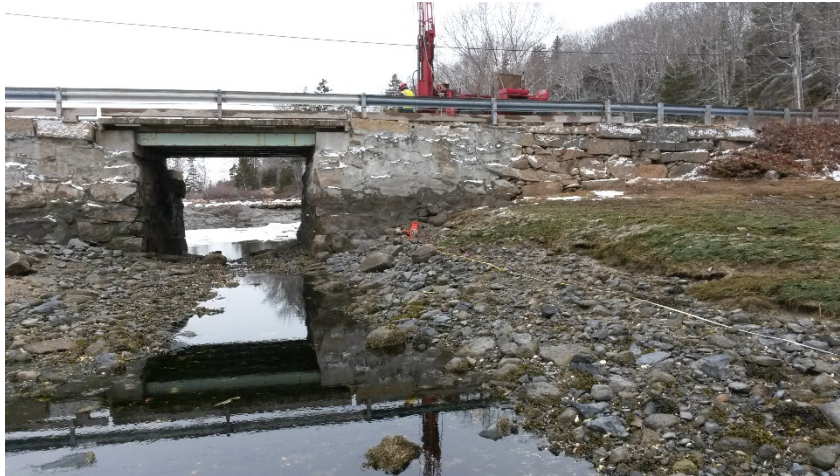
Northeast Abutment – Flat Grass Mud to Cobble Channel

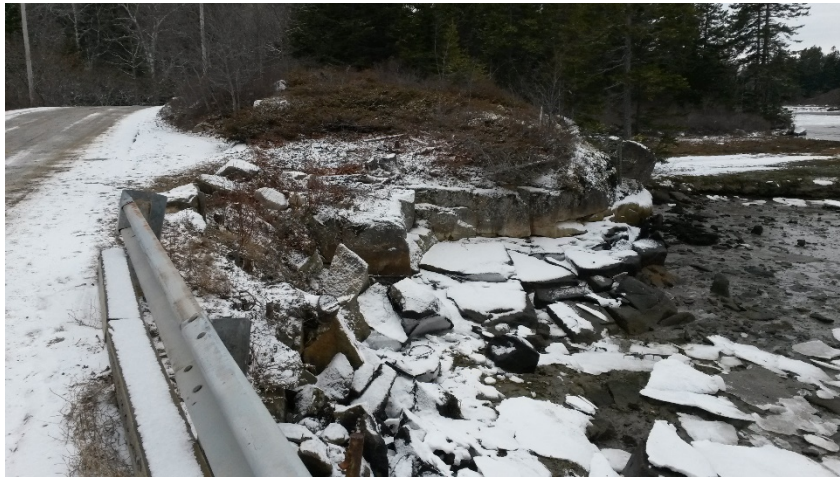
Southeast Abutment – Steep Bedrock to Mud to Cobble Channel

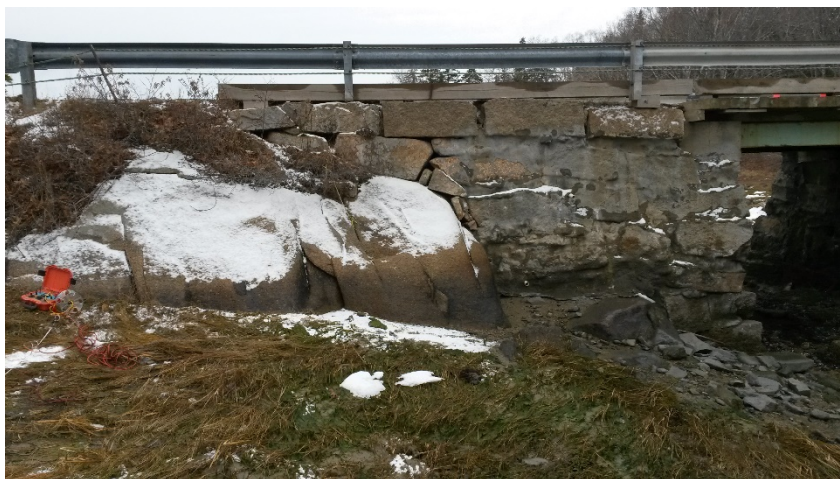
Southwest Abutment – Dipping Ledge to Mud/Ledge to Cobble Channel
